## 3D characterisation of RCF crack networks

Johan Ahlström, Casey Jessop, Lars Hammar and Christer Persson

Department of Materials and Manufacturing Technology, Chalmers University of Technology, SE-412 96 Gothenburg, Sweden

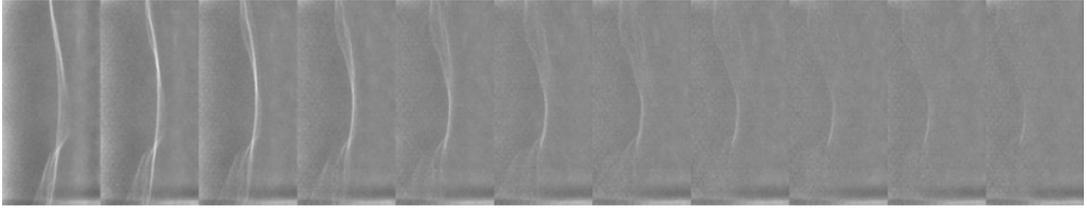
**Figure 1.** Series of pictures exposed at different angles from  $+80$ – $+60$  degrees relative to the rail head normal.

Figure 1 shows a compiled picture of one squat showing the different angles of exposure from  $+80$  –  $+60$  degrees relative to the rail head normal. It is evident that the relation between the angle of exposure and the crack plane is critical for the visibility of the crack.
