Root cause analysis of the folding deformation for the expansion joint in the nuclear power station

Abstract. In the nuclear power station, the expansion joint of moisture separator re-heater (MSR for short) was founded locally folding deformation under the outage condition. Folding deformation increasing will lead expansion joint leak, it would cause emergency stop when leaking seriously. To solve these problems, this paper analysis mainly on three aspects: the material organization performance, the expansion joint installation and the stress characteristic of expansion joint. Both the verticality deviation in the process of installation and the material hardness value exceed standard are the root cause of these problems. At the end of the paper, the improvements have been put forward for this problem.

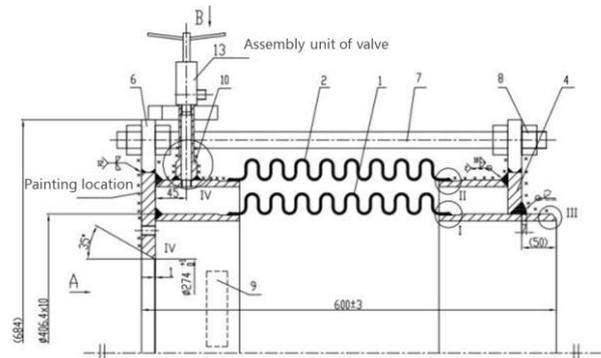
Figure 1. First and second level hydrophobic expansion joint.

The folding deformation expansion joint is secondary hydrophobic expansion joint of MSR in this nuclear power station. Expansion joint has inside and outside part; each part divided into 5 layers and each layer is 0.6 mm.

Through hydraulic forming making the internal and external layers fit closely, as shown in figure 1. According to maintenance manual operation, the equipment parameters of first and second level hydrophobic expansion joint are as in Table 1.

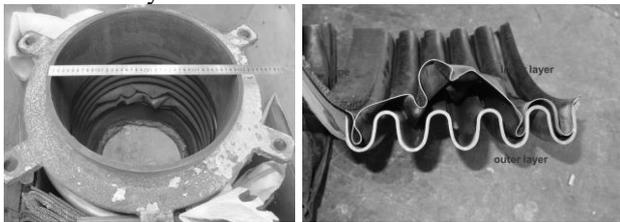
Three corrugated segments of expansion joint has folding deformation on the side where is taking over the end surface area. The maximum deformation position has about 20 mm length crevasse shape defect, it has obviously plastic deformation on both ends of the defect, as shown in figure 2. When cut the both ends of the expansion joint, found that deformation is only in the innermost layer 1 where is taking over the end surface area near the bottom part of the expansion joint, no deformation appears in the other four layers. The outside part expansion joint does not have deformation, the ends of the first layer and the rest four layers exists gap, which was not totally fit.

Figure 2. The deformation morphology of expansion joint.

Peeling off the innermost layer 1 where has folding deformation, found that the rest four layers of corrugated pipe have no crack, and no traces of corrosion around the crevasse. Using asana microscope observed inside and outside section morphology of the expansion joint, wave height of inside part is 29.6 mm by measured, pitch of wave is 41.6 mm. The wave height of outside part is 29.1 mm by measured, pitch of wave is 36.2 mm. The design of wave height is 29 mm, pitch of wave is 36 mm. Measurement data shows that the inside part of expansion joint has been out of shape.

1) Given the expansion joint has quality defects, whose displacement has small allowance and installation precision is difficult to control, suggesting that choosing bigger displacement allowance expansion joint, and waiting right time to replace it.

2) Before the expansion joint replacement has been finished, evaluating the expansion joint of MSR system. According to the evaluation results, arrange the reasonable replacement order.

3) Update version of installation procedures, the expansion joint of the original horizontal displacement and radial displacement measurement, ensuring that the expansion joint displacement allowance is enough.

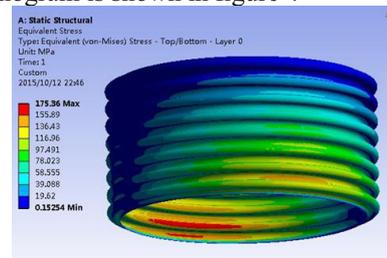
(1) When the horizontal displacement is 4 mm, the stress nephogram is shown in figure 4

Figure 4. The stress nephogram of expansion joint.

Stress simulation results show that when the expansion joint stress deformed, the highest stress position is on the end of corrugated pipe where is connecting with the pipe. The simulation result is consistent with the deformed position. When the horizontal displacement is 4 mm, the maximum stress is 175.56 Mpa [5]; When the horizontal displacement is 9 mm, the maximum stress is up to 394.56 Mpa, almost exceeds material yield limit [6].

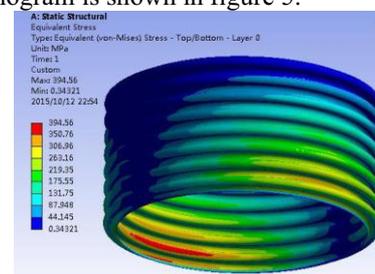
(2) When the horizontal displacement is 9 mm, the stress nephogram is shown in figure 5.

Figure 5. The stress nephogram of expansion joint.

2) When the expansion joint is under the force, the highest stress position is on the end of the corrugated pipe where is connecting with the pipe. The simulation results are in conformity with the deformation position. Expansion joint folding deformation position locates in the maximum horizontal displacement. Macro and micro analysis shows, the welding ends and corrugated pipe has no abnormalities, those exclude the possibility that gas first came into the expansion joint interlayer. When the interlayer of expansion joint has water, the expansion joint has condition to deform. Based on the above evidence, this paper thinks that the innermost layer of expansion joint in maximize deformation first occurs to crack.
