Role of defects in fatigue damage mechanisms of cast polycrystalline superalloy MAR-M 247

Miroslav Šmíd, Stanislava Fintová, Ludvík Kunz and Pavel Hutař

Institute of Physics of Materials, AS CR, Žitkova 22, Brno 616 62, Czech Republic

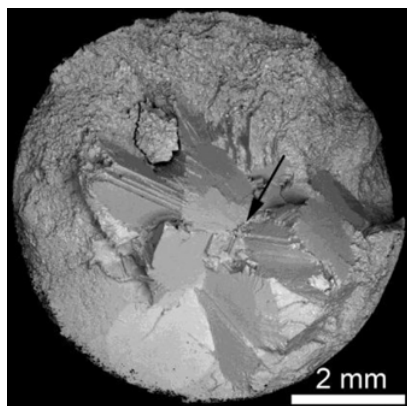
Figure 1. Crystallographic fatigue fracture surface of specimen cycled at 650 °C, ($\sigma_a = 220$ MPa, $N_f = 2.0 \times 10^6$). The fatigue crack initiation site is marked by arrow.

The fatigue fracture surfaces revealed changes in appearance due to the increase of the test temperature. Crystallographic fatigue crack propagation with characteristic facets on the surface was dominant for tests at 650 °C (see Fig. 1). Observation of longitudinal cross-sections of specimens revealed intensive cyclic slip activity along the activated shear planes. EBSD analysis confirmed that these planes are of (111) type. Extend of crystallographic crack propagation was significantly lower at temperature 800 °C. The facets appeared just in the vicinity of the crack initiation sites and from a certain distance the fatigue crack propagated by non-crystallographic mode macroscopically perpendicularly to the loading axis. This mode of fatigue damage was dominant even in areas around crack initiation site at temperature 900 °C (see Fig. 2). This change of the fracture surface appearance is mainly caused by emergence of thermally activated processes in structure like diffusion and dislocation climb and cross-slip.

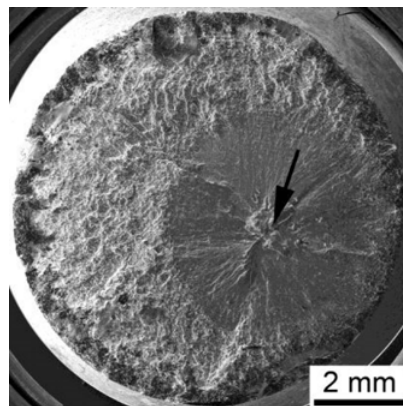
Figure 2. Non-crystallographic fatigue fracture surface of specimen cycled at 900 °C, ($\sigma_a = 220$ MPa, $N_f = 6.51 \times 10^5$). The fatigue crack initiation site is marked by arrow.
