Study of the Use of Lime Plaster on Heritage Buildings' in Malaysia: A Case Study in George Town, Penang

A.A. Mohamed Sabri¹, M.Z. Suleiman^{2,a}

^{1,2}School of Housing, Building and Planning, Universiti Sains Malaysia, 11800, Penang, Malaysia

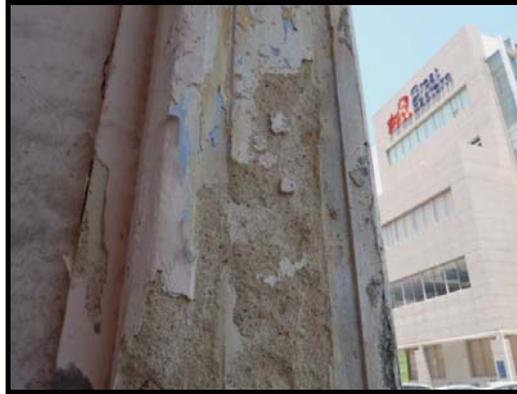
Overall, it can be clearly seen from Figure 3 that the most commonly occurring building defects were staining, discolouration, and chalking. The least common defects were erosion of mortar and efflorescence. Plaster is used to protect the brick and to create surface finishes for wall paint. However the use of cement plaster on a wall will trap moisture inside the wall, and after a few years, the plaster will start to crumble and eventually fall off (Figure 4). The same thing will happen to the wall when

using chemical paint that does not allow the wall to breathe. From the site observations, a few buildings were identified that were using incompatible materials. The use of incompatible materials will cause walls to deteriorate. Cement rendering and chemical paint were identified as the main factors contributing to wall deterioration.

Fig 4: Wall deterioration due to the use of incompatible materials.

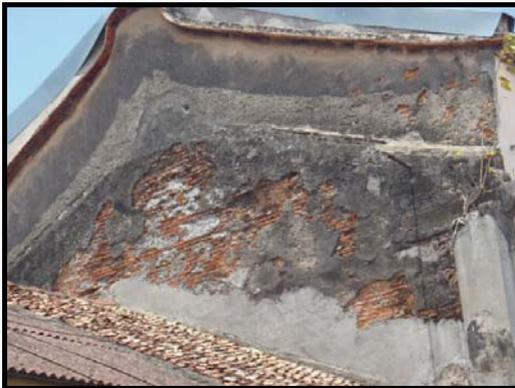
The combination of discolouration, chalking, staining, and peeling paint is due to environmental effects. Stains are a type of discoloration produced by foreign substances that have penetrated into the masonry of a building. The result is a chemical reaction between the masonry and the foreign matter. Two types of stains were found from the site observations in this study; these were bio-growth and black crust due to air pollution as shown in Figure 5. The most common stain found was a type of black layer on the external surface caused by vehicle smoke. Stains due to bio-growth are caused by moisture. Surface repainting will not solve both of these stain problems. Moreover, a serious stain problem will lead to damage to the façade in the form of loss of plaster and erosion of mortar.

a) Black crust due to air pollution

Fig 5: Two types of stains found in George Town, Penang.

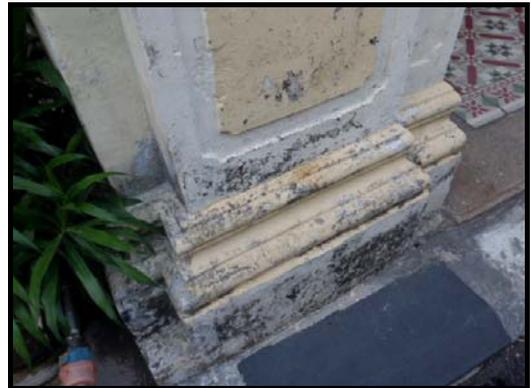
b) Black stains due to bio-growth (algae)

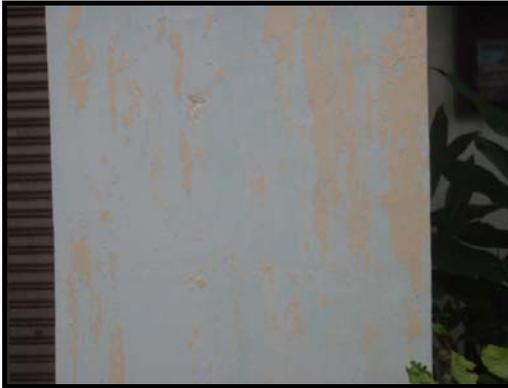
Chalking or powdering of the paint surface is caused when resin in the paint film is slowly weakened. The amount of chalking can be determined by the formulation of the paint and the amount of ultraviolet light to which the paint is exposed [6]. Chalking can be considered a way for the paint to “age.” Discolouration of paintwork was commonly found in several historical buildings. This was due to the impact of the climate in George Town, Penang. Discolouration also happens when minerals in the paint react with water or chemical cleaners. Peeling paint could be the result of improper surface preparation or due to incompatibility between paint types. As an example, the use of a non-breathable type of paint on a lime plaster surface, such as a chemical paint, will prevent evaporation and the

excess moisture will lead to wall deterioration (Figures 6 and 7). Paint bulging or blistering is the result of common application errors. It is not likely caused by moisture, but rather, by the reaction of ambient heat on paint. When paint is applied in direct sunlight, the top surface will dry quickly, and, as a result, moisture will get trapped beneath the dried paint. When the moisture vaporizes, it forces its way through the paint film. This problem occurs mostly to dark coloured paint because dark colours absorb more heat than lighter ones.

Fig 6: Discolouration on a wall

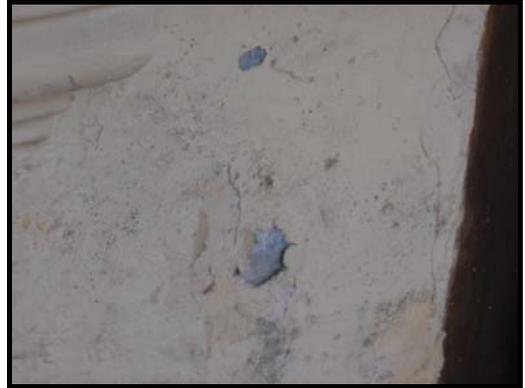
Fig 7: Peeling paint on exterior wall
