Vibration testing and evaluation for source detection of bothersome structural vibrations

Matthew A. Pavelchak^{1,a}

¹Walter P. Moore and Associates, Diagnostics Group, Houston, Texas, United States of America

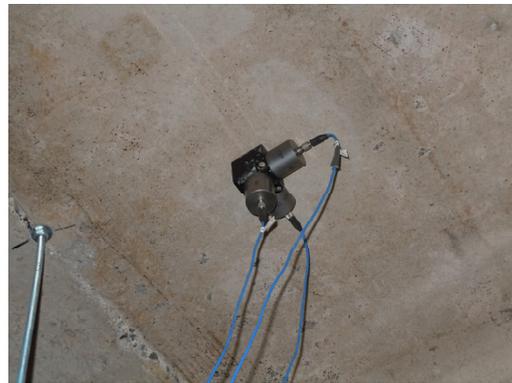
A tri-axial accelerometer cluster was installed on the underside of the operating room slab from the interstitial space as shown in Figure 1. This approach allowed for instrumentation without contaminating the sterile surgical suites. Initial results indicated that the principle vibrations at this location were in the vertical orientation with a peak response of approximately 7,000 MIPS at 12 Hertz (Hz). These vibrations fluctuated overtime but were generally continuous in nature.

Figure 1. Tri-axial accelerometer cluster installed on floor slab.

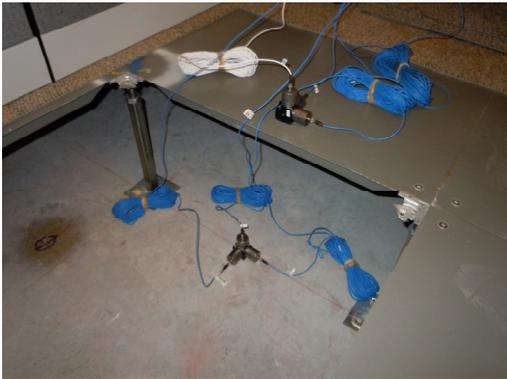
Accelerometers were installed on both the structural floor system and the raised floor system at the location of the occupant complaints as shown in Figure 2. The intermittent nature of the vibrations significantly complicated source detection as the timing and duration of detectable events could not be forecast. During periods without vibration events, systematic testing of adjacent mechanical systems including AHUs, elevators, and pumps was conducted.

Figure 2. Tri-axial accelerometer clusters installed on the structural floor slab and raised floor system.

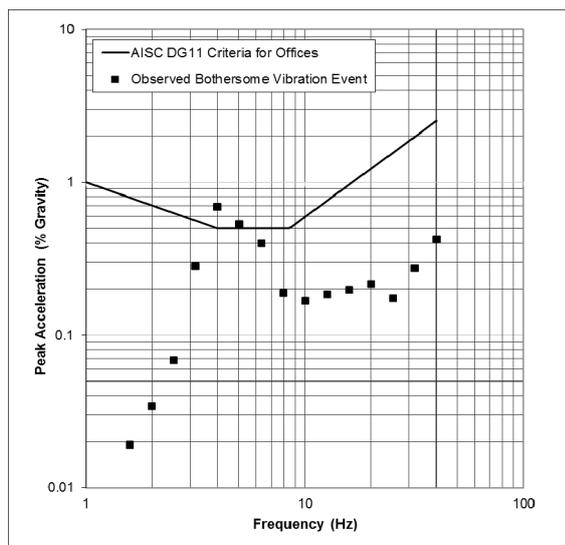
Near the end of the first day of testing two perceptible events were captured lasting approximately 10 minutes each. The results indicated exceedance of the AISC DG11 limits for human perception in an office setting at 4-5 Hz as shown in Figure 3. Similar monitoring was conducted on Level 11 below. The baseline measurements (excluding bothersome events) were found to be comparable between the two floors.

Figure 3. Comparison of bothersome vibration event and AISC DG11 limits for human perception utilizing third octaves analysis.

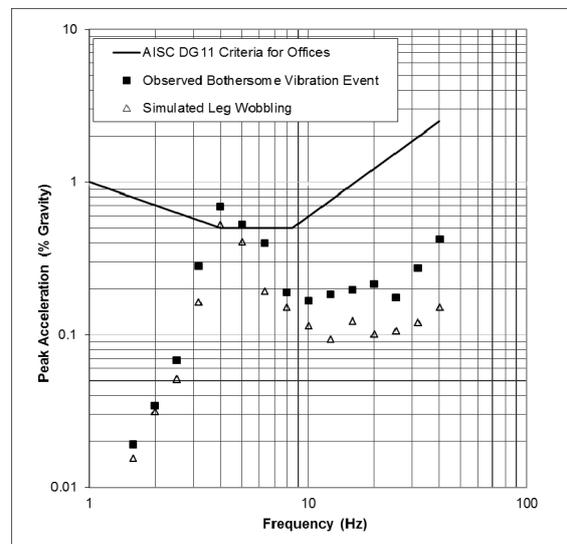
Having ruled out likely mechanical systems and group walking, focus shifted to observing localized staff behaviour. Eventually it was observed that a staff member several workstations removed from the area of complaints was vigorously bouncing/wobbling both legs while working at his computer. Further observation indicated that times of extreme activity by this staff member corresponded to perceptible events. He was observed to be bouncing/wobbling each leg at approximately 2 Hz in a staggered fashion very closely matching the 4 Hz natural frequency of the floor system.

After hours when the staff had left for the day the observed behaviour was recreated and compared with the results obtained earlier in the day as shown in Figure 4.

Figure 4. Comparison of bothersome vibration event, simulated leg bouncing activities and AISC DG11 limits for human perception utilizing third octaves analysis.

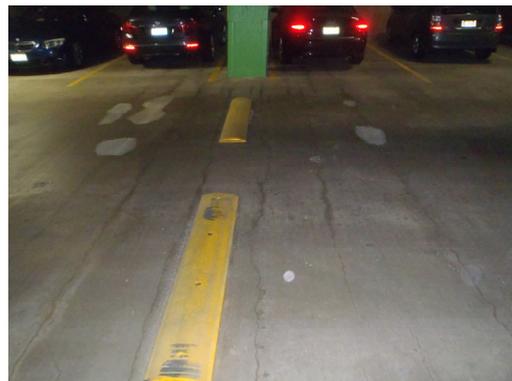
Once it was determined that the vibrations were not unique to the fifth floor, observations and testing spread out vertically centered around the columns adjacent to the location of the complaints on the fifth floor. During this process a speed bump was observed adjacent to the column line on the top level of the subterranean parking garage as shown in Figure 5. Observation of the garage traffic and simultaneous review of the vibration data on the fifth floor confirmed the link. The vibration events were correlated with vehicles traversing the speed bumps at a high rate of speed. Vehicles traveling at slow speeds did not produce noticeable events.

Figure 5. Speed bumps adjacent to the column line of interest.

After presenting the data to the building management, the modular speed bumps were removed from the garage slab and the testing was continued for another working day. The results of the monitoring without the speed bump confirmed that the perceptible vibration events had been eliminated as shown in Figure 6.

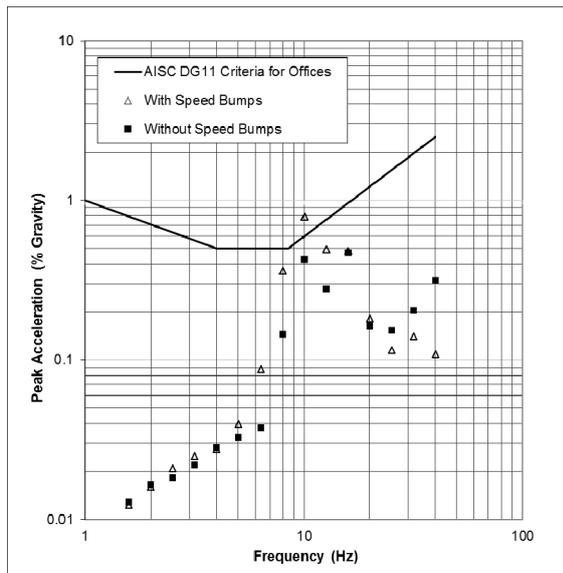
Figure 6. Comparison of vibration levels with and without the speed bumps installed with AISC DG11 limits for human perception utilizing third octaves analysis.
