Creep damage assessment of a 50 MW steam turbine shaft

Abstract. This paper reported the evaluation of a 50 MW steam turbine shaft that has exceeded the designed lifetime (30 years). The inspection of turbine is a mandatory for safety and continued reliable operation. The shaft was made of nickel-chromium-molybdenum alloy steel. The turbine operated in the range temperature of 500-600 °C, and creep was considered to be a major damage mechanism. The remaining life assessment of the turbine shaft was also conducted using replication technique. The replica samples were taken from 125 position distributed along the turbine shaft. The microstructural analysis of replicas showed that creep had occurred, which was indicated by the cavities formation at the grain boundaries. After evaluation and assessment, it can be concluded that the turbine shaft still can be used however it needs to be re-inspected within 6 months.

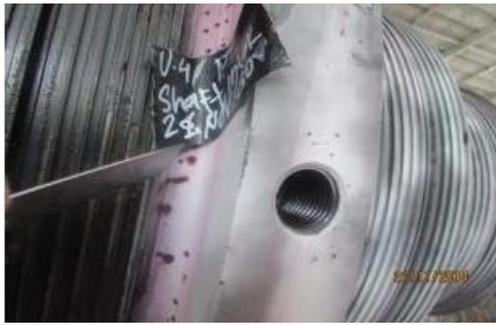
(a)

Pitting occurred due to the effect of the corrosion environment in which during the process and the phase transition of working fluid took place from dry surface to wet region. Furthermore, the turbine shaft has been operated for 30 years. The pitting condition was then clarified by Eddy current and UT phased array. The eddy current surface test results show that no fine cracks were detected on all areas.

Scanning on overall surfaces of the turbine shaft using UT phased arrays results no reflector of defects appeared in the monitor. Hence, it can be concluded that the pitting was observed by dye penetrant test occurred only on the surface and no evidence the pitting propagated towards inside the turbine shaft as well as internal defect. The microstructural analysa of 125 replica samples gave strong evidence that creep had occurred in the steel. Two optical images of replica taken from different areas are shown in Figs. 5 and 6.

Figure 4. Penetrant test results on inspected turbine shaft

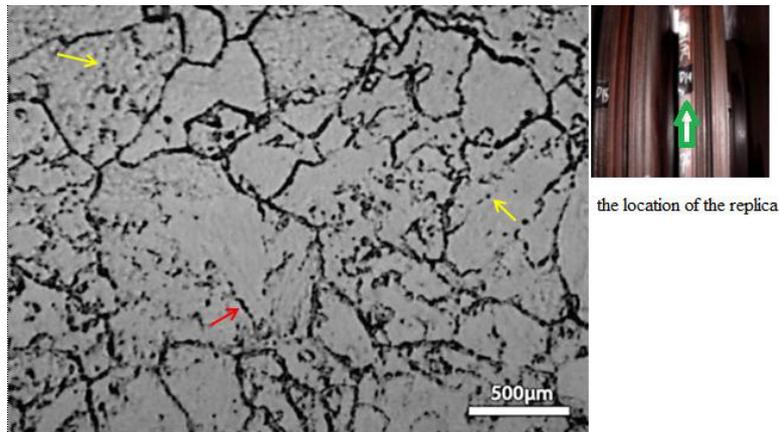
Figure 5. An optical image of replica (left) taken from 14th stages showing isolated (yellow arrows) and oriented cavities (red arrows) and location of replica was taken (right, indicated by green arrow).

Figs 5 and 6 show that a change in the microstructure occurred by forming isolated and oriented cavities at the grain boundaries. The presence of those cavities gives significant evidence that the turbine shaft had creep damage. The cavities start linking up to develop microcracks. From microstructural analysis of 125 replicas, 90 % of them show that the isolated and oriented cavities were present and 10 % of replicas reveal that microcracks had already formed. From this point of view, the remaining life of turbine shaft was assessed adapting the data in Table 1. Although only 5 % of the replicas analyses exhibit the microcracks however it is important and used as a basis in determining the stage of damage, namely stage C. Hence, it is clearly that the inspected shaft turbine needs to be re-inspected in 6 months.

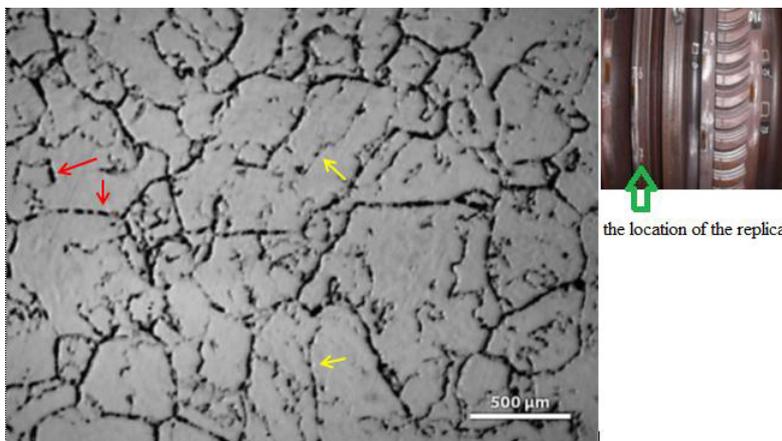
Figure 6. Replica image (left) taken from 14th stage showing isolated (yellow arrows) and oriented cavities (red arrows) and location of replica was taken (right, indicated by green arrow).
