Surface Defects on Forged Nut of Stainless Steel

Abstract. Surface quality of nuts used in gas pipe joints is an important issue because the surface state affects the fatigue characteristics. Surface defects of nuts produced by warm forging from a stainless steel are observed and the cause of defect generation is discussed based on the numerical results of FEM simulation. It is revealed that there exists the lap defect on the drawn wire surface with an opened end and the surface defects on the forged nut are generated by the tensile stress during forging since there exists a moment at almost the whole area of the billet surface that a tensile stress over 200MPa is generated during nut forging.

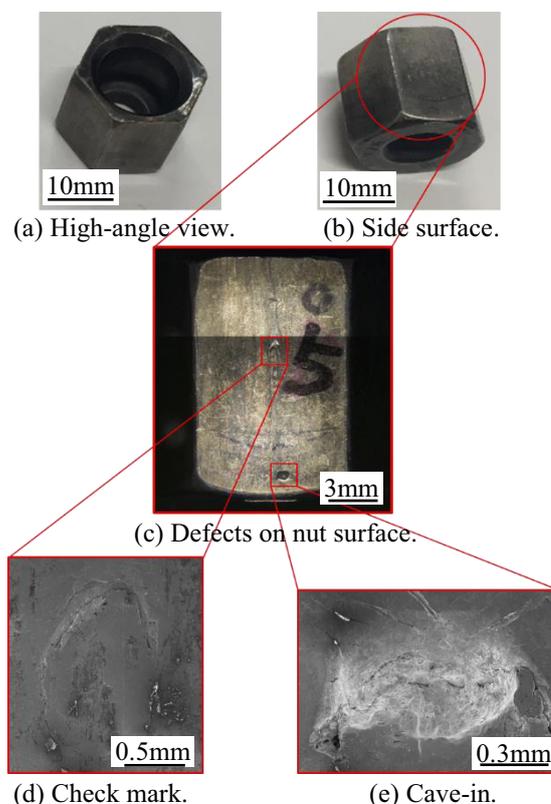
Nuts under investigation in the present paper are used in gas pipe joints (**Figure 1**) for experimental devices and buildings. These gas pipes serve mainly for poisonous gases and flammable gases. Serious accidents occur if the gas pipe joint in the service had been broken. Therefore the demand for nuts is severe and the surface quality of the nut is considered as an important issue because the surface state affects the fatigue characteristics [1, 2]. However, the nuts produced by warm forging sometimes have surface defects as shown in **Figure 2**. The nut is produced from a drawn wire of SUS316 by four stages forging; upsetting, 1st extrusion, 2nd extrusion and piercing. Figure 2(d) shows a check mark on the nut surface, Figure 2(e) gives a cave-in. The cave-in appears near the bottom of the nut. A few check marks exist almost on a straight line.

Figure 1. Nuts used in gas pipe joint.

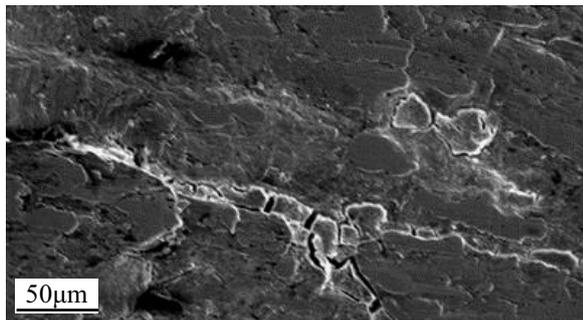
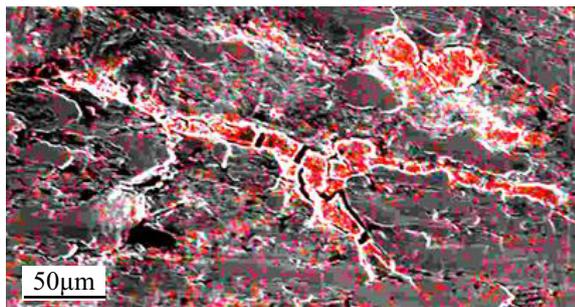
As shown in **Figure 3**, some particulate zones are seen and their surfaces are covered by lead. As shown in **Table 1**, the chemical composition in the particulate zones is distinctly different with that of the stainless steel shown in **Table 2**. The main compositions, Pb, C, S in the particulate zones perhaps come from ingredients of the lubricant used in the forging process [4, 5]. No hard particles can be found on the surface of forged nuts.

Figure 3. Photograph of nut surface.

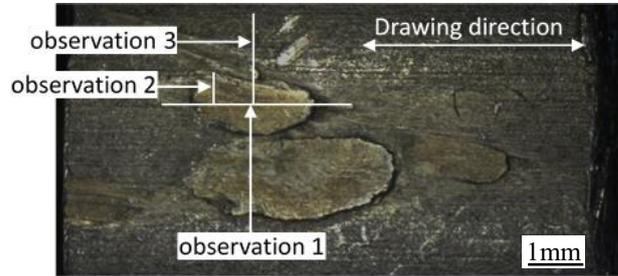
The billet in warm forging is cut off from a coil of drawn wire. First, the billet surface is observed with a microscope. **Figure 4** shows the observation results. The lap defects perhaps become the cause of the surface cracks of nuts.

Figure 4. Defects on wire surface.

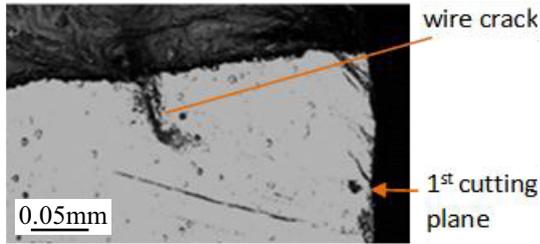
Cross-sectional structure of the defects at observation 1 is shown in **Figure 6**. The defect has an open end and connects perfectly at the other end. Observation 2 and 3 are made to check connecting situations in the hoop direction of billet. As shown in **Figures. 7, 8**, observation 2 shows almost perfect connecting although there exist caves at the ends of the defects. Observation 3 shows a crack throughout the length of the defect. It is found that the defects on the wire surface in the present study have the connecting part with the substrate material and the cracking part. It is difficult to clarify the cause of defect generation, but the possibility is extremely high that the cause of defect generation is due to unsuitable forming conditions of the rolling and wire-drawing process [6-8].

Figure 7. Crack at observation 2.

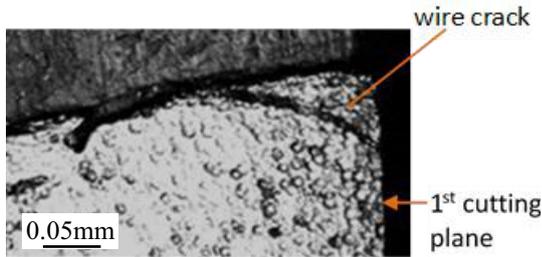
Figure 8. Crack at observation 3.

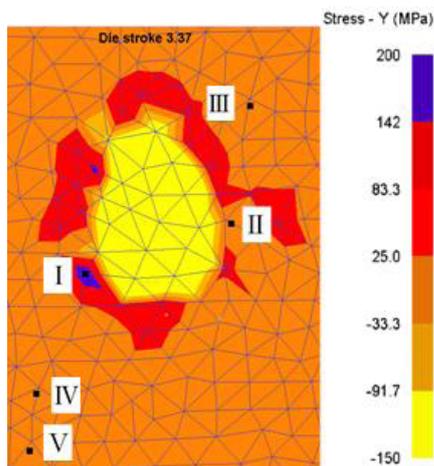
Figure 11 shows the stress state of the surface in the radial direction when the point 1 comes to contact with the die surface. It can be found that the surrounding area of the contact area with the die surface is in a tensile stress state.

Figure 11. Image of simulation result and points position.

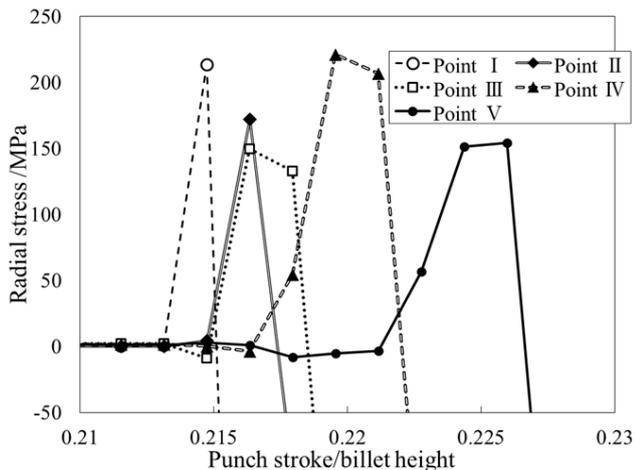
varies from point to point. When a point on the billet surface comes to contact with varies from point to point. When a point on the billet surface comes to contact with the die, a compressive stress is caused on that point, the stress value rapidly shifts to minus in Figure 12. Before the stress shifts to minus, a tensile stress near 200MPa is generated on the surrounding area. The tensile stress is perhaps caused by bulging as a reaction when the compressive stress is caused on the material beneath the die.

In the forging process of the nut, it is found that there exists a moment for each point on the billet surface that a tensile stress is generated. The tensile stress is larger enough to make the lap defect shown in Figure 2 separate from the billet surface and generate a cave on the forged nut surface [9, 10].

Figure 12. Relation between radial stress and punch stroke at simulated process.
