Post incident analysis report: Lacrosse Docklands, 25 November 2014

Metropolitan Fire and Emergency Services Board, Melbourne, Australia

1. EXECUTIVE SUMMARY

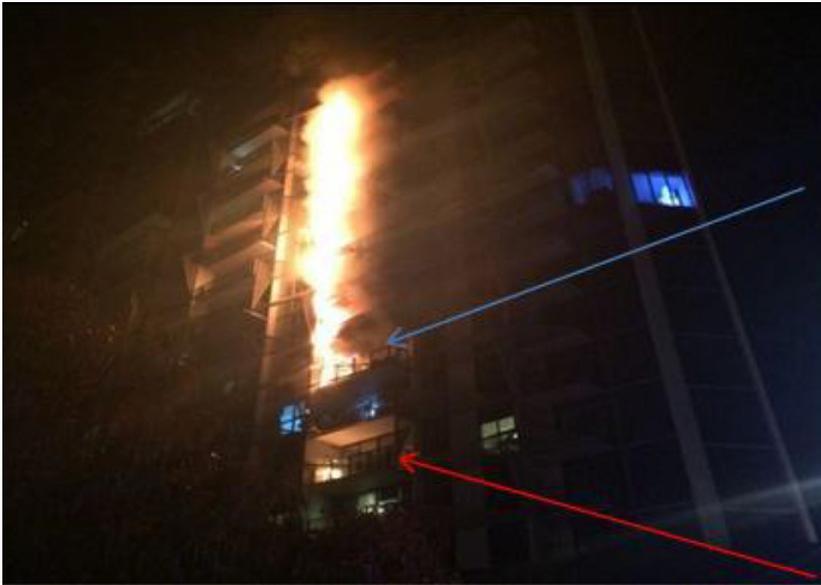
MFB fire investigators concluded that the fire was started by a cigarette butt disposed of in a plastic container located on the top of a timber topped outdoor table, positioned towards the southern end of apartment 805 balcony.

The occupants from Level 6, Apartment 605 reported later to fire-fighters, seeing fire embers and flaming debris falling from levels above their apartment and igniting materials on their balcony. They then evacuated the building (see Fig. 1).

Figure 1. Picture of the fire on level 6 (red arrow) and fire on level 8 (point of origin – blue arrow) extending up to level 14 (02:29).

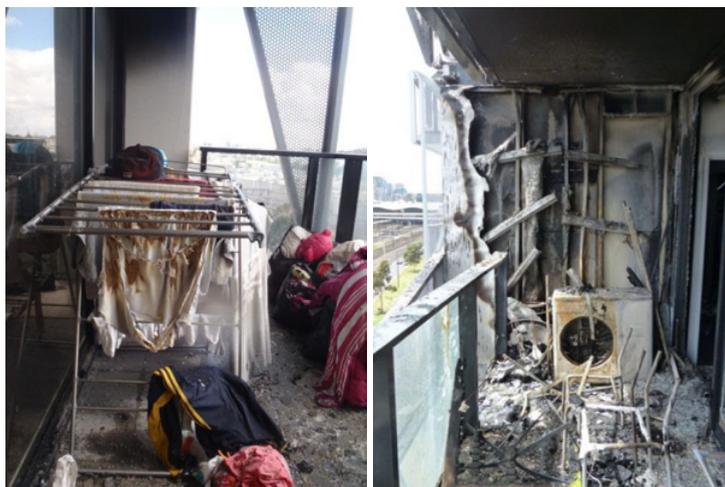
Figure 3. Picture of typical combustibles present on balconies.

In this instance, typical combustibles identified to be present on balconies throughout the building consisted of clothing, bedding, bicycles, electrical appliances and other miscellaneous combustible materials, notwithstanding the air conditioner compressor units and other combustible furniture items (see Fig. 3).

High occupancy rates in apartments can lead to reliance on balconies for additional storage space, increasing the fire load.

Had the sprinkler system extended to the balcony area of each apartment, fire would have most likely been contained to the level of fire origin.
