# Maintenance of Heritage Building: A Case Study from Ipoh, Malaysia

**Abstract.** Heritage buildings represent the tangible cultural heritage of a community. However, many of the heritage buildings have being left neglected. Ipoh as a city rich in heritage, has many dilapidated heritage buildings which are experiencing a resurging interest. However, the problems faced by many owners are the lack of technical information of such buildings, leading to premature abandonment and demolition. Therefore, the objectives of this study are to determine the types and extent of defects present in the building studied. To achieve these objectives, a case study of a century old heritage property in Ipoh, Perak was conducted. The study aims to provide reference to owners and those responsible for the conservation of heritage buildings with similar conditions to identify and prioritize critical defects in relation to the building life span to determine its condition. The findings determined the probable causes of defects such as settlement and façade cracks, which are over 30 years old, were attributed to leaking plumbing pipes, rainwater ingress and the construction of an adjacent 20 story apar

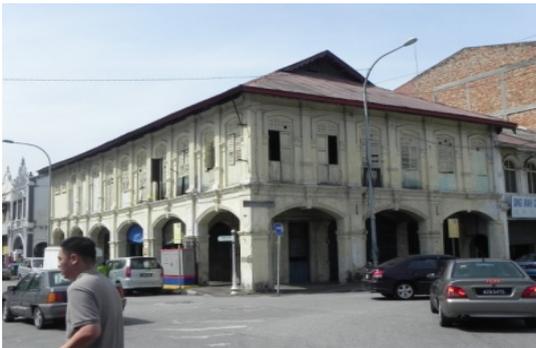
The building studied (Figure 1) is at the intersection of Patrick and Leech Street which faces the Kinta Height apartment block (Figure 2) that used to be the town market before it was relocated. The building is classifiable as Edwardian architecture as it was constructed between 1900 and 1910.

**Figure 1.** Case study building at Patrick Street.

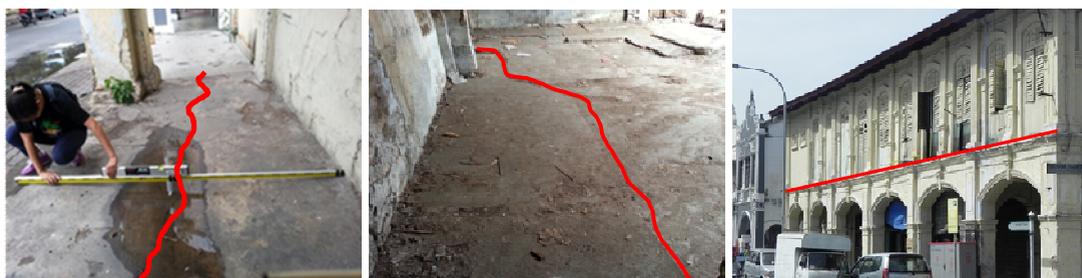
However, the original owner of the building as well as its original function could not be verified from historical records. From the interview, the building was used as a furniture shop before being converted to a school and later for retail of cooking wares with the first floor being used as store for about 40 years until 2014 where it was vacated. It was a period where plumbing technology was introduced but before connected sewer was established as the architecture utilized the 'bucket outhouse' system. Its original function was most probably designed for warehousing due to its internal riveted structural steel system, span and height as well as rear courtyard which is a different typology from the conventional shop houses. Table 1 shows the estimated period of major failures experienced by the building. The clay roofing was possibly replaced in the 1970s with asbestos roofing sheets. Building settlement were reported during the 1980s when the internal plumbing had to be replaced and the construction of Kinta Heights began. The building also has systemic cracks on its arches and ground floor slabs which had a 'saucer' shaped settlement and which is part of a larger eccentric settlement that most likely occurred during the construction of the 20 storey Kinta Heights. The

building cracks are dormant but the overall crack pattern on the wall, edges of openings and the floor seem to indicate a horizontal soil movement occurring on the façade side facing Kinta Heights. Other major defects include the failure of 1<sup>st</sup> floor timber balcony due to exposure to moisture and subsequent decay. The floor slab in the corridor has sunken between 75-80mm (Figure 3) on the exterior and interior (Figure 4) of the building and this leads to a visible ‘bow’ of the building façade (Figure 5).

1903-1970	Likely failure of terracotta barrel roof tiles, replaced with asbestos roof. The ground floor fenestration renovated to folding door for commercial use.
1903-1980	Likely failure of plumbing with leaks causing floor settlement. Replaced with exposed piping.
1982-2014	Likely crack defects start on walls due to settlement from the construction of the adjacent Kinta Heights apartment block. Excessive loading and rain water ingress contributed to decay of timber elements.

**Figure 3.** Settlement and water ponding    **Figure 4.** Interior floor crack.    **Figure 5.** Façade bowing effect.

The areas with most settlement also coincide with the ingress of the plumbing pipe from the public main into the building. This pipe has since been replaced with an aboveground piping route, indicating that the previous pipe had leaked and this can cause soil erosion. The building's adjacent location to Sungai Kinta (150m) may also contribute to the issue due to the fluctuation of water table levels during monsoon seasons which leads to annual flash flood. The primary concern is to ensure that the foundation is stabilized and further settlements are prevented and any causes of soil erosion are addressed. The crack patterns found on the arches and piers are part of the pattern of building envelope stress that forms, especially on a brick load bearing construction that does not cater to tensile stresses due to eccentric settlement. Other defects relate to moisture ingress through rising damp (failure of water barrier) and falling damp (failure of roof drainage). The building is deemed in good condition as most of the lime plaster is not delaminating, nor the majority of the timber structure decaying or attacked by termites, indicating overall water tightness for the preservation of the building elements as well as effective ventilated drying of moisture.

Soil samples of the site are to be taken to determine the suitability of using cement grouting for foundation remediation. The benefits of this method are to avoid the need for excavation, cement the non-cohesive soil particles to prevent erosion and to improve the bearing capacity of the soil as well as to seal the adjacent public drain from future leaks. To further ensure that future problems are avoided, all plumbing pipes should be installed above ground and visible for maintenance. As the building is to retain its structural integrity, it is recommended that minimal destruction of its original envelope be permitted as it acts as a complete load bearing system. Instead, it requires future spatial needs to be adapted to its layout and this requires that the floor system must be upgraded and
