Degradation of Gas Turbine Blades for a Thermal Power Plant

Ahmad Afiq Pauzi, Norlia Berahim, and Shuib Husin

Materials Engineering Group, TNB Research Sdn Bhd, Kawasan Institusi Penyelidikan dan Latihan Bangi, 43000 Kajang, Selangor, Malaysia

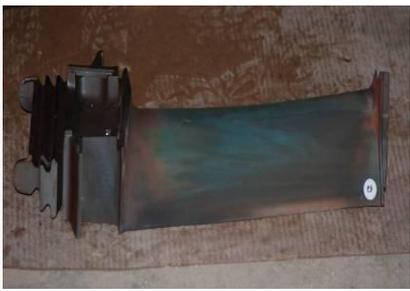
Components	Visual observation	Microstructure
<p>First stage blade Operating time: ~ 24,000 hours Temperature : 1000°C</p>	<p>Coating diverse colour was observed at blade airfoil surface. Occurrence of wear was observed at root area. No evidence of wear was found on the airfoil surface.</p>	<p>The first stage bucket was cut into small pieces for detail analysis.</p>

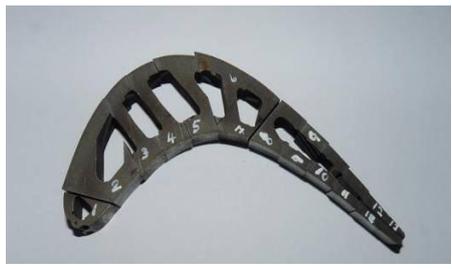
<p>The airfoil surface shows erosive mode. The occurrence of brownish colour was observed at certain areas at the airfoil surface. Occurrence of wear was observed at root area.</p>
