Stabilization Techniques for Road Lower Structure and Roadbed Constructed on Permafrost Soil

Vyacheslav Vorontsov^{1,}, Aleksey Kraev¹, and Victor Mironov¹*

¹Industrial University of Tyumen, 625001 Volodarskogo str. 38, Tyumen, Russia

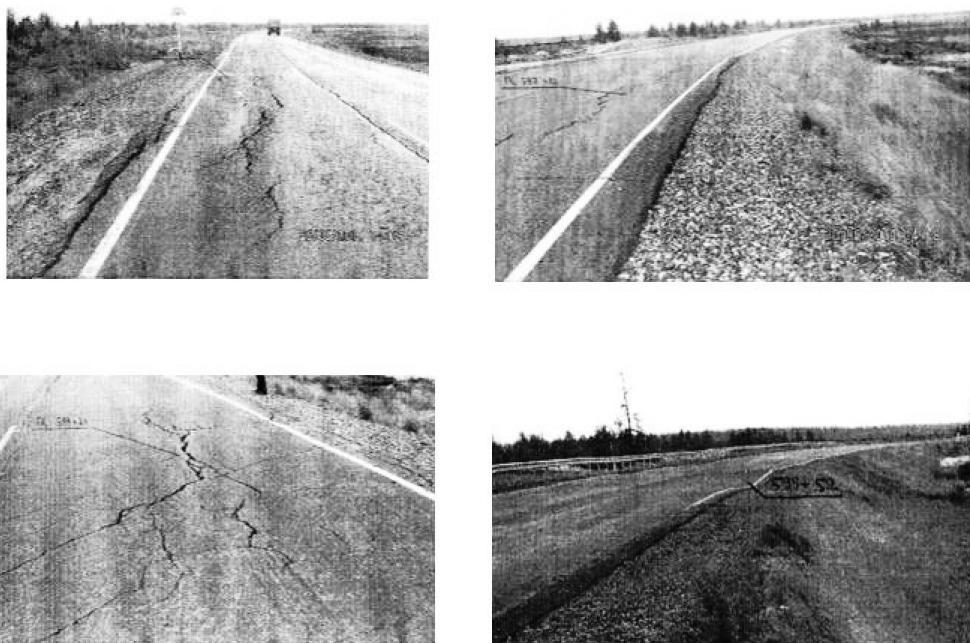
Roadbed

Deformation of the roadbed –vertical movements of the road border

Minor destructions of the roadbed near the head walls of the culverts.

Fig. 1. Defects of the road pavement and the roadbed.

Development of longitudinal and transverse cracks could be seen on the surveyed section of the road pavement. Sections with a strong network of cracks were observed in the areas where the roadbed and road borders were deformed.

Cracks generated in the center of the pavement along the axis of the road with 3 cm of growth indicated that vertical movements of the road pavement were accompanied with the horizontal ones toward the slopes. Development of longitudinal cracks up to 23 m in length indicated the possibility of deformation of the roadbed and the road lower structure.

Development of transverse cracks on the surveyed sections of the road pavement indicated vertical movements both along the entire width of the roadbed and pavement and also along the local sections. This type of defect called a hollow spot was accompanied by

development of perpendicular cracks thickened on both sides to a maximum vertical movement.

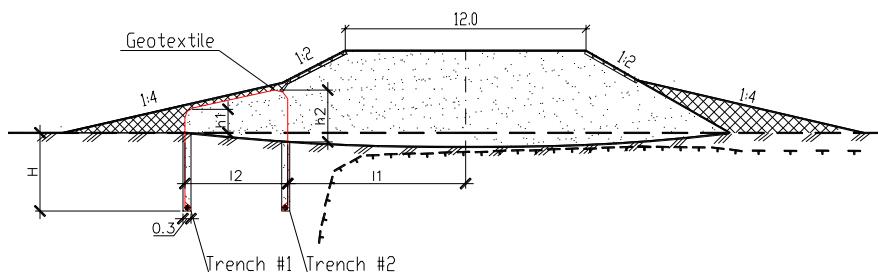
- Section №1 (PK 594+00 – PK 594+90) - the absence of permafrost on the right side in the lower structure of the road and the presence of permafrost border on the left side indicated that the road structure rested upon the heterogeneous base. Deformations occurred due to settlements in the lower structure from the right side of the road, thus resulting in displacement of the roadbed structure toward the slope;

Fig. 2. Constructional and technological solution for roadbed stabilization on road section №1 (PK 594+00 – PK 594+90).

Vertical reinforcement of the right side of the roadbed being deformed vertically and horizontally (Fig. 2.) is suggested on section №1 (PK 594+00 – PK 594+90). Reinforcement is performed by vertical placement of the reinforcing material - to a depth of $H = 2$ m into the roadbed bottom with a hard soil roller $l_2=2$ m in width and $h_2=0.75$ m in height. Its size h_1 is chosen so that the roller tilt agrees with the slope of the given transverse profile of the roadbed. The roller is constructed in the sloping part of the roadbed at a distance of $l_1=8$ m from the axis [5]. The soil roller located in the sloping part of the roadbed will block the deformations to be developed in the direction of the slope. To prevent the roller from horizontal movements it is reinforced with the material which is fixed in the bottom with the polyethylene tube 25 mm in diameter. This reinforcement allows horizontal and vertical deformations to be reduced when they occur in the roadbed body and the road lower structure during the period of maximum active layer capacity and prevent further strain on the given section. Geotextile "Geospan TH 80" is used as reinforcement.

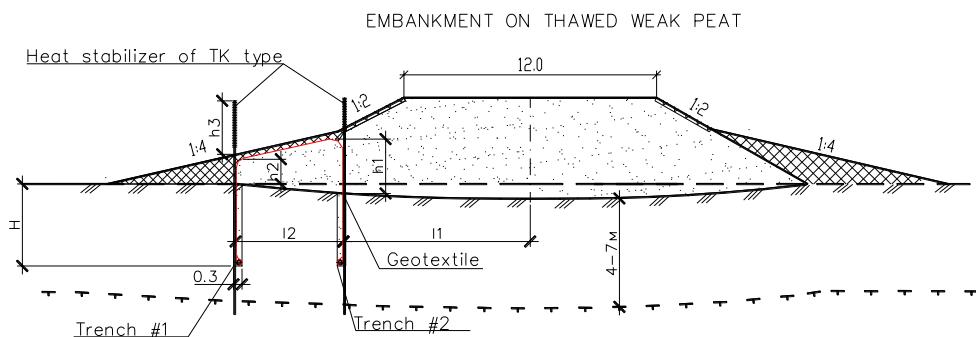
- Section №2 (PK 596+40 – PK 597+00) – failures in the pavement were due to the deformations in the left side of the roadbed as a result of thawing of the frozen peat layer. The process of thawing in the upper layers was worsened by long-standing surface water at the left slope of the road;

Fig. 3. Constructional and technological solution for roadbed stabilization on road section №2 (PK 596+40 – PK 597+00).

It has been proposed to reinforce the roadbed and the lower structure vertically in the left side of the road on road section №2 (PK 596+40 – PK 597+00) forming a hard soil roller wrapped with the reinforcing material around the outer perimeter (Fig. 3.). Vertical reinforcement is performed to a depth of $H = 2$ m into the roadbed bottom with the hard soil roller $l_2=2$ m in width and $h_2=0.75$ m in height. The roller size h_1 is chosen so that the roller tilt agrees with the slope of the given transverse profile of the roadbed. The roller is placed in the sloping part of the roadbed at a distance of $l_1=8$ m from the axis. The soil roller will reduce the deformations to be developed in the roadbed and the lower structure and prevent penetration of surface water into the body of the roadbed. Lowering of moisture content is achieved by reducing the filtration rate due to the reinforcing material placed vertically which prevents penetration of water into the body of the roadbed and the lower structure of the road. To prevent thawing of weak soil, heat stabilizers TK 32/10 10m in length and 32mm in diameter are added. Heat stabilizers are placed 2m from the outer sides of the reinforced roller. Heat stabilizers will make it possible to raise permafrost level to the daylight surface and reduce the capacity of easily deformable thawed soil layer. Heat stabilizers will allow a cylindrical volume of frozen soil of 1.3 m in radius to be formed for 2 years of operation. Step of 2 meters between the stabilizers allows the vertical frozen soil massif to be formed along the reinforcing elements; that will give additional stability to the road structure [3, 5].

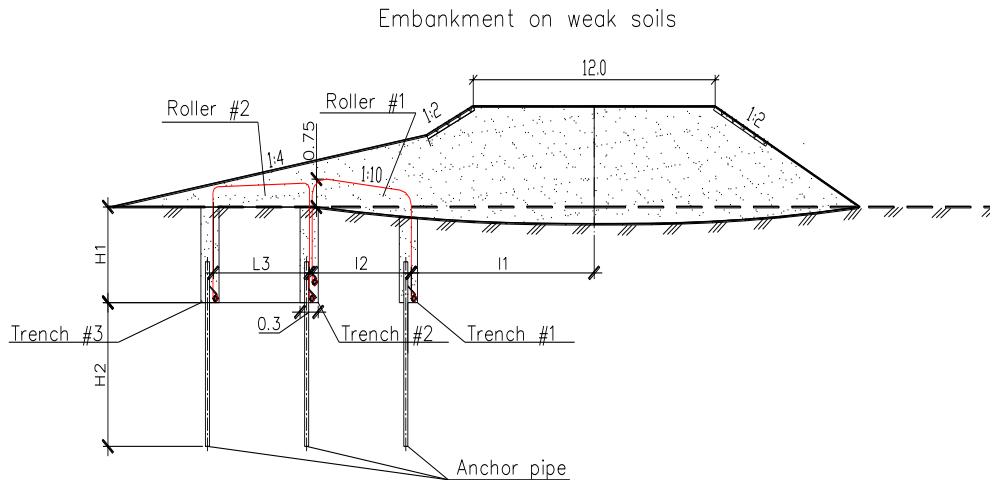
- Section №4 (PK 598+80 – PK 599+9) – failures were caused by the pressure from the weight of the roadbed and covering of the roadway transmitted onto the weak soil resulting in settlements both in the road lower structure and the roadbed. The slope of the terrain and structure of the road (virage) in the direction of the deformable lane worsened the situation. These factors led to an increase of pressure on the weak soil under the left side of the road and an increase of stresses in the roadbed causing vertical and horizontal deformations of the lower structure and destruction of the left lane pavement of the carriageway.

Fig. 4. Constructional and technological solution for roadbed stabilization on road section №4 (PK 598+80 – PK 599+90).

To ensure stability of the road structure and the roadbed slope on section №4 (PK 598+80 – PK 599+90), the constructional and technological solution has been developed in order to eliminate deformations occurring in the roadbed and the lower structure of the road (Figure 4.).

It is suggested to perform vertical reinforcement of the roadbed and the weak lower structure to a depth of $H_1 = 2\text{m}$ with reinforcement to be anchored to steel tubes immersed in the underlying soils to $H_2 = 3\text{m}$. Reinforcement is done with two rollers wrapped with the reinforcing material along their outer surface. Vertical reinforcement is placed in 3 rows with the distance from the axis of $l_1 = 6\text{ m}$, $l_2 = 2\text{ m}$ and $l_3 = 2\text{ m}$. A hard soil roller $l_{2,3} = 2\text{ m}$ in width and $h_2 = 0,75\text{ m}$ in height is placed in the sloping part of the roadbed. These vertical rows of reinforcement will prevent soil movement toward the slope. Anchor tubes immersed in the weak subgrade soil to a depth of 3m allow the reinforcing element to be fixed firmly in the design position, and thus increase the stability of the slope and the roadbed structure.

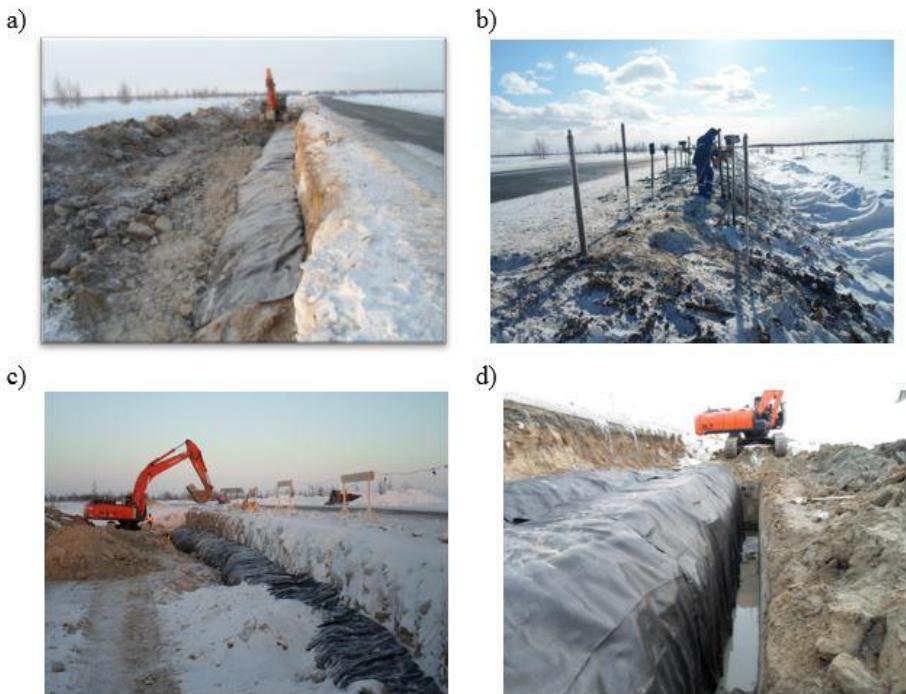
Fig. 5. Reinforcement of the roadbed and the road lower structure: a) – Section №1 (PK 594+00 – P K 594+90); b) –Section №2 (PK 596+40 – PK 597+00); c) –Section №3 (PK 597+20 – PK 597+45); d) –Section №4(PK 598+80 – PK 599+90).

In 2012 the proposed stabilization techniques for the road lower structure and the roadbed constructed on permafrost soils were implemented in the section (PK 593+00 – PK 600+50) - "Surgut - Salekhard, Novy Urengoy - Nadym" the 1st commissioning and start-up complex: Pangody (km 870) – Pravohettinsky (km 936) (Fig. 5)..
