Fracture analysis of the planet support used in a nuclear power plant

Abstract. In this paper, the fracture analysis of the planet support, which was made of aluminium alloy and used in an electric actuator, was investigated. The laboratory analysis was conducted to find out whether there are defects generated during manufacturing process. Besides, the finite element analysis was carried out to calculate the maximum tensile stress and compared it with the material strength. The mechanism of the fracture was found to be low-cycle fatigue.

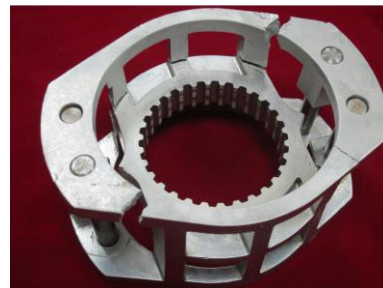
Figure 1. The fracture image of the planet support.

The planet support was broken into three parts. Through restoring these three parts, the two fractures were obvious and could not be recovered to the original position as shown in Fig. 1. This phenomenon was an

indication that the two fractures were generated firstly. Besides, no obvious deformation was found on all fractures and all crack originations were found located at the corners in the structure.

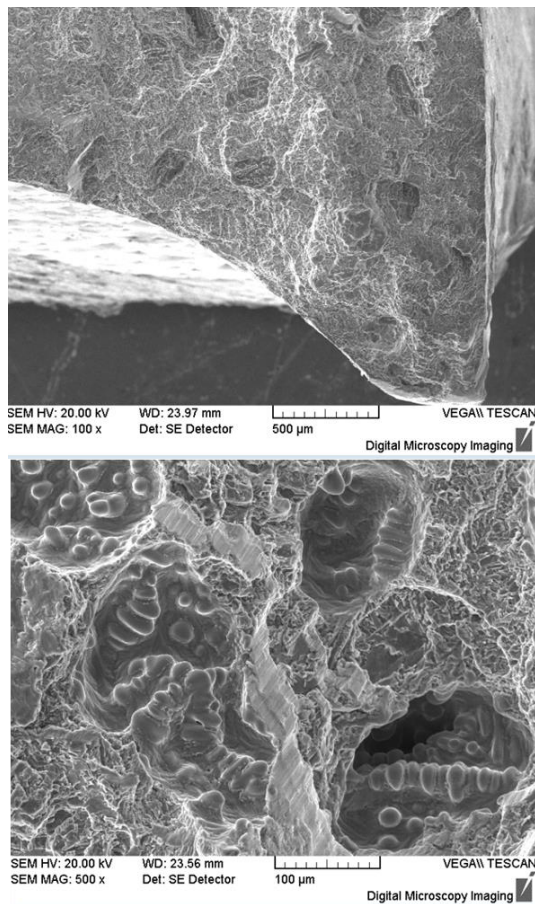
Figure 2. The SEM images of the fracture surface.

The micro-images of the fracture surface were shown in Fig. 2. The crack origination was observed under the scale of 500µm, no plastic deformation was found. And through Energy Dispersive Spectrometer (EDS) measurement, no corrosion element was found near the crack origination.

Some holes were found in the structure as shown in the image of 100µm scale, and the maximum diameter of the hole was 200µm. The holes were generated during manufacturing, and could affect the mechanical properties of the structure. The size of the holes will affect the mechanical properties as shown in the previous study [4].

Through chemical composition analysis, hardness test and tensile strength test, no abnormal phenomenon was found. Some holes were observed in SEM images and metallographic examination. The holes should be taken into consideration seriously during manufacturing in order to improve the mechanical properties.

Further studies should be focused on the effect on the mechanical strength caused by the defects generated during manufacturing process. Meanwhile, the manufacturing craft should also be improved to avoid the generation of such defects.

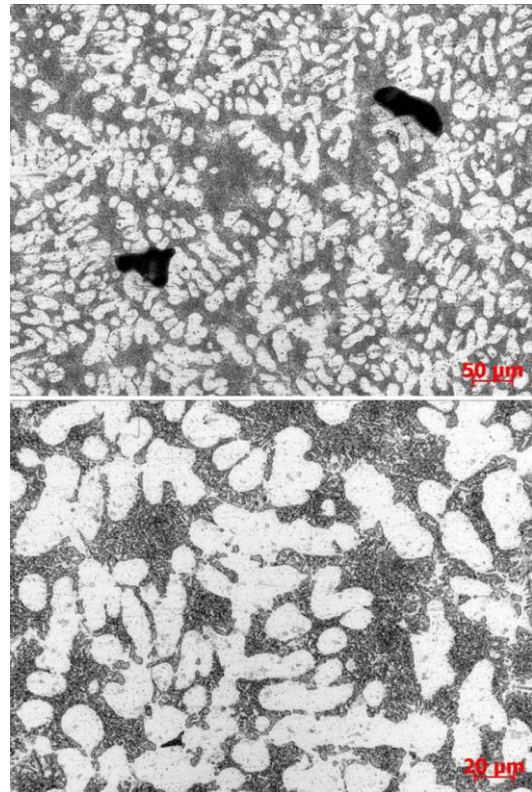
Figure 3. The metallographic images of the structure.

The metallographic examination images were shown in Fig. 3. The primary crystal phase and eutectic phase could be observed through the picture. Also, some holes were found in metallographic images. No abnormal phenomenon was found through metallographic examination.

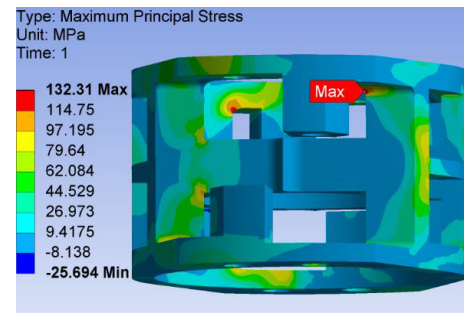
The maximum tensile stress distribution was shown in Fig. 6. The location of the maximum tensile stress was

corresponding to the crack origination in the two obvious fractures. Besides, the maximum tensile stress under the load 840N•M was 132MPa. According to the standard EN_1706, the yield strength and tensile strength were 90MPa and 180MPa respectively. The planet support should not be broken even if the motor was stalled. But, the planet support could also be broken if the motor started frequently in a short time, which corresponds to the fatigue fracture.

Figure 6. The tensile stress distribution.

as for design aspect, large radius is benefit for the structure due to the decrease of stress concentration.

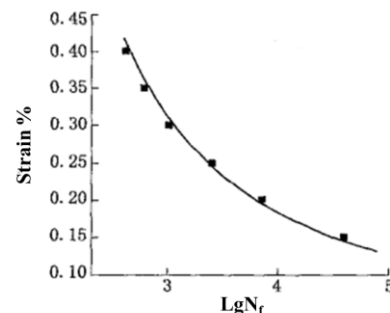
As we know, there is an inverse ratio relationship between the fatigue life and the stress or strain level. Fig. 7 shows a typical curve between the fatigue life and the strain level of the aluminium alloy AlSi7Mg with T6 treatment [5]. The maximum tensile stress of 132 MPa which nearly corresponds to the strain 0.5%, is excessively beyond the fatigue strength. If the cyclic strain is nearly 0.5% of the planet support, the fatigue life should be less than 1000 times as refer to Fig. 7.

Figure 7. The relationship between the fatigue life and the strain level.

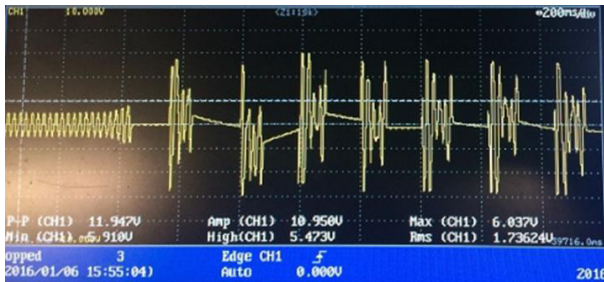
The motor of the electric actuator used to start frequently due to the failure of the self-locker which was used to keep the rotation irreversible. The motor started every 0.2s according to the current curve as shown in Fig. 8. The total time was nearly 144s which corresponds to 720 cycles. The 720 cycles also corresponds to the low-cycle fatigue fracture as shown in Fig. 7.

Figure 8. The current curve corresponds to the motor starts frequently.

The mechanism of the fracture of the planet support was proved to be low-cycle fatigue. Firstly, the abnormal working condition must be eliminated. On the other hand,
