# Moisture diagnostic of a failed roof drainage situated behind a parapet wall and a subsequent condensate influence to a wooden construction

<sup>1</sup>BUT, Faculty of Civil Engineering, Veveří 331/95, 602 00 Brno, Czech Republic

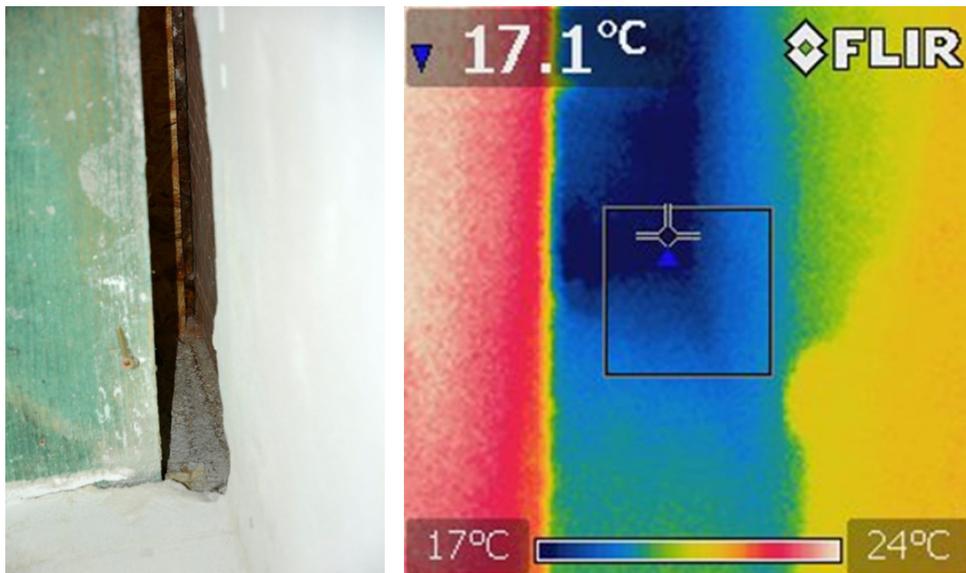
Critical temperature is evident in the themogram. The temperature difference between an edge and corner of ceiling construction is obvious. Following temperature was recorded during border condition:

**Fig. 4.** Thermographical screening of the hollow on the interface of beam and circumferential construction (bedroom).

Dew point temperature is during this condition 15.992°C. The temperature was almost reached and even though the exterior border condition was really advantageous.

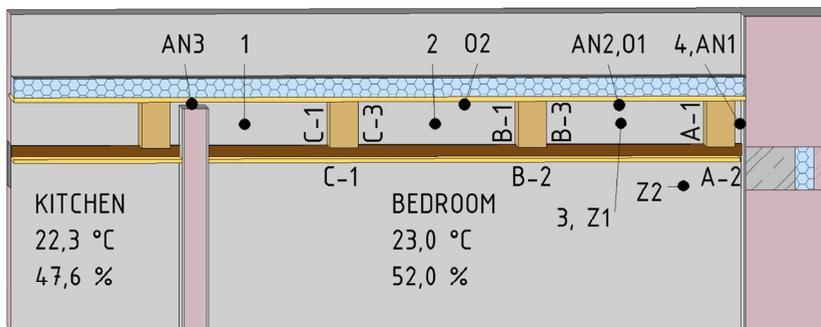
Fig. 5. Measuring points position.

Measuring was performed by MOIST device and the moisture of approximately 20–35% was shown. Based on the calibration curves, which had been specified during previous measuring, this moisture responds to the 10% spruce wood volume humidity. This can be considered as a normal moisture of build-in wood and is not a sign of significant surface condensation yet.

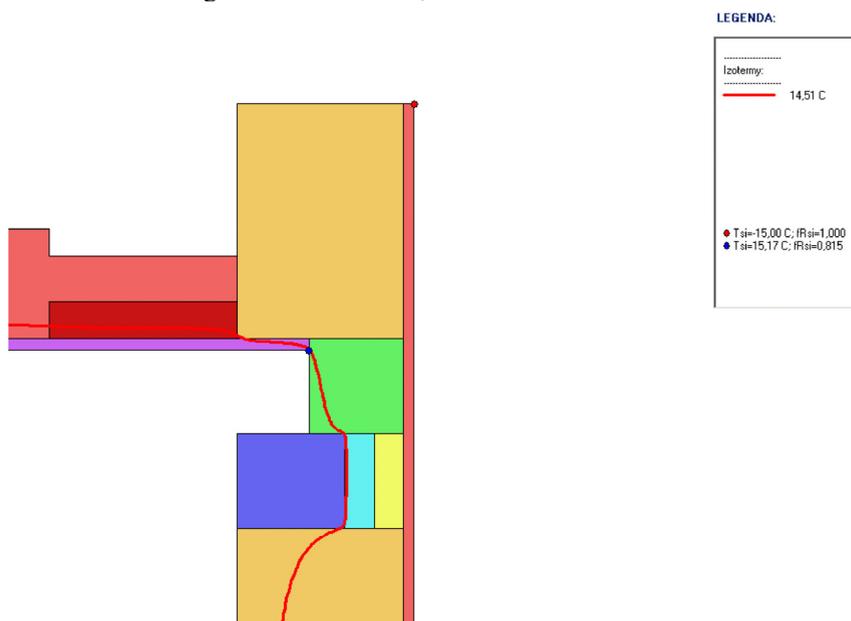
Actual 2D modelling of critical area during local border conditions was used. Applied isotherm represents critical temperature development. In an interruption area this requirement is underestimated which brings water condensation. Water vapour condensation is even higher in the roof area, which is weakened in the roof catch basin.

Fig. 6. Critical corner 2D modelling.

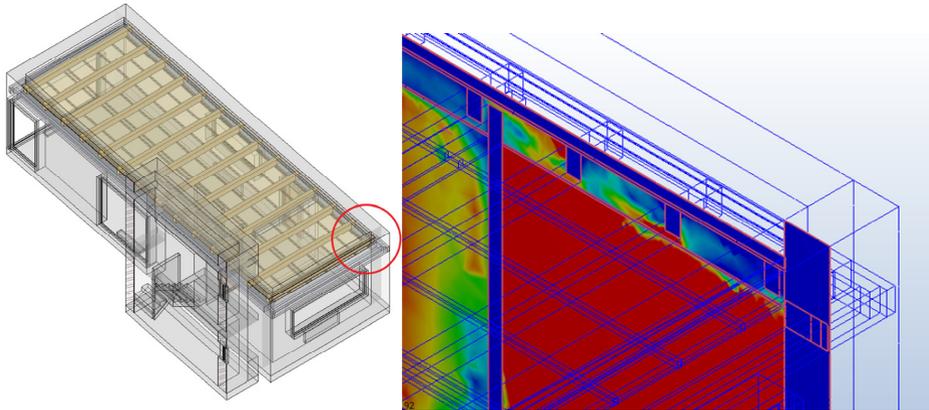
In order to take into consideration a moisture occurrence due to a distribution in bad aired air layer a simulation of CFD (Computational Fluid Dynamics) was used to examine real flow in the building in comparison with real measuring on the site. Thanks to the simulation it was possible to exclude significant influence of redistribution of moisture from neighbouring rooms.

Fig. 7. Area and output example from CFD simulation.
