Pathological changes waterproof membranes and their identification

Abstract. With the development of waterproofing systems based on synthetic membranes, especially mPVC, there is an increase in pathological changes of these membranes. Competing manufacturers and pressure on price of the final product have resulted in usage of unstable or low quality raw materials. After production, these materials keep their specific characteristics, however, their aging is accelerated, i.e. they lose their essential qualitative characteristics very quickly. Very important is the detection of these processes which is possible using chemical analysis (gas chromatography, IR analysis and others) as well as using visual inspection of surface by microscope, including 3D modeling. Very important are weldability tests which identify glass transition temperature of the material. The results can then be used as a basis for correct identification of problems with weldability, nonweldability of synthetic membranes, respectively, as well as for identification of normal or abnormal aging of these materials.

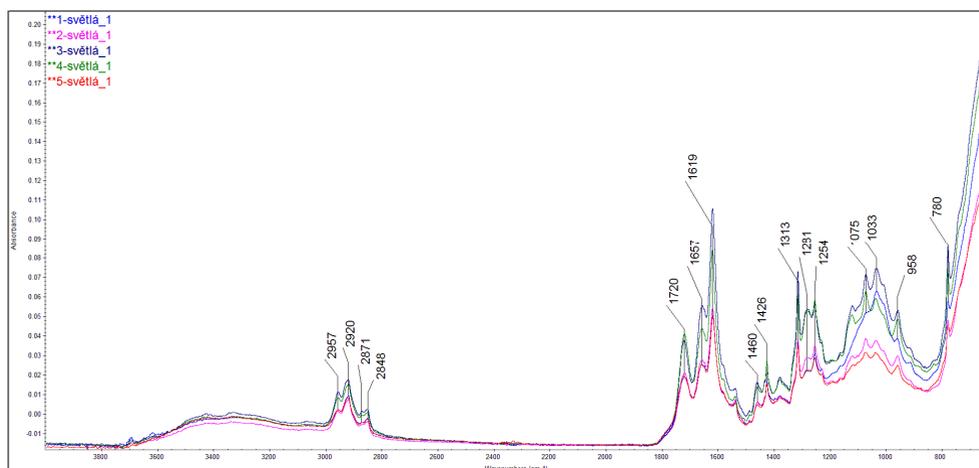
Fig. 1. Documentation of changes in mass of mPVC between covered and uncovered material.

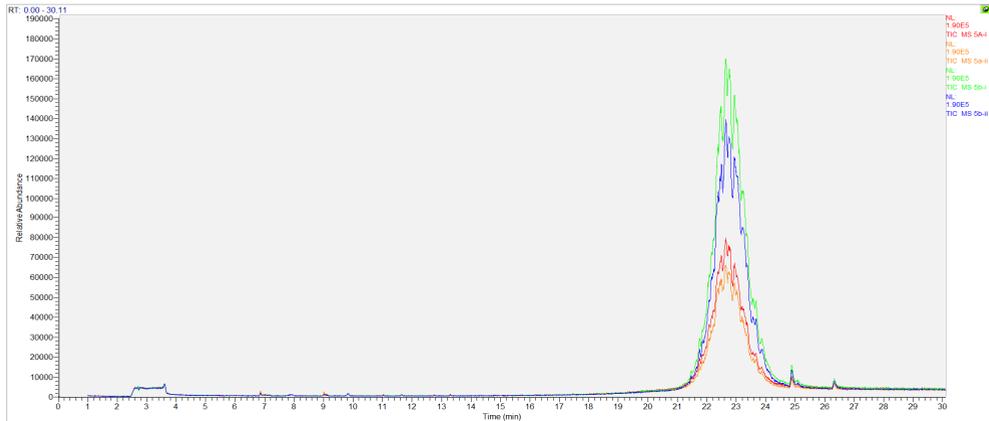
Fig. 2. Documentation of softeners and their comparison between covered and uncovered material.

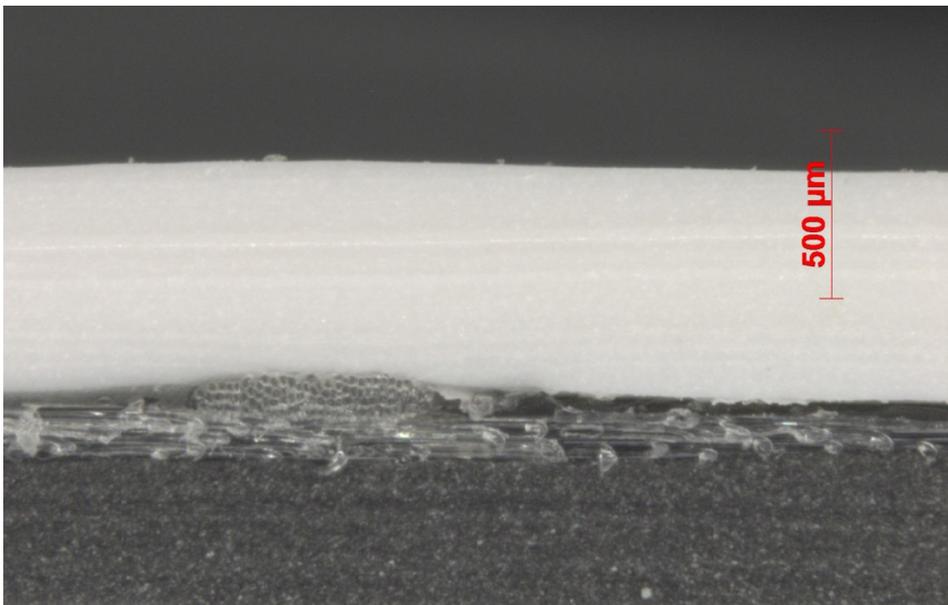
Fig. 3. The optimal condition of mPVC foil.

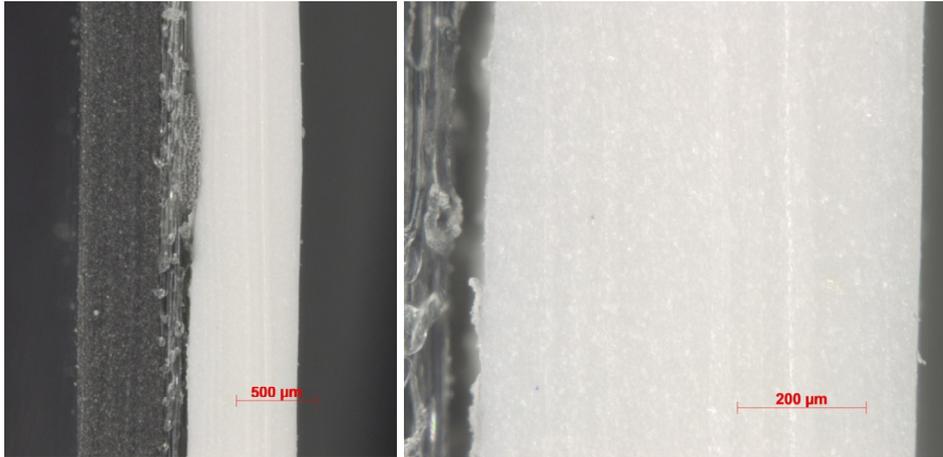
Fig. 4. Higher magnification shows inhomogeneity of the mPVC foil - The absorbency of humidity is the consequence of this inhomogeneity.

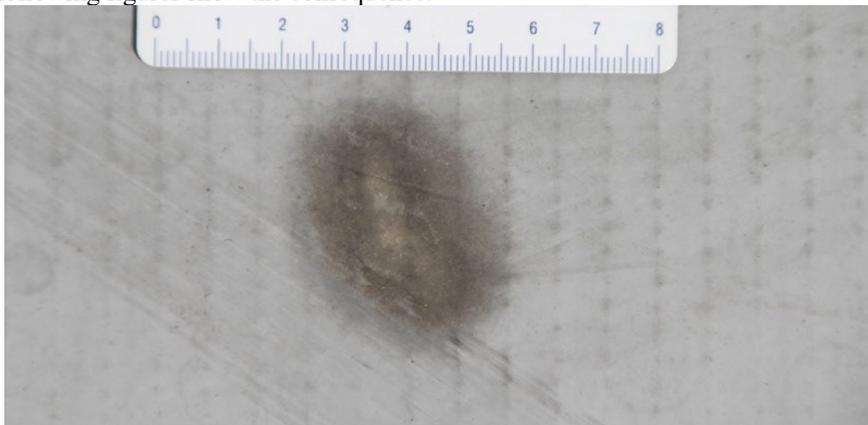
Fig. 5. Degradation spots on PVC foil.

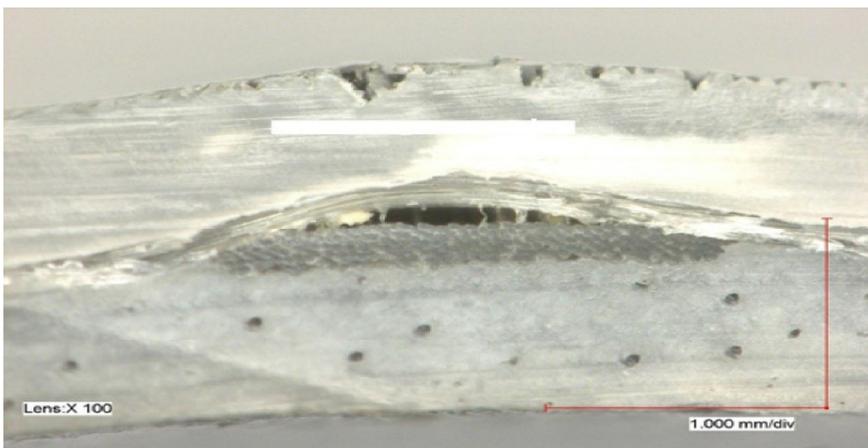
Fig. 6. Degradation blisters on the foil mPVC.

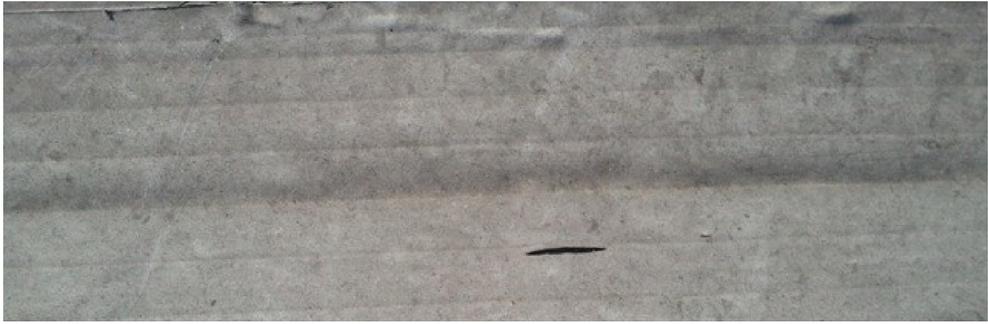
Fig. 7. The crack in mPVC foil.

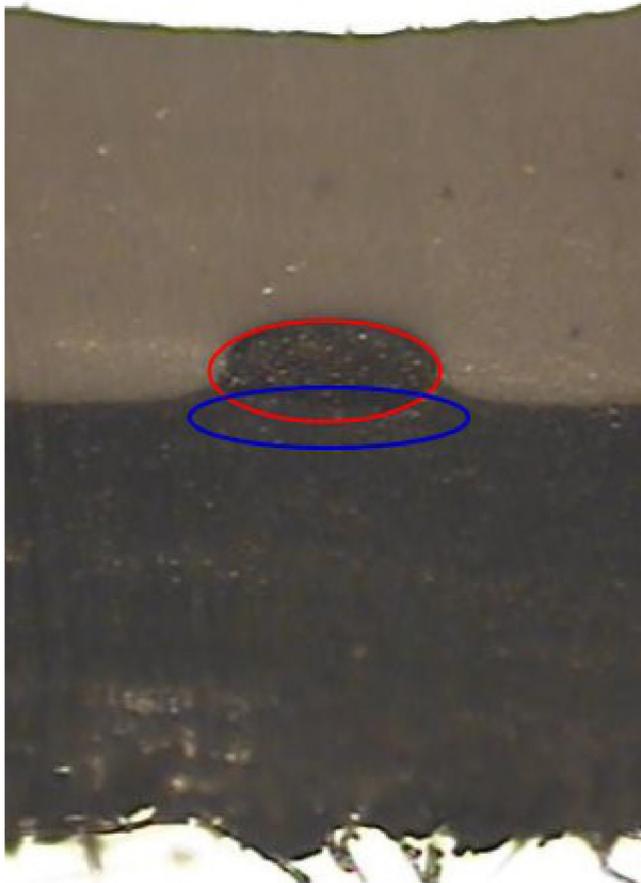
Fig . 8. Notch, weakening on the top of the PVC foil. At the correct position of the reinforcement should be in the shape of the bottom (blue) oval.

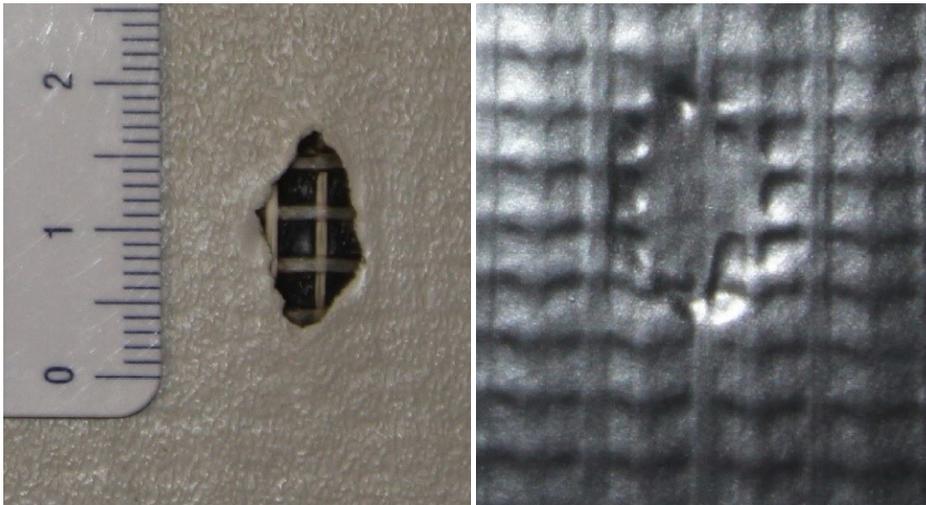
Fig. 9. Broken lower and upper surface of the mPVC foil.

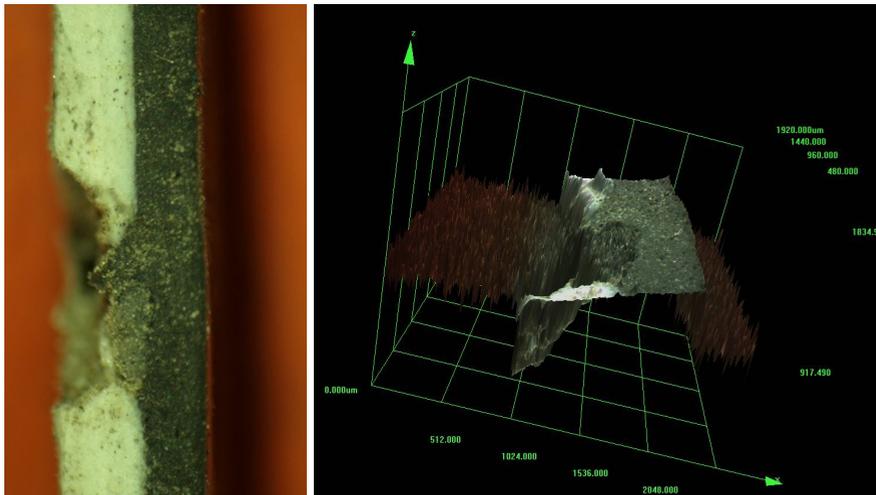
Fig. 10. Macro violations (left) and 3D modelling (right) of the violation by the mPVC foil.

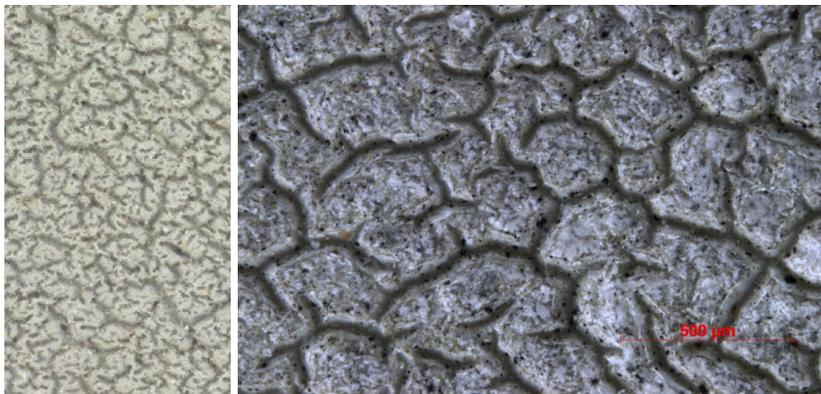
Fig. 11. Documentation "alligator ring" on the surface of the foil degrading mPVC and lower magnification (camera) on left side and micrograph of the surface on the right side.

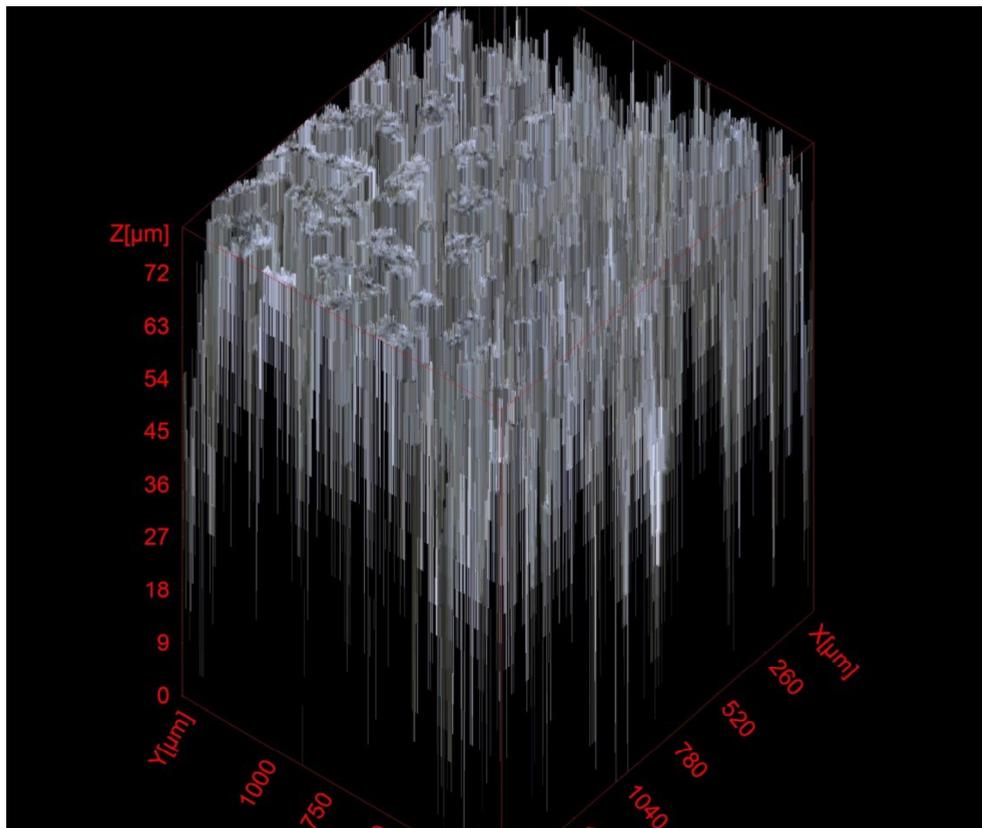
migration of plasticizers from film material. Aging does not have a linear character. The aging is accelerated with respect to increasing surface of evaporation (Figure 12).

Fig. 12. Documentation of vaporizing surface of mPVC foil obtained from alligator ring, see fig. 11.

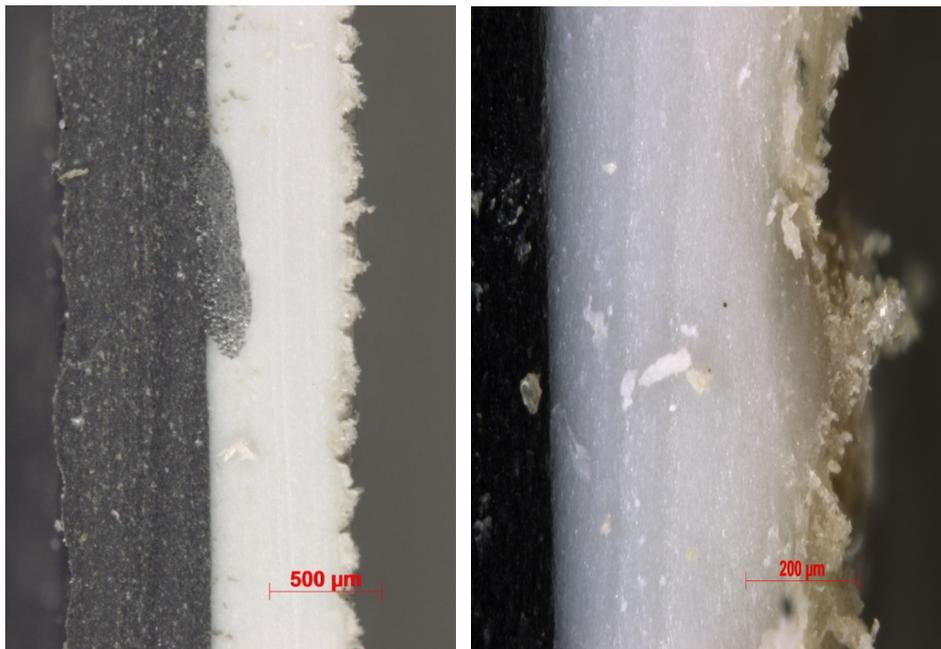
Fig. 13. Degradation of mPVC surface of the foil including a bad position of reinforcement.

Figure 13 illustrates degradation of the surface of the waterproofing membrane. It is a visible reduction in the volume of plasticizers. Figure 14 shows the state just before the collapse or collapse of the film.

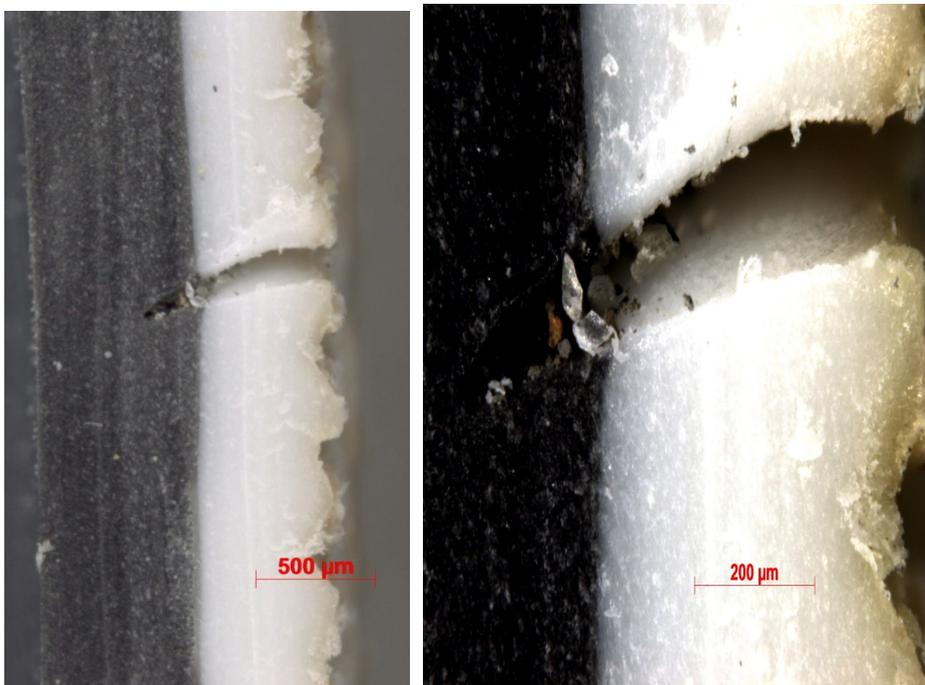
The bursting of upper layers mPVC film is caused by forcefully stress. The overall loss of waterproof characteristics of waterproofing membrane is consequence of the rupture.

The figure 14 illustrates clearly visible crack in the top portion of the film that there are caused by the force stress of the film during its lifetime.

It is important to note that the total lifetime of the film is only 6 years old (Figure 1-4, 11-14). The durability is does not match the investor needs as well as the lifetime does not correspond with the EU standards and technical reports. According to the EOTA 002 (12/1999), the expected lifetime is at least 25 years.

Fig. 14. Definitive end of functionality of PVC foil (waterproofing membrane) as a result of rupture.
