Fracture Failure Analysis of Fuel Pump Transmission Shaft of Dual-Fuel Engine

Abstract. NTS6ZL_{Cz}-129 dual-fuel turbocharged and intercooled engine durability test at 1000h, fuel pump shaft fractured. Fracture analysis, chemical analysis, microstructure examination and finite element stress analysis were carried out on the fractured shaft. The analysis result showed that the shaft fracture cause is forging fold. By improving the forging process, the forging fold was solved, and the durability test can be carried out smoothly.

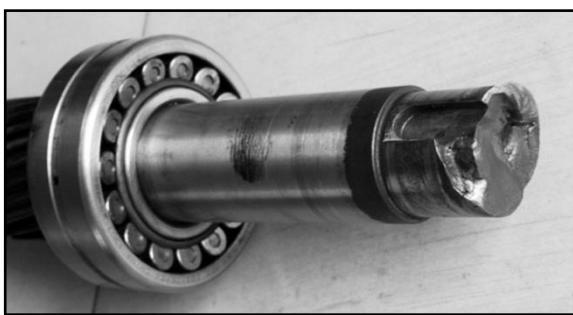
High pressure pump is driven by the fuel pump transmission shaft. NTS6ZL_{Cz}-129 dual-fuel turbocharged intercooled engine, in 1000h durability test, fuel pump transmission shaft fractured suddenly. Fuel pump could not supply oil, the engine stopped. The fractured transmission shaft is shown in Fig. 1. The transmission shaft is made of 40Cr, fracture diameter is 30mm, and manufacturing process consists of cutting, forging, roughing, quenching and finishing.

Figure 1. Fractured fuel pump transmission shaft

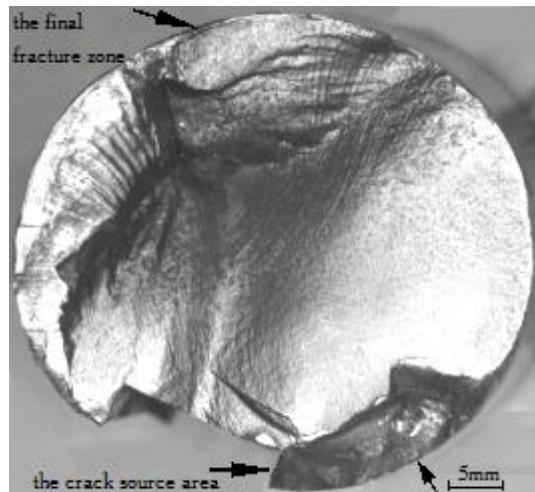
Fracture surface rust obviously, certain areas have bumps. Specimens were cut from fracture surface, fracture surface observed after ultrasonic cleaning with alcohol. Macro picture of fracture is shown in Fig. 2. The fracture surface was rough, around the bumps and final crack area had obvious plastic deformation, the other parts had no

significant deformation. Fracture in most regions showed obvious macroscopic fatigue Bay Ridge. According to the shape of the distribution of fatigue Bay ridges, the path of crack extension, the crack source faults and final fracture zone can be determined. The source region of the crack and the final fracture zone are shown in Fig. 2. The crack source area is located in a small longitudinal cross section. This section is close to the keyway site and nearly vertical to step surface and the main fracture. Because of the crack source area had obvious impact on the abrasion, obvious macroscopic defects failed to be observed. The final fracture zone is located on the circumference, opposite to the source region of crack, and has a smaller shear lip. Since the fracture is not well protected, no obvious rapid tear streaks are observed in the final fracture zone except in the cut lip.

Figure 2. Macro picture of fracture

Take the area near the final fracture as the rapid tear streaks area before the final fracture. This area has no obvious macroscopic fatigue Bay ridges. This area is very small, and takes a small proportion of the total area of the

fracture. From the above examination and fracture analysis, it can be determined that the fracture of the shaft is caused by low stress and high cycle fatigue in the keyway.

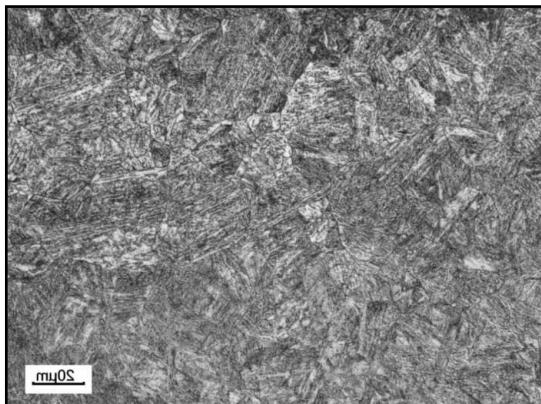
Figure 3. Microstructure organization of transmission shaft (Magnification of 500, 4% Nital)

Fig. 3 illustrates the microstructure of fractured transmission shaft is tempered sorbite. Grain-size number is 8 according to GB / T 6394-2002, and it is the normal quenching and tempering heat treatment state organization.

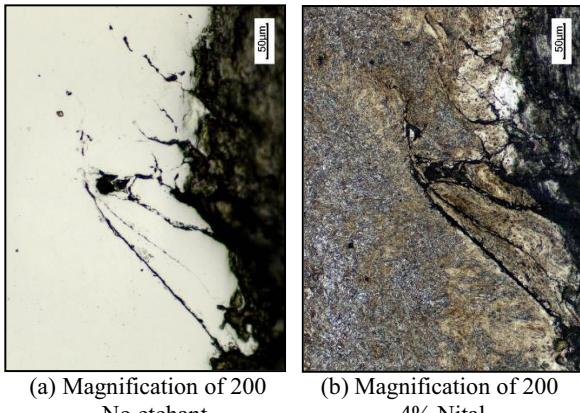
Figure 4. Surface defects and microstructure of the fracture surface in the source region of the crack

Fig. 4 illustrates there are cracked defects oblique stretched into internal in the crack source region. Oxide inclusion exists in the fracture surface, inner and surrounding areas of defects. Nearby the fracture surface and cracked defects, there is obvious decarbonization phenomenon. The defect has forging or rolling folding defect characteristics.

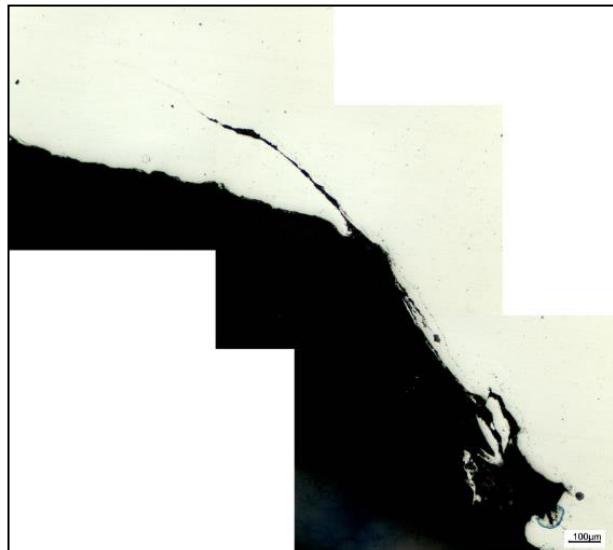
Fig. 5 illustrates there are cracked defects oblique and smooth stretched into internal. Oxide inclusion exists in the fracture surface and inner area of defects. There are continuous tiny dots and granular inclusions on both sides

near the crack. The defect has forging or rolling folding defect characteristics.

Figure 5. Surface defects of the fracture surface in the source region of the crack (Magnification of 500, no etchant)

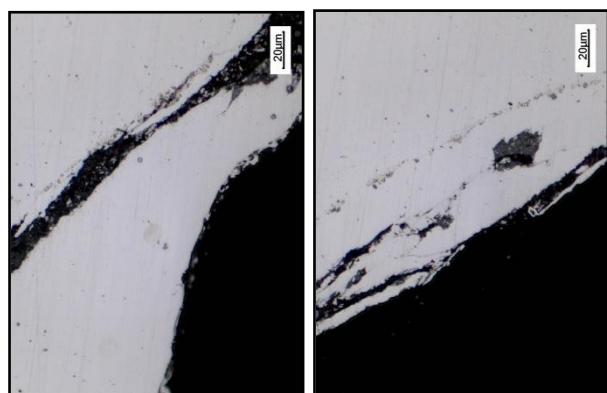
Fig. 6 is a partially enlarged view of Fig. 5. Fig. 6 illustrates oxide inclusion exists in the fracture surface and inner area of defects. Continuous tiny dots and granular inclusions on both sides near the crack are clearly visible.

Figure 6. Surface defects of the fracture surface in the source region of the crack (Magnification of 500, no etchant)

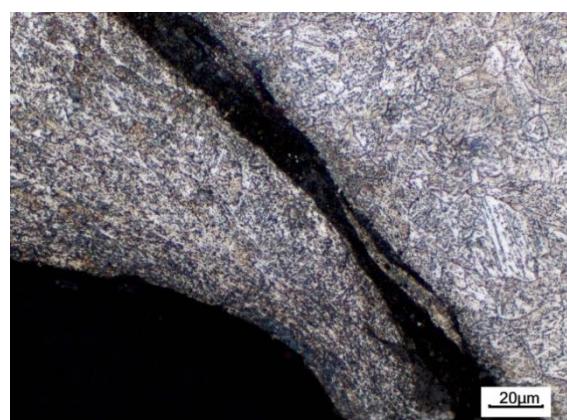
Figure 7. Surface defects and microstructure of the fracture surface in the source region of the crack (Magnification of 500, 4% Nital)

The microstructure in Fig. 7 obtained after etching in 4% Nital. There are decarbonization in the surface and both sides of the crack.

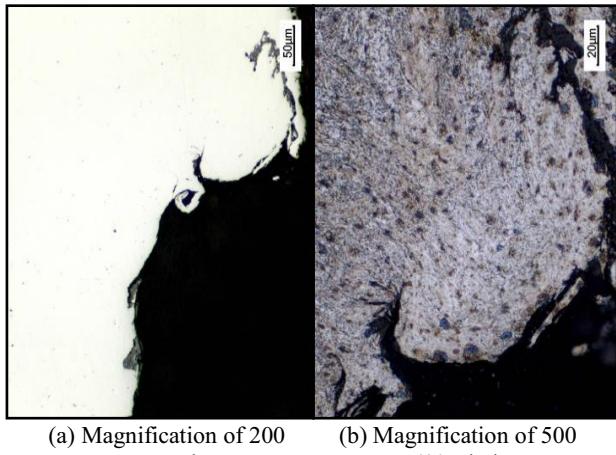
Figure 8. Surface defects and microstructure of the fracture surface in the source region of the crack

Fig. 8 illustrates there are curling defects and oxides in the crack source region. Obvious decarbonization exists in the surface organization, thus shows that this defect has forged or rolled folding defect characteristics.

According to the fuel pump shaft fracture position, it is preliminarily concluded that the shaft end stretching and small amount of feed lead to the folding defects. [5] Then, shaft forging process checked, and feed amount found indeed too small when stretching the shaft end. The pushing amount is too large, feed and unilateral compression ratio $L / (\Delta h / 2)$ is less than 1, thus leads to a large metal deformation on surface layer and the end concave into a fold. Increase the amount of feed, when the feed unilateral compression ratio reached 1.2, the transmission shaft was reprocessed. By ultrasonic inspection, no folding defects were found. The shaft was installed and the durability test was carried out, then the fuel pump transmission shaft worked properly.

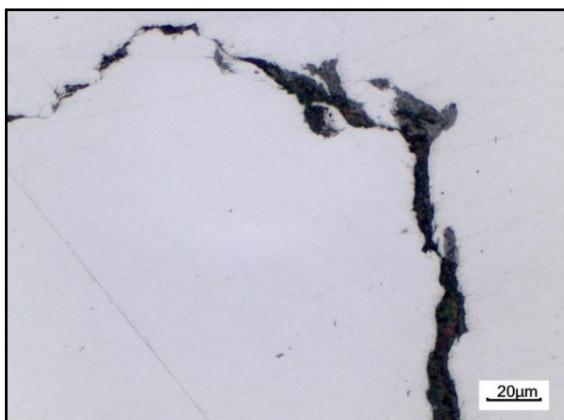
Figure 9. Internal cracks of the fracture surface nearby the source region of the crack (Magnification of 50, no etchant)

Fig. 9 illustrates there are internal cracks nearby the source region of the crack. The crack snaked stretches and has a tapering tail. There are oxide inclusions inside the crack.

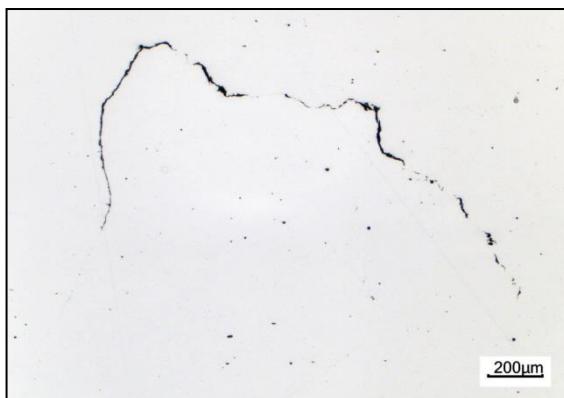
Figure 10. Internal cracks of the fracture surface nearby the source region of the crack (Magnification of 50, no etchant)

Fig. 10 is a partially enlarged view of Figure. Internal crack is filled with oxide, it can be seen clearly.

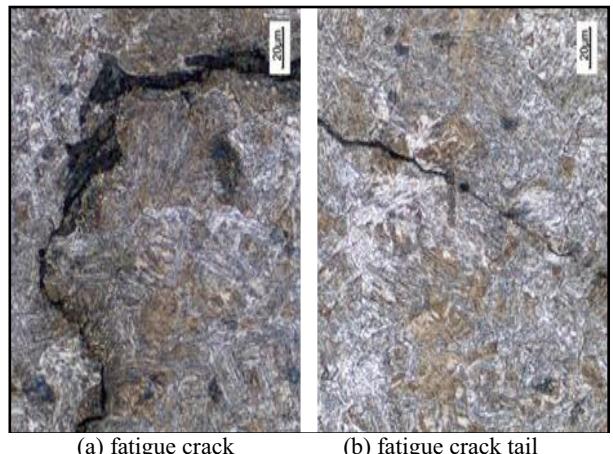
Figure 11. Internal cracks and microstructure of the fracture surface nearby the source region of the crack (Magnification of 500, 4% Nital)

Fig. 11(a) is microstructure of fatigue crack, and Fig. 11(b) is the microstructure of fatigue crack tail. Except the wider parts of the crack, the crack is mainly dominated by the extension of transgranular crack. This crack may be an extension of the original crack in heat treatment, and has a tapering tail. The crack should be fatigue extension during service of the transmission shaft.

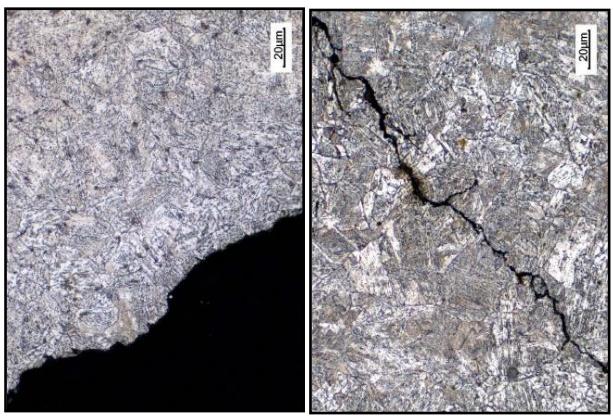
Figure 12. Fatigue Crack Growth Area and organization (Magnification of 500, 4% Nital)

Fig. 12 (a) is microstructure of fatigue crack, and Fig. 12 (b) is the morphology and microstructure of fatigue crack tail. Fig. 12 illustrates the fatigue crack is mainly transgranular cracks. The microstructure is tempered sorbite, which belongs to the normal quenching and tempering heat treatment microstructure.

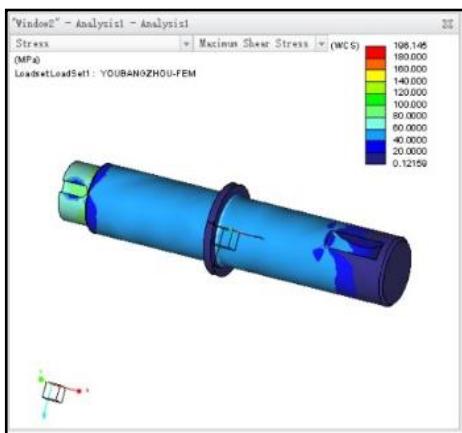
The static analysis is mainly used to analyze the maximum stress of the transmission shaft. [3] Fig. 14 shows the shear stress distribution and the maximum stress of transmission shaft. The maximum stress is 198.1MPa at the flat key, and the allowable shearing stress for 40Cr is 227 MPa. Obviously, the maximum stress is less than the allowable shearing stress. Thus the strength of the fuel pump transmission shaft meets the requirements.

Figure 14. Shear stress distribution of transmission shaft
