Assessment of structural condition of steel bridge in Brandýs nad Orlicí

Abstract. This paper deals with structural condition assessment of historical steel through arch bridge in Brandýs nad Orlicí. Structure was dynamically tested to obtain mode shapes and eigenfrequencies on non-loaded structure and to estimate logarithmic damping decrement after traffic loading. Material properties were verified. Calculation model was created to validate its statical and dynamical behaviour. Article focuses on comparison of calculated results and properties of real structure upon excitation.

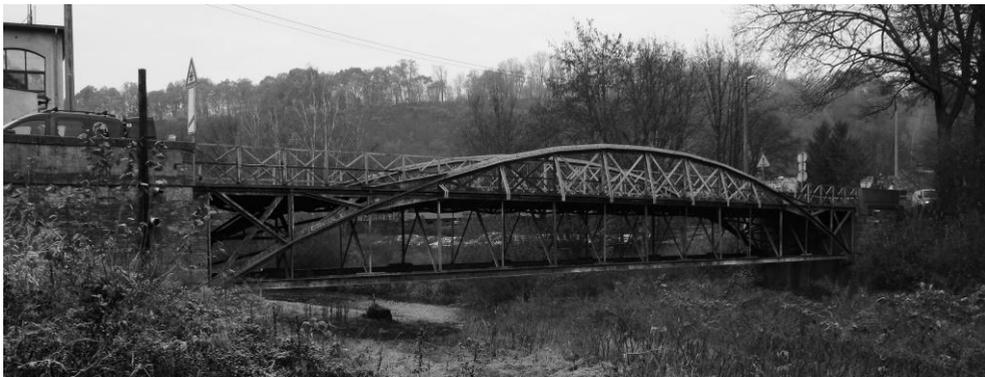
Bridge was built (according to bridge control protocol from 2014 [1]) between 1905 and 1929. Superstructure consists of single span through arch bridge made out of riveted steel sections. Compressed upper part of the arch is strutted using diagonal struts in outer profile of the cross section. Base of an arch is connected by steel tie. Original deck was rebuilt in 2014 using modern rolled “I” beams with steel ribbed plate. Structure is stiffened by longitudinal and transversal diaphragms. Main arches with ties are simply supported using cast iron bearings. Longitudinal deck beams are resting on abutments, which are made out of stone blocks.

Fig. 1. Tested bridge over Orlice river.

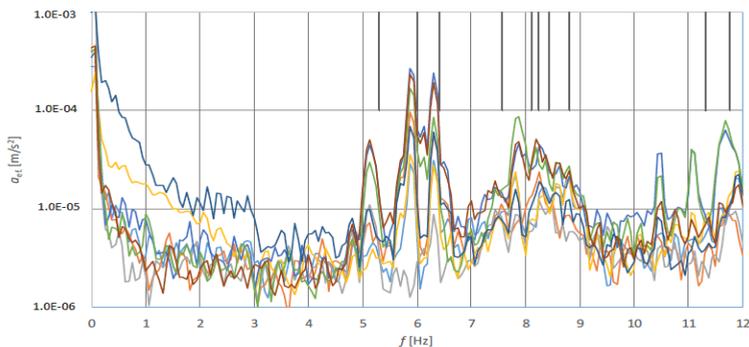
Bridge permanently vibrates with low acceleration amplitudes. Cause of this behaviour is technical and natural seismicity of the surroundings. Eigenfrequencies can be found in acceleration spectra (Fig. 4) as sharp peaks. These frequencies are systematically lower than frequencies calculated in FEA model. Both results are various around 8.0 Hz area, where significant peaks are missing in measurement. Vertical lines in upper part are representing calculated eigenfrequencies.

Fig. 4. Acceleration spectra in idle state of the structure.
