# Risks of the Durability of Large-Panel Buildings Elevations in Reference to the Conclusions from Technical Conditions Audits

**Abstract.** In article the problem of durability of elevations of large-panel technology buildings is analyzed. In Poland this is a serious technical issue because it has an impact on the whole country. Heat loss through infiltration, the possibility of mold growth and general breakdowns are also reasons for increasing user discomfort. In article the results of the diagnostics presented in the literature and the authors' analysis and diagnostic results are presented. Article also presents conclusions regarding to the durability of applied insulation systems ETICS and the need to strengthening the layers connections of the facade panels.

### **3 Results of technical inspections in years 2005-06 and 2016-17 in Warsaw**

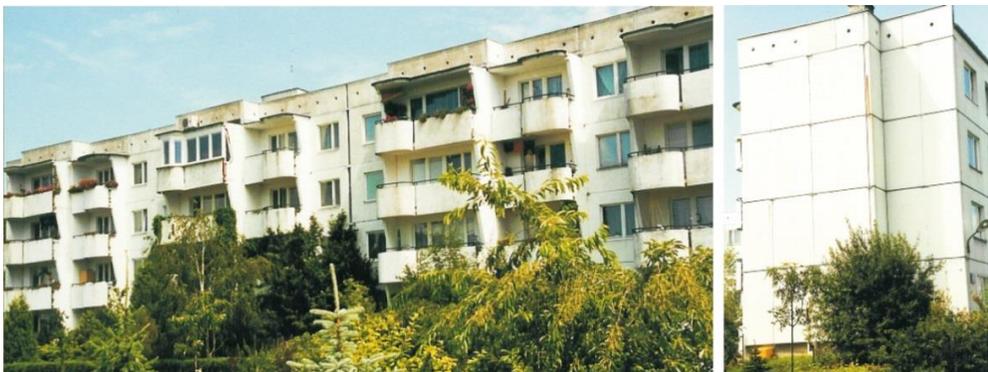
Nowadays the high thermal conductivity of panels and connections leak causing moisture of precast elements are very important problems (Figure 2). Often wetting of the structure resulting from the leakage of connection is a stimulator of many degradation processes. They have a significant impact on the condition of not only individual panels or components, but the entire building. The negative effects of moisture have an influence on the health of residents by supporting the development of fungi and molds.

**Fig. 2.** Building façades in Wk-70 technology, Warsaw (photos by Janusz Krentowski)

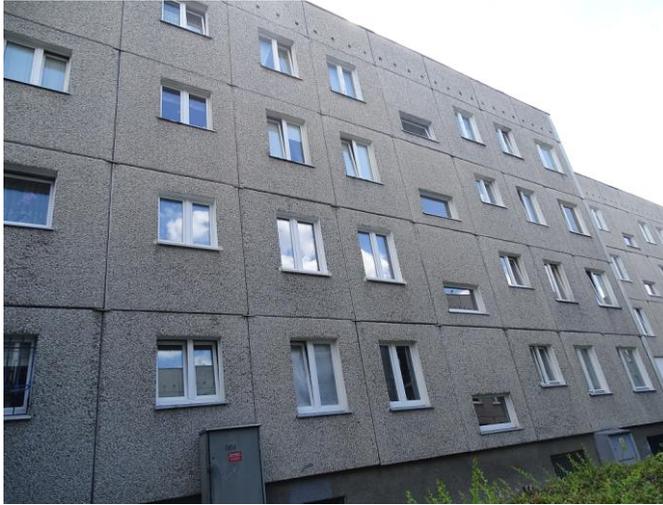
In addition, it has been found that not-insulated buildings are characterized by a relatively good quality of prefabricated materials, and the cases of leakage occur sporadically, between adjacent plates rather than in many plates. The frost's penetrations were present in few corners of examined buildings. The buildings were relatively new, and the façades are not technically problematic (Figure 3), so up to now, the co-operatives managing these buildings have not considered the insulation works economically and technically feasible.

**Fig. 3.** Elevation of a non-insulated large-panel building (photo by Piotr Knyziak, 2016)

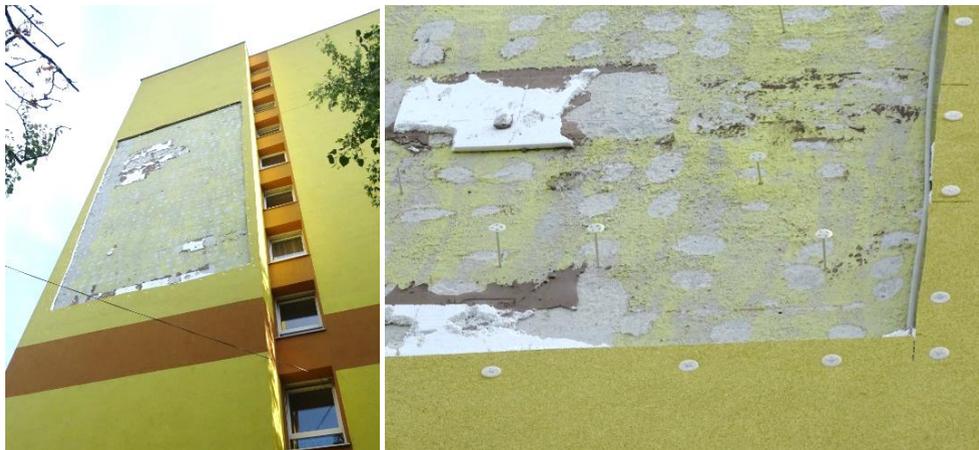
**Fig. 4.** ETICS system failures (photos by Piotr Knyziak, 2016)

In 2016-17 surveys, the symptoms of incorrect operation of the ETICS system included deformation of the surface layer, scorching of the plaster in the outlines of styrofoam boards (excessive moisture transfer in the partition), unusual fractures (many plaster cracks due to incorrect execution or passes of time). The remark concerns not only the investigated 110 buildings, but also many neighboring buildings.

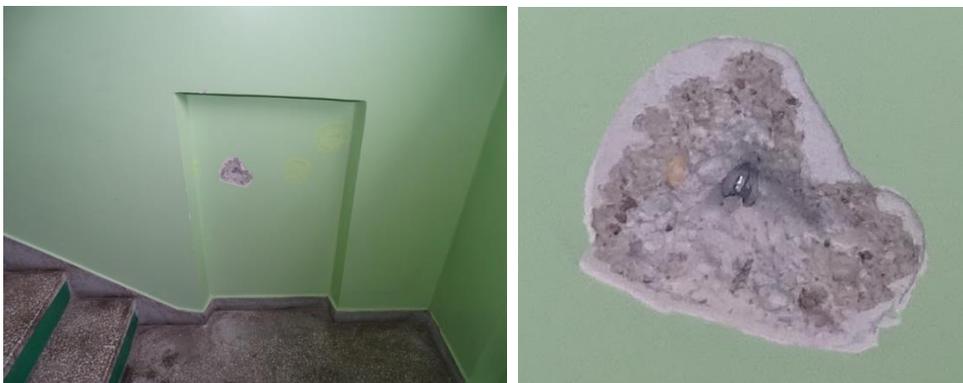
Avoidance of reinforcing the layer connections is most often the result of significant costs (more than 10% of the value of the works) and executive issues that arise during the work. In one of the areas, after the initial experiences with the first reinforced building, the reinforcement of the joints was discontinued due to brittle concrete problems in the prefabricated buildings. During the drilling, there were extremely fragile breakings of concrete cones inside the apartments. A similar phenomenon can be sometimes observed in stairwells where residents made holes for dowels (Figure 6).

**Fig. 6.** Brittle breaking of concrete cones during drilling (photos by Piotr Knyziak, 2016)
