Fracture Analysis of CNG High Pressure Container using Fractography and Measurement of Property

Abstract. Bursting accidents of pressure containers due to design and manufacturing defects are frequently occurring. Due to high-pressure gas or harmful substances, when this vessel is fractured, it can lead to catastrophic disasters. Especially, in the event of bursting accident of composite pressure vessel for CNG bus, many unspecified people can be damaged. Most of the accidents were caused by problems in the manufacturing process. The manufacturing process for TYPE2 pressure vessel is very complicated such as three drawing processes, two ironing processes and one spinning process. In the middle of process, various heat treatments are performed for imparting toughness and removing residual stresses. It should cause a serious problem such as bursting and fragmentation of the pressure container due to defects of this process. In this research, the fracture cause of CNG vessel is evaluated through fractography and measuring material property using IIT and analysis of chemical composition.

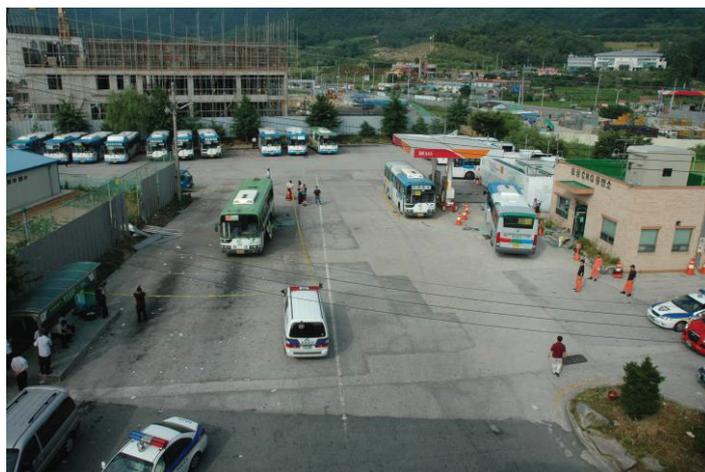
This accident was caused by bursting of CNG container loaded in the vehicle while charging the CNG bus at the CNG gas station as shown in Figure 1. The lower dome of the bursting pressure vessel is separated from the main body and this caused damage to the surrounding area by penetrating the upper part of the bus that was parked nearby. The accident CNG bus was equipped with a total of eight metal liners which is charged through connection pipes and the explosive liner is the sixth liner from the front of the bus.[4] The charger is equipped with three safety devices: mechanical safety valve, pressure switch, and pressure controller. The charging status of the charger is monitored and this record is stored automatically. Looking at the charging system, At the time of the accident, the gas pressure to the vessel is about 150 ~ 180 bar and malfunctions & specific defects are not observed. Therefore, possibility of accident due to charging overpressure and surrounding environment is very low. After all, the root cause of the explosive accident can be found in the problem of container itself such as defects of the design and manufacturing. To identify the exact causes of the CNG vessel failure, it is necessary to collect and investigate the fracture fragments of the vessel, which include composite parts, clamps.

Figure 1. Scene of explosive accident of CNG buses

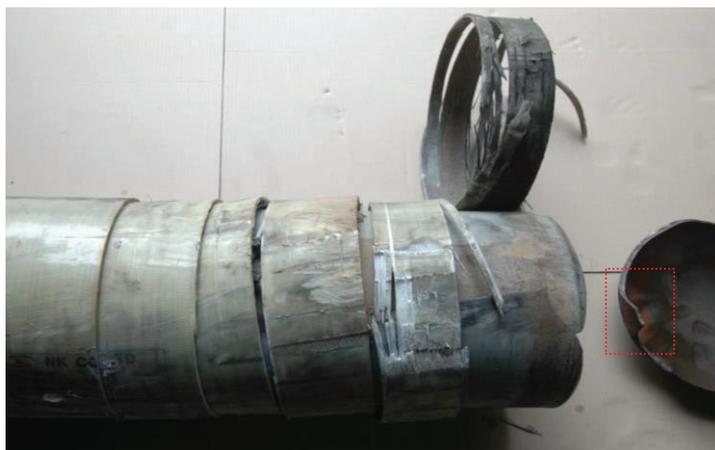
The lower dome of the liner is fractured and separated from the body as shown in Figure 3. The traces of damage before an accident are not observed in the laminate of the composite material and the composite part was burst dependently by fracture of inner liner. In the result of observation after removing composite material, fracture of the liner was progressing along the axial direction. Also, severe corrosion patterns are observed on the surface around the fracture section and marks of the combustion reaction such as soot is not identified inside and outside the liner. A chevron mark which can determine the point of the crack initiation and the direction of the crack propagation in the axial fracture section of the lower dome and the body is observed. In the result of watching this mark, the shape of serration was observed in the section of the circumferential direction at a point 4 cm from the point where the lower dome of the liner meets the body. It is recognized that the crack propagates from the division

where the shape of serration is observed to the axial direction. Looking at the fracture section of crack initiation, The corrosion layer is locally observed and the forms of brittle and ductile fracture are simultaneously identified.

Figure 3. Fracture and corrosion pattern of CNG container

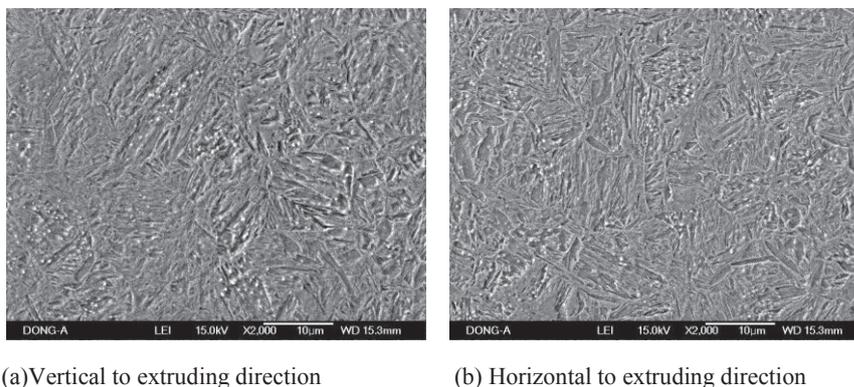
The crack point on the crack initial surface was carefully observed by scanning electron microscopy (SEM) as shown in Figure 4., Figure 5. In case of TYPE 2 pressure container, metallic liner is manufactured of one circular blank by drawing and ironing continuous process. Depending on the process characteristics, vertical and parallel directions in the extrusion direction, the mechanical and structural properties in the container are different. Therefore, in order to examination mechanical properties and micro-structure of crack point, Test is examined according to the extrusion vertical direction (one direction) and parallel direction (second direction). As a result of the inclusion inspection, special point was not identified in all directions as shown in Figure 6. Martensite structure was observed as a result of micro-structure examination. However, it shows fine martensite structure in the cross section perpendicular to the extrusion direction, but coarse martensite was identified in the cross section parallel to the extrusion direction as shown in Figure 7. Martensite is observed in the entire region of the vessel which must have the quenching and tempering process, and it is judged that there is a defect in the heat treatment of the tempering skip. It can be seen that it is very brittle and the fragmented because the toughness is not given. As a result of FE-SEM observation, we know that the precipitation was seen much more in vertical cross section than the parallel cross section of the extrusion direction.

(a) Vertical to extruding direction

(b) Horizontal to extruding direction

Figure 5. SEM Images of crack initial point (2000x)

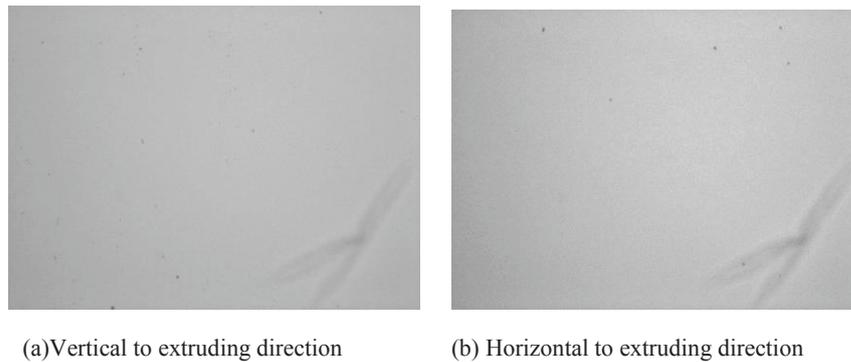
Figure 6. OM Images for inclusion(100x)

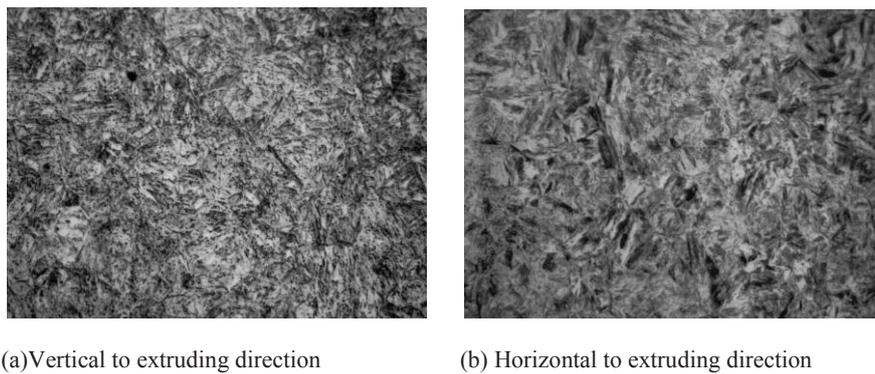
Figure 7. OM Images for martensite (1000x)
