Analysis and Experimental Study on Perforation Abnormity of Perforating Gun

Yu Han ^{1,*}, Ma Tao ²

¹China Oilfield Services Limited (COSL) Tianjin Branch, No.1581, Hai Chuan Road, Tanggu Marine Hi-tech Development Area, Binhai New District, Tianjin, China

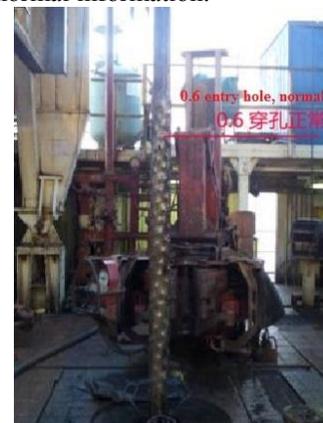
The Bohai oilfield in recent years due to anti-sand and fracturing, used 60 shots per meter (18SPF), this type of gun has the advantages of ultra-high density and big hole size, can satisfy the requirements of perforation process in fracture sandstone heavy oil well completion process, to effectively reduce the pressure near well, and production differential pressure in the same production quantity, to achieve stable sand control purpose. But in the process, due to the increased quantity of shaped charge, in the moment of perforating, the gun body also will have a lot of pressure, if in the assemble process have a problem, is likely to cause serious accidents of perforating gun^{[1][2]}. This well the first TCP process on February 8th, 2014, after the process of running gun, depth correction and pressure firing, when lifting the gun, the operator found gun seized, after 180Klb, the gun released; on the ground, the operator found the 9# perforating gun occurred abnormal phenomenon (See Fig1,2) the rest of perforating gun perforated normal^[3].

Fig1 9# perforating gun lifting out of wellbore

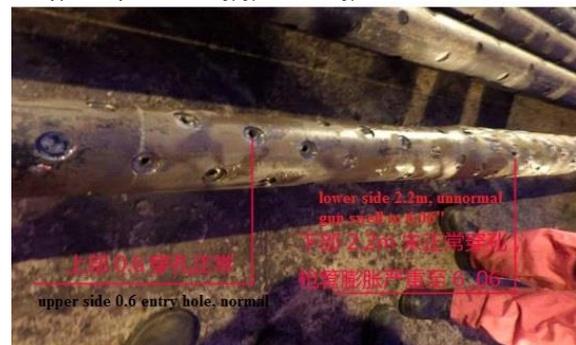
Fig2 entry hole of upper and lower side on perforating gun

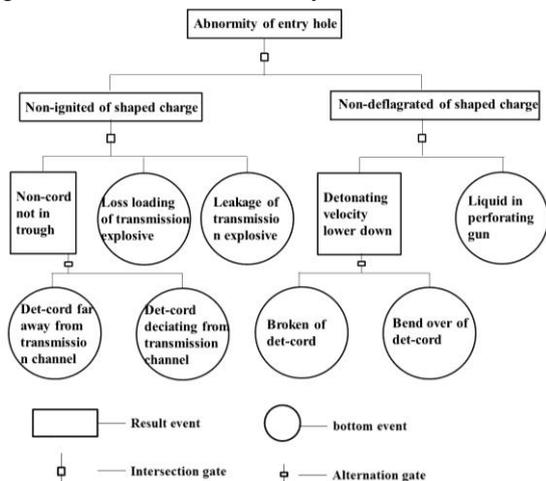
Using failure mode analysis method, to analyze the possible cause of abnormal perforation of 9# perforating gun in this well. (see Fig 3).

Fig 3 FAT of abnormality of entry hole

1. According the fault tree analysis, the possible cause of gun bulge and no perforation mainly is four aspects: the quality of product, the bend damage of detonating cord, shaped charge abnormal load, and well liquid influence.

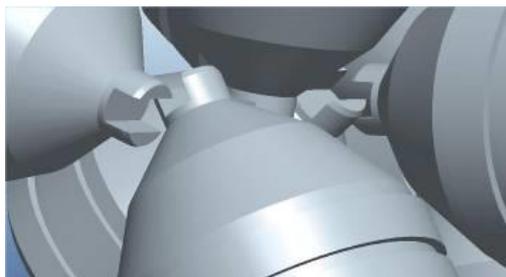
The detonating is protected by package during the delivery, is not easy to be damaged. In the loading gun process, is easy to be squeezed and bent by shaped charge which leads the change the density of the detonating cord. In the design of 60shots per meter perforator, the detonating cord deviates from the centerline of the perforation gun 2.3mm, the distance of two adjacent shaped charges is 16.7mm, the detonating cord is repeated bending (60 times bending per meter)^[7]. Under this condition, the detonating cord may be damaged and in extreme cases may lead to decrease the detonating velocity cause the detonation of detonating cord, lead the problem in this process. (see Fig 6,7)

Fig 6 60 shot/m 127shaped charge loading simulation

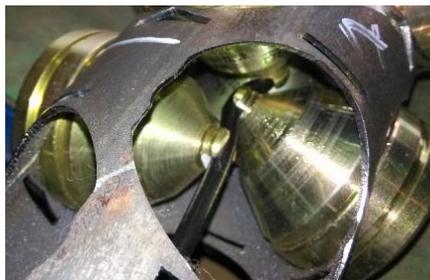
Fig 7 60 shot/m 127shaped charge loading in reality

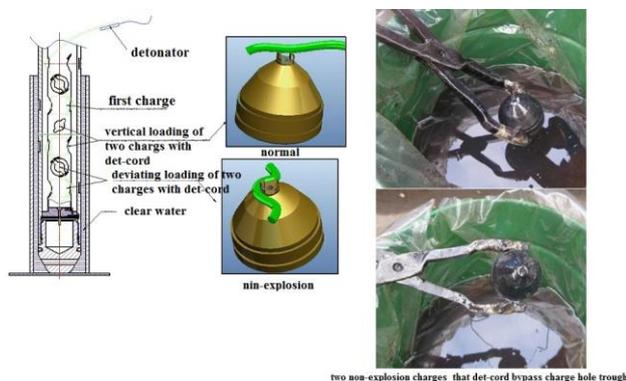
The normal assemble and shaped charge bottom against the detonating cord the performance is normal to perforating, the detonating cord deviated the shaped charge is not perforating. (see Fig 12)

Fig 12 Test assembling and result

When the detonating cord is slightly away from the detonation hole, the shaped charge can be detonated normal. No eliminate the possibility that the detonating cord deviated the detonation hole and caused shaped charge is not detonated.

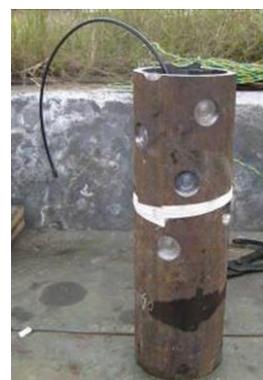
Fig 13 three charges at bottom end in water in 3h

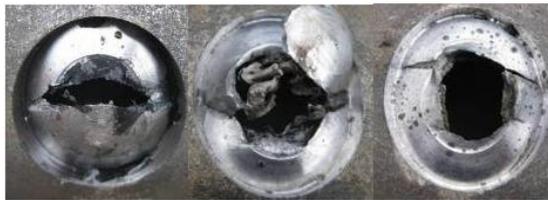
perforating charges penetrated normally in air. Three perforating charges penetrated abnormally in water. (See Fig 16 to19).

Fig 17 4 charges' un-normal entry hole

If the perforating gun is water seepage, the shaped charge soaked in water after certain time, the water will go into the powder, and shaped charge performance occurs abnormal phenomenon.

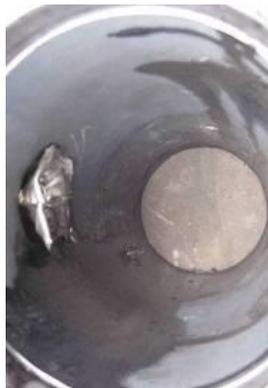
Fig 18 charge case being close to entry channel in un-normal condition

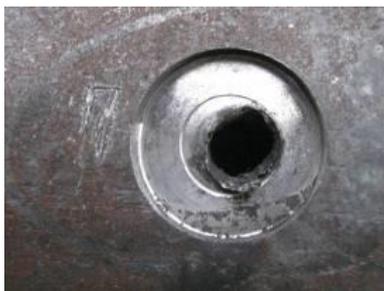
All perforations are normal. (See Fig 20 to 23)

Fig 22 entry hole on gun tube after test

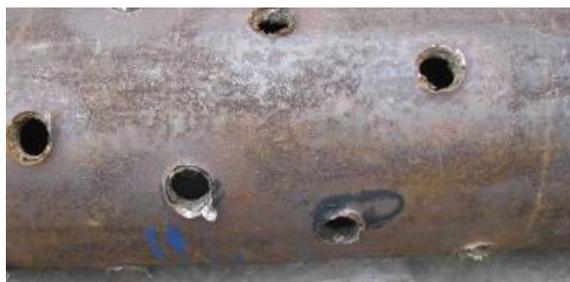
Fig 23 entry hole on casing after test
