# Prevention of uncontrolled progressive collapse of a high-rise brick building

**Abstract.** In recent years, there is a trend towards increasing the failure rate of buildings and structures as a result of unforeseen situations. This study is aimed at assessing the operational reliability of the structure to prevent emergencies and progressive collapse. The behavior of structures affected by various factors was analyzed. The operational condition of a building with stone walls and a rigid structural frame constructed in the middle of the 20th century was considered. By means of a detailed instrumental examination, effects of long-term operation, climatic factors and violations during construction on the serviceability of the building were analyzed. Geotechnical conditions of the site were investigated. Necessary re-calculations for load-bearing structural elements and foundations were carried out. An expected failure diagram for vertical load-bearing structures of the building is presented. Proposals for preventing progressive collapse were developed on the basis of the author's technique.

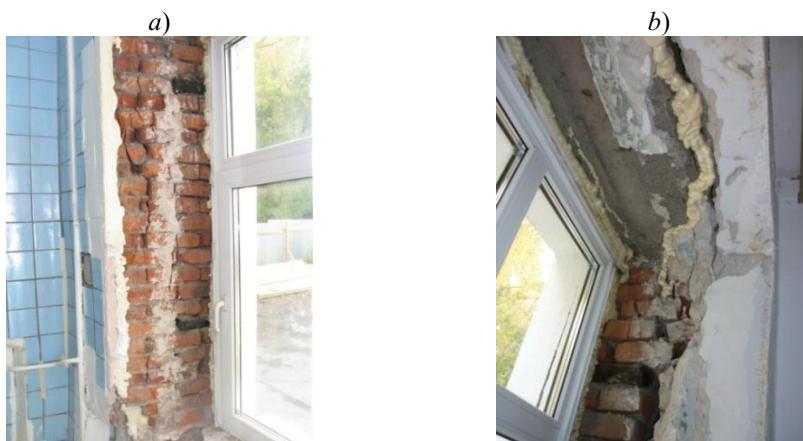
Due to saturation of the masonry with ground water, atmospheric precipitation and household water accompanied with cyclic exposure to negative temperatures, the strength of the masonry has significantly deteriorated. Crushing and disintegration of bricks are observed in exposed sections of the masonry of the ground floor walls (Fig. 2).

**Fig. 2.** Destruction pattern of the masonry of ground-floor wall partitions.

Samples of bricks and mortar taken from the walls of the building were tested. The results show that the strength of the ground-floor and basement walls changes from “zero” to M 10. According to the compression test, the strength of bricks corresponds to grade M 25 ... M 50.

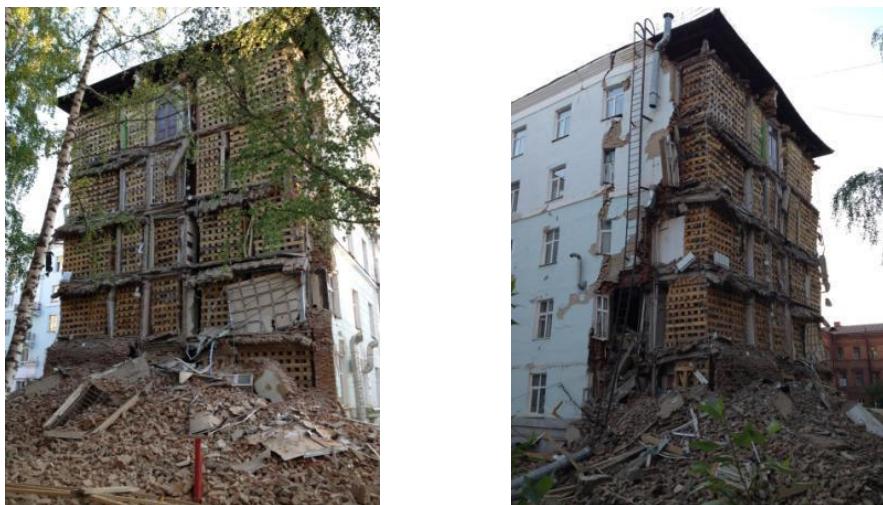
It should be noted that the end wall collapsed as expected, in full accordance with the prediction (Fig. 4).

**Fig. 4.** The real collapse of the northern block of the building.
