# Failure of pillar of sports and entertainment hall structure

**Abstract.** This paper deals with the failure of one of the sports and entertainment halls in Poland. The facility was built in the years 1977-85. Its main load-bearing members were three-hinged double-sloped frames with a total span of 45 m. The main girders of the frames were made of glued-laminated timber. The girders rest on reinforced concrete pillars. Because of the considerable expansion forces the facility was founded on concrete padstones. In the summer of 2016 one of the reinforced concrete pillars was found to have failed. It was established that the failure condition was mainly due to construction errors. A way of strengthening all the pillars with additional RC members was proposed.

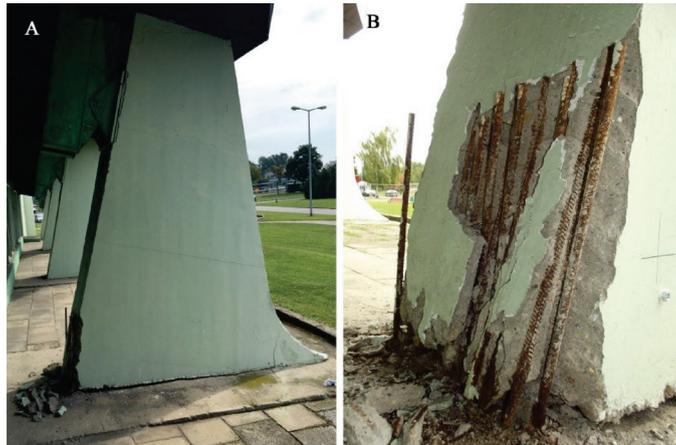
In the summer of 2016, during clean-up work, one of the supporting columns on the facility's south side was found to be damaged. In the zone of the joint with the concrete padstone the cover of concrete debonded extensively along the length of the lap of the starting foundation rebars and the tension reinforcement of the column (fig. 3). At the same time the column turned relative to its compression zone and a gap appeared between the column and the foundation. In its widest part the gap was 3.5 wide. Numerous cracks (most with allowable width) were found on the column's sides. A macroscopic visual examination of the other structural members did not reveal any other negative effects of the failure. This could be owing to the static system (the three-hinged frame), the interaction (via the bracings) between the individual frames in carrying loads and the adaptation properties of the wood.

As the column was damaged, a direct survey of its reinforcement could be carried out. Eight ribbed bars 16 mm in diameter, made of steel with the characteristic yield strength of 410 MPa, extended from the concrete padstone. The bars were joined by a 59-65 cm long lap splicing with the column's reinforcement of the same density (8 steel ribbed bars 16 mm in diameter), but made of steel with the characteristic yield strength of 355 MPa. The reinforcement starting from the foundation and the column's reinforcement suffered from corrosion, with the corrosive losses estimated at 10%. No lateral reinforcement was found in the exposed area. Also above this area examinations carried out by means of a reinforcement detector did not show any lateral rebars. In the gap which had appeared at the

joint there were no vertical rebars along the column's longer side. The concrete cover of the exposed rebars amounted to 5-15 mm. All the other columns were examined using the reinforcement detector. The same faulty reinforcement layout was found.

**Fig. 3.** Damaged column (A – overview, B – place of damage initiation) [1].

In the authors' opinion the primary cause of the failure was the faultily constructed reinforcement, particularly:

- the absence of transverse reinforcement which should surround the longitudinal reinforcement and which would hinder the separation of the rebars from the concrete, the disruption of the interaction between the rebars, and the pulling out of the longitudinal rebars along the length of the lap;

- the absence of vertical reinforcement at the lateral edge of the column; this reinforcement could prevent the intensive propagation of cracks between the column and the foundation (in the years when the facility was built, the recommended maximum spacing of longitudinal rebars in a column was 40 cm [6]);

- the too small length of the lap of the reinforcement extending from the foundation and that of the primary reinforcement, which did not exceed 65 cm (according to the then guidelines, the required length of anchorage was 56 cm; moreover, it should have been increased even as much as two times since all the tension rods were connected together in one cross section [2]).

The next cause of the failure was the insufficient rebar cover (5-15 mm). This adversely affected the durability (concrete carbonation, reinforcement corrosion) and adhesion (the layer of concrete surrounding the rebars was too thin). Finally, another cause could be the overloading of the structure during periods of intensive snowfalls.

Taking into account the above circumstances, it was proposed to strengthen all the columns [7]. The strengthening was to consist in erecting 20 cm thick concrete walls on both sides of each of the columns (fig. 7). The walls were to take over the whole load from the roof. A transfer slab (a kind of cap) was to introduce uniform stresses into the padstone. The existing members and the strengthening ones were to be joined together by means of epoxy resin bonded rebars. The new structure was to transfer the entirety of the roof load.

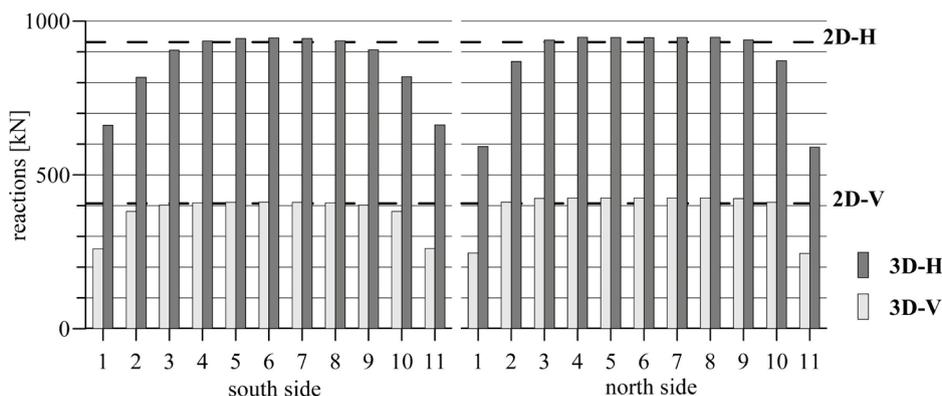
The resultant maximum design vertical reactions (denoted as **3D-V**) and horizontal reactions (denoted as **3D-H**) for the individual supports are presented in the chart (fig. 5). Also the reactions computed in the planar system (denoted as **2D**) for the load originating from the band corresponding to the spacing of the frames is included. The differences between the values yielded by the 3D model and the 2D model can be regarded as negligible for the 3-9 supports.

**Fig. 5.** Maximum design reactions [1].

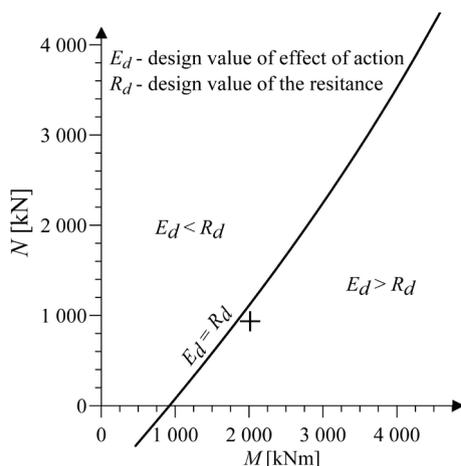
An interaction curve [5], which can be equated with the load-carrying effects, was plotted for the analysed columns. The bending moment and the axial force, resulting from the interactions, were calculated on the basis of the maximum reactions, acting on the damaged column. The results are compared in the diagram shown in fig. 6.

**Fig. 6.** Interaction force and cross sectional forces for damaged column.

The design check calculations showed a relatively small exceedance of the load-bearing capacity, which cannot be regarded as the single direct cause of the failure, considering that the damage was noticed in the summer (there was no snowload). The snow load amounts to about 25% of the total reaction. The couple of internal forces  $M, N$  produced solely by the permanent loads would be within the safe range. The possible overloading of the structure in the winter period can be regarded as a factor which speeded up the failure, but did not initiate it. Nevertheless, it should be stated that the pillar needs to be strengthened because of the exceedance of the strength limit state.
