Facade renovation - replacement and restoration of the panels in a monument protected object

Michal Novotný^{1,*}, and Barbora Nečasová¹

¹ Brno University of technology, Faculty of civil engineering, Institute of Technology, mechanization and construction management, Veverčí 331/95, Brno, 60200, Czech republic

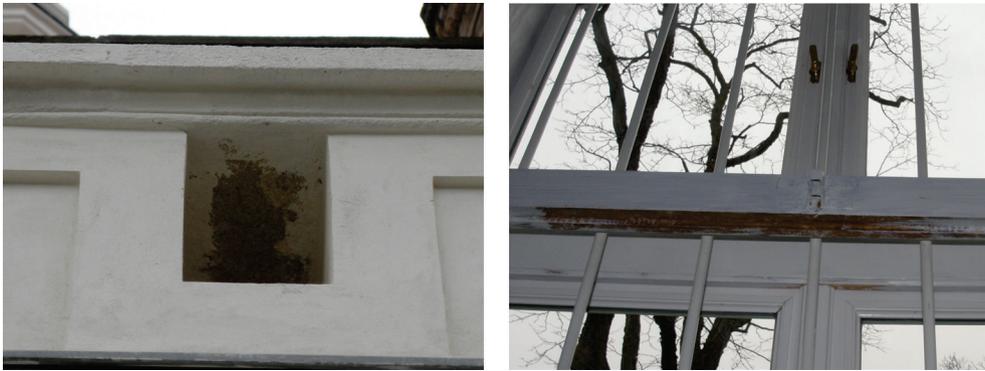
- surface defects of the repaired parts – on the facade and panels - dirt, scratches, residual paints, mortars and adhesives, uneven coloring, unfinished coatings (fig. 1a), missing sealing, surface damage etc.
- incomplete or not started repairs of the elements (fig. 1b), missing elements such as railing, tiling of ledges, and roof entrance,

Fig. 1. Aesthetic defects: **1a** - Left - incomplete facade surface, **1b** - right - unfinished window frame coatings [1].

After evaluating the findings and assessing the problems resulting from the local investigation, various repairs were recommended – for instance - the removal of defects and faults during the subsequent construction works. Unfortunately, some of the defects were not of a character to be repaired – it was recommended to replace the concerned panels. This, however, mainly concerned the repairs not yet implemented. On the basis of all the facts, the following conclusions can be drawn:

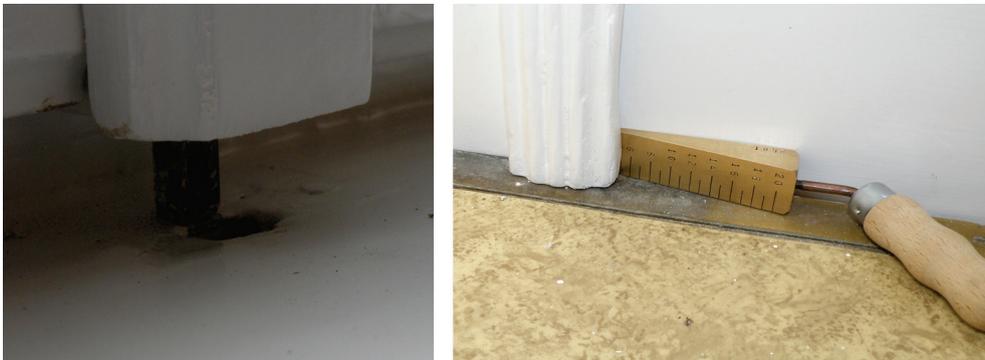
- mechanical problems of the functionality of the panels - impermanence (large gap between wings and frame - up to 5 mm joints – fig. 2b) and crossed or hinged casements, failure of the fitting or its absence (fig. 2a), crossing of the casement in the frame, missing seals,
- aesthetic defects - imperfections of paintings - different shades, splashes of paints and other materials on final surfaces, scratched glasses, paintings, etc.

Fig. 2. Functional defect – **2a** - left - inoperative window fitting, **2b** - right - large gap between the wings of the exterior door - measured by the measuring wedge - gap of approx. 6 mm, [1].

Point 9 - Installation - specifies the variance tolerance, for us were important the values of the rectangular dimensions of the frames: the difference in diagonal lengths, which is 3 mm for windows up to 1800 mm, and 5 mm for windows up to 3000 mm. The gap between the contact surfaces of the casements and the frames, and the frames with respect to each other, is permitted at the maximum value of 2 mm - which can be considered difficult to repair, and therefore, an additional solution is needed, for example by sealing.
