# Active and passive fire protection system in academic building KH. Mas Mansur, Islamic University of Indonesia

**Abstract.** According to the theory of fire triangle, the existence of combustible materials, heat, and oxygen can cause fire disaster. KH. Mas Mansur building, Islamic University of Indonesia has a fire protection, but rarely to be checked regularly and the number of equipment is less standard as well as the lack of an evacuation route map to facilitate the evacuation process. Inside the building also does not provide safety signs such as the evacuation directions, exit, and warning in case of fire. Therefore, researchers analysed the infrastructure of prevention and control in the building KH. Mas Mansur. Researchers used the method of observation, interviews, and checklist to know the condition directly, and compare with the standard regulations. Results concordance rate of existing infrastructure is 67% fire extinguisher, hydrant box 56%, 71% alarms, sprinkler 0%, 40% detectors, emergency doors 71%, 50% emergency stairs, assembly point 0% and directions 0%. The current results were below the standard of at least 80%. As for recommendations, researchers create a ne

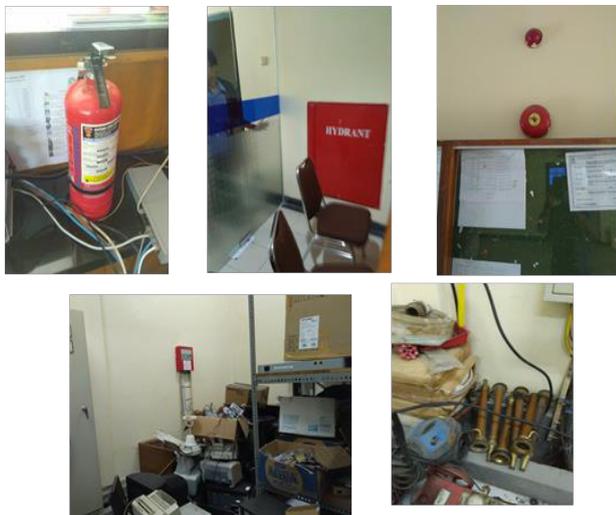
Fig 2. Active fire protection

Some active and passive fire protection in the building KH. Mas Mansur were found. The condition of the infrastructure suits with the result of interview toward three people. Figure 2 shows some of the fire protection tools.

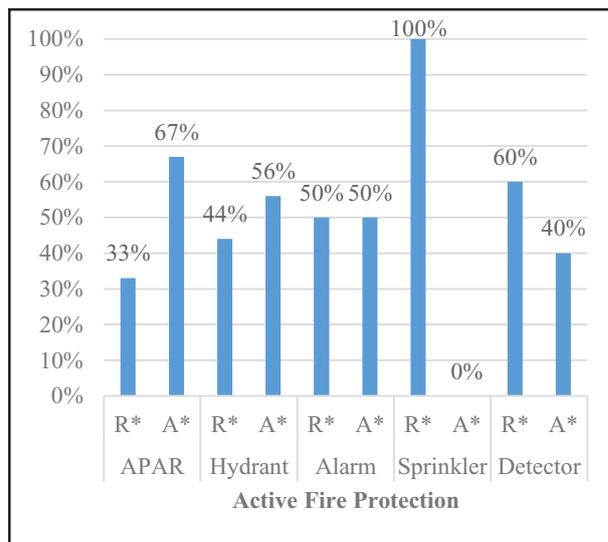
Fig 4. Comparison between R\* (Required) and A\* (Actual) Active Fire Protection

The suitability of the existing condition towards the standard of active fire protection as follows. 10 out of 15 requirements related to APAR [12] were fulfilled, so that the score is 67% means conformance level is enough. While 5 out of 9 requirements of hydrant according to [13]. It means the suitability with Indonesian National Standard is less. Regarding the alarm, there are two specifications needed which are the availability of the alarm and the signal of the alarm that is tested. Since only one fulfilled, the score is 50% or not in accordance with SNI. Whereas the existing condition of sprinkler at building KH. Mas Mansur does not fulfil 13 requirements of [17] which means not good. Regarding the heat detector, 2 out of 5 requirements are fulfilled which are the availability of detector in all rooms and the ease of reaching the detector. It means 40% and categorized as not good level. Therefore, the average suitability of active fire protection facilities in the building KH. Mas Mansur is 42.6% which means less good. The low fulfilled requirements because there are still many active protection facilities that do not meet the standard terms

and conditions. It can be seen from each active protection that is less than 80 % (Fig. 4).

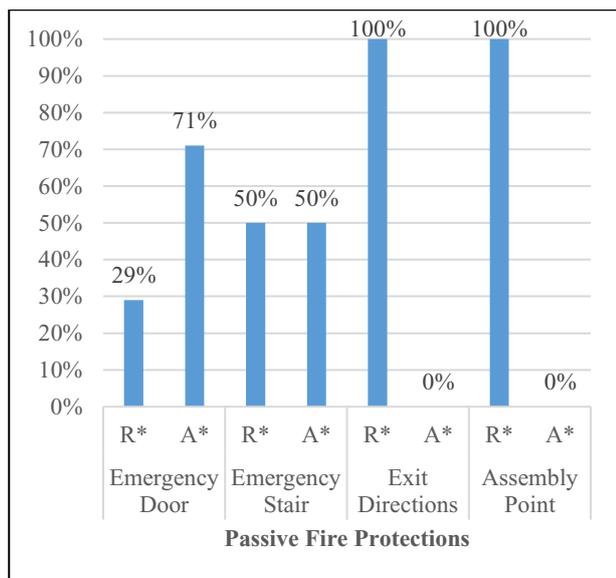
**Fig 5.** Comparison between R\* (Required) and A\* (Actual) passive fire protection

The passive fire protection consists of the emergency door, emergency stairs, exit direction, and assembly point. According to [16], there are seven requirements for the emergency door, but only five is fulfilled (71%). Emergency doors can utilize side hinges that are designed to swing from any position and completed by exit sign marked out in the corridor [12]. Emergency stairs should meet six specifications, but only three fulfilled (50%). It means not suitable with [12] due to no special identification, no floor level hints, and the use of space under the stairs to store goods, even not to store goods. The exit direction does not get any point (0%) due to no installed exit directions yet. This also happens to the fourth passive fire protection (0%) in which nothing assembly point installed. Whereas, according to [15], there should be three requirements that are met following [18] and [19]. Assembly point is critical so that people who save themselves know where the safe gathering place is. Only 8 out of 35 total requirements of passive fire protection fulfilled. The low percentage because many infrastructures do not meet the terms and conditions applied. It can be seen from each of the passive fire protection which less than 80% (Fig 5).
