Analysis of Piping at Kedung Uling Earthfill Dam, Wonogiri Regency, Central Java Province, Indonesia

Abstract. Kedung Uling earthfill dam is located between Eromoko and Wuryantoro district, Wonogiri Regency, Central Java, Indonesia. Water leaked from the dam was found and could decrease volume of dam. The objectives of this study are to identify piping and to recommend for solving piping problem. In order to determine the piping direction and litological pattern, investigation of 10 boreholes with various depth has been carried out. This investigation aim to determine characteristics of soil and rock by analyzing 45 cm of thickness of undisturbed samples and to perform permeability test. Permeability test have been conducted by falling head method with 3 different depths. Leaking at the dam was analyzed by Slide 6.0 software. The results indicated that litology of dam have been identified as claystone, sand and tuff. The piping passed under the eastern abutment of the dam is the accumulation of groundwater in the aquifers formed by 8-10 meters thick layer of sand. The total debit of piping is 17,774 cm³/sec. The Factor of safety of piping is under the minimum of standard namely 3,

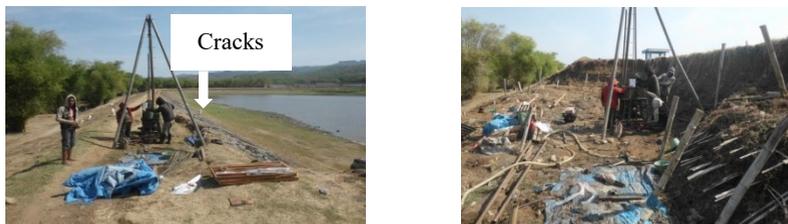
Based on the surface and drilling observation, dominant litology of the research area is grey to black of clay with characteristics of soil is loose to stiff. Intercalation sand and yellowish white limestone pebble is found in some limited research area. The tickness of soil depends on the countour and weathering stage. Based on the surface observation, the area of dam is categorized as flat with the slope close to $0^\circ-2^\circ$. This site are categorized flat morphology. There were found cracks top of the dam (fig 1.a) and sliding (fig 1.b) on the embankment of dam.

Fig 1. (a) Cracks at the top of dam and (b) sliding at the embankment of dam.

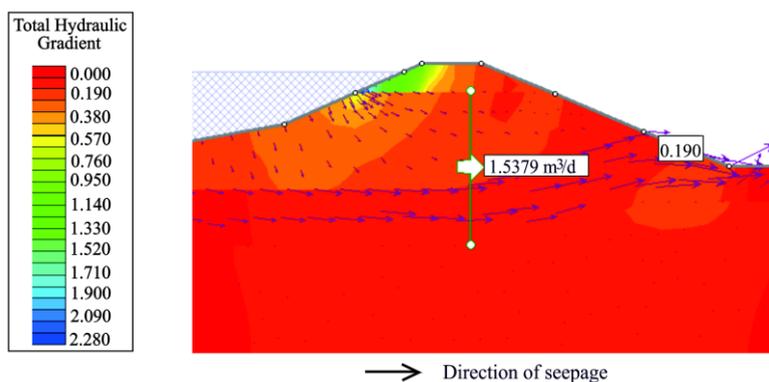
Piping curve is the direction of flow water coming out when the dam encounter seepage. This curve used for giving information where the leak happen. This curve was simulated by using slide 6.0. In this program, permeability value from each materials was set based on the laboratory analysis. Afterward, it was calculated to find where the flow of seepage takes place (fig 3). Seepage flow direction head to east of Kedung Uling dam and reach to the dam body (fig 4). This means the dam has vulnerable to piping because water flows to the area of dam body. Piping curve which pointing up possibly caused by soil critical hydrolic gradient. If the condition of piping pointing up, this means piping pressure same with density of soil. Therefore, effective pressure is zero. If the soil hydrolic gradient exceed critical hydrolic gradient, then possibly grains soil which is empty will pushed by seepage flow resulted in piping. Seepage curve headed to east of dam has total hidroulic gradient value is 0,190 (fig 4). By increasing higher value of total hydrolic gradient, the dam will not safe.

Piping discharge has been calculated from falling head test in the field and afterward has been modeled by slide 6.0(fig 4). Fig. 4 shows piping discharge value with direction of water outflow. Based on analytical results using slide 6.0, discharge of piping is 1,5357 m³/day or 17,774 cm³/sec per meter. Value of piping discharge permission in a dam is under 0,1m³/sec or around less than 1% Q of river. Piping discharge in Kedung Uling dam is categorized as vulnerable and induces potential for sliding. This result coincide with field investigation that slidings are found at the embankment of dam. This piping discharge is

highly influence stability of body of dam. Piping discharge at this model is categorized as large value. By encountering piping, the water in dam will loose largely resulting in piping lines at the ground. As the result, the dam could not resist the loading of water and could trigger sliding at the embankment of dam.

Fig 4. Direction of seepage modeling and seepage discharge value. Total hidrouic gradient value is 0,190.

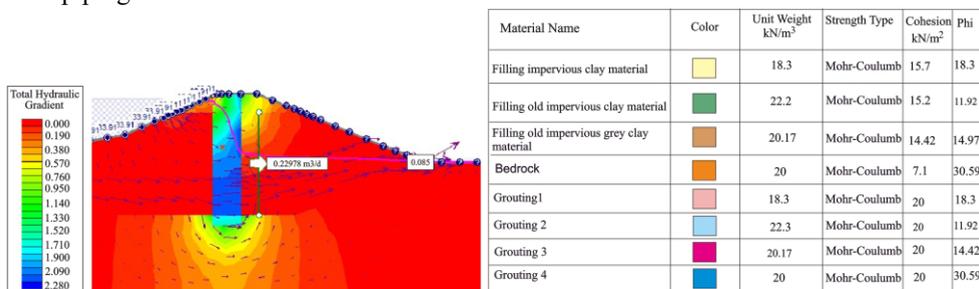
Fig 5. The model of dam after grouting.

From the analysis of piping showed that factor of safety of piping is not satisfying the standard of factor of safety. This means Kedung Uling dam is not safe. Mitigation can be managed by grouting. Before grouting is simulated, discharge of piping at the foundation at the bedrock is 17,774 cm³/sec. This means the seepage is swift resulted in friction among materials bringing by flowing water. Direction of flow curve (fig. 4) also show that the flow reach the body of dam resulting piping at the inside body of dam. After grouting, piping discharge has change quite significant and the piping flow is not reach the body of dam (fig 5). Discharge piping changed to 3,134 cm³/sec. This result shows that grouting can reduce

permeability value and heightening strength of soil. Thus, grouting can minimize discharge of piping. Grouting can be set up in the body of dam which is determined by using the equation of grouting depth [8].

Grouting depth is calculated by using equation 3. Based on the calculation, depth of grouting is between 23,4 meter to 28,6 meter. Grouting depth is set up from top of dam to the end of dam foundation. The reason is slurry sement can fill pores or cracks causing piping. Discharge and total hydraulic gradient value change after grouting at the body of dam. After grouting, specific gravity and porosity will change smaller due to soil pore is filling by grouting materials. Calculation of factor of safety of piping after grouting use equation 1. The result shows piping factor of safety after grouting is 7,5. This results show that factor of safety of dam is higher than that of standard (more than 4) and the dam is safe from piping.
