# Failure Analysis of Shaft Circulating Water Pump (CWP) used in Power Plant

**Abstract.** Pump shafts are generally exposed to the liquid being pumped either on a continual basis or at certain locations along the length of the shaft. The shaft material is austenitic stainless steel, description ASTM AU 79 TY 316. The purpose of this study is to determine the failure of the water pump shaft used in the power plant. Metallography is the study of structure metal shaft can used as a means for CWP metal pelleting (Circulating Water Pump), for the purpose of damaged or deeply degraded areas. SEM test is used to know the beginning of the crack (crack initiation). EDS test is used to chemical composition and Vikers hardness test is also used to know the hardness material. These three tests to support in analyzing the failure of the pump shaft. The conclusion of this failure analysis is the shaft material has porosity. Fatigue cracking comes from the outer surface area.

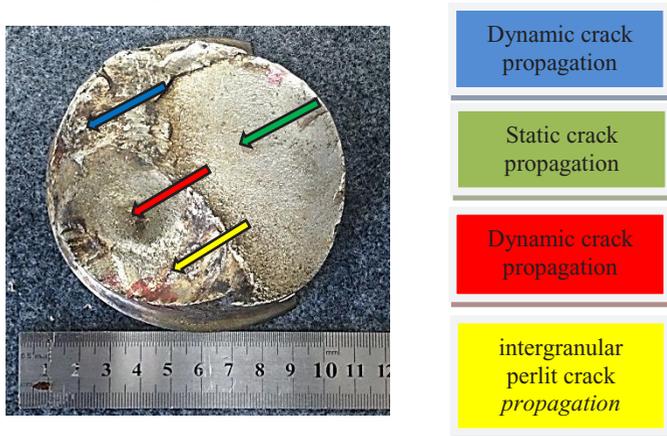
Visual examination of the failed end gave the appearance that the shafts of CWP failed by fatigue. A macroscopic view of the failed region of shaft is shown in **Fig.3**. Signs of smearing and distortion at the key edge were observed.

Areas of damage to the CWP shaft as fatigue failure. Crack propagation begins from an intergranular perlite gap in the yellow arrow. Dynamic layout is displayed on the blue arrow and the red arrow. Static cracking is a very quick propagation in green arrows. The area of damage to the shaft is shown Figure 3.

**Fig 3.** Sites of initiation of fatigue cracks indicated.

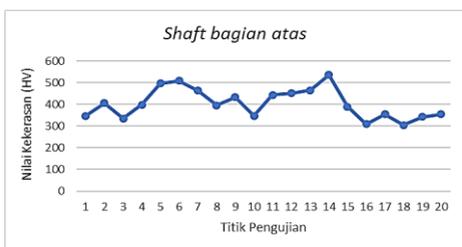
Regarding the hardness test, the top axle has a constant HV value and the failure shaft has a very high HV value. Hardness value of the upper shaft and failure shaft are provided in **Fig 4** and **Fig 5**. From the results of hardness testing (HV) obtained a very high abrasion hardness value this proves that the broken shaft fails because of the residual stress on the material. The residual stress causes the axis to be broken suddenly (unexpectedly).

**Fig 4.** Hardness value upper shaft.

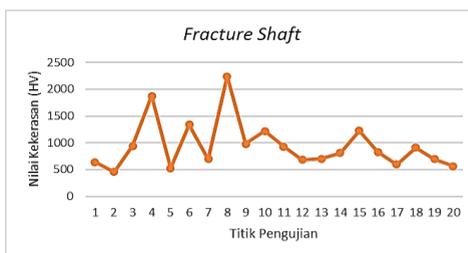
**Fig 5.** Hardness value failure shaft.

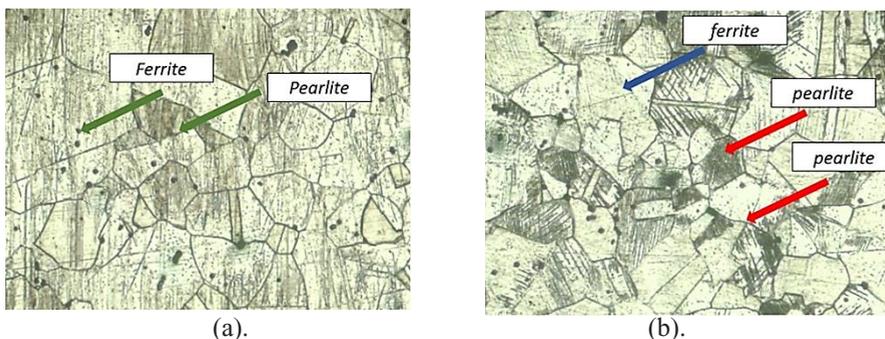
Figure 6 shows the microstructure of upper shaft and failure shaft. The failure shaft formed has new pearlite, its means that the failure shaft more hardness than the upper shaft.

**Fig 6.** Microstructure of upper shaft and failure shaft: (a) microstructure of upper shaft and (b) microstructure of failure shaft.

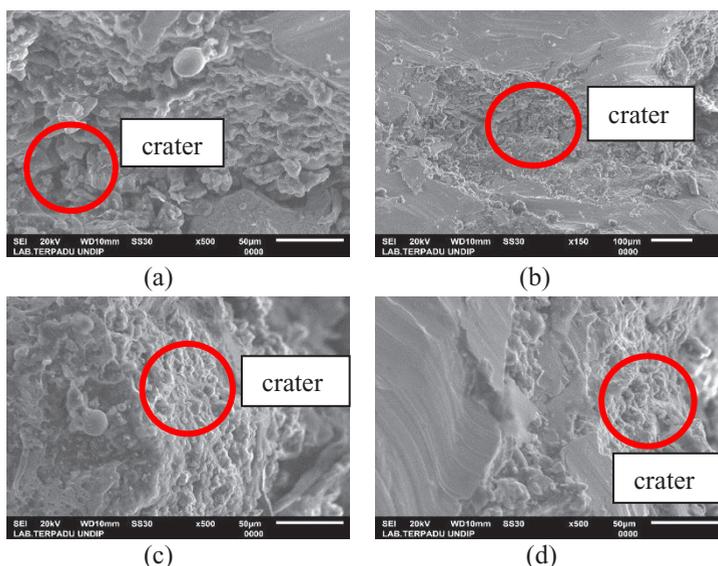
Scanning Electron Microscopy (SEM) is used to fractographic examination. The result of the SEM test we can see the area that became the initial reference of the beginning of the crack. The brittle fracture experienced by the failure shaft can be explained by the contour of a SEM photo marked by a circle, looking very rough because the area has a brittle and high hardness. Figure 7 shows the result SEM in initial crack.

Fig 7. The result SEM in initial crack (a, b, c, d).
