Failure analysis of a 40 ton crane hook at a Hot Strip Mill

Souvik Das*, Goutam Mukhopadhyay, Sandip Bhattacharyya

R&D and Scientific Services, Tata Steel Limited, Jamshedpur-831 001, India

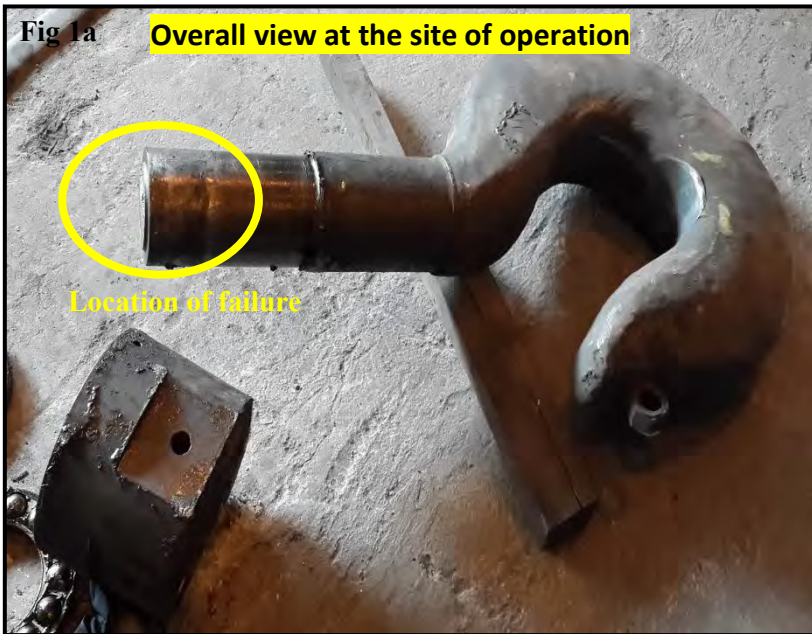
Overall view of the sample referred for analysis is shown in Fig. 1(a). The hook failed from a step where there was a cross sectional change (Fig. 1b); rough-machining marks and chatter marks were observed near the location of failure (Fig.1c). Such locations involving cross-sectional change are the potential sites of stress concentrations leading to crack initiations. Fracture surfaces of broken pieces of hook reveal presence of beach marks from both sides with granular rough surface at the middle of fractured zone (Fig. 1d). Beach marks initiated from both sides indicate origin of reverse bending fatigue. Distinct granular rough zone at the middle is due to final brittle fracture.

Fig. 1(a) overall view of failed hook at the site of operation (b) shows the engineering drawing of the hook with the location of failure.

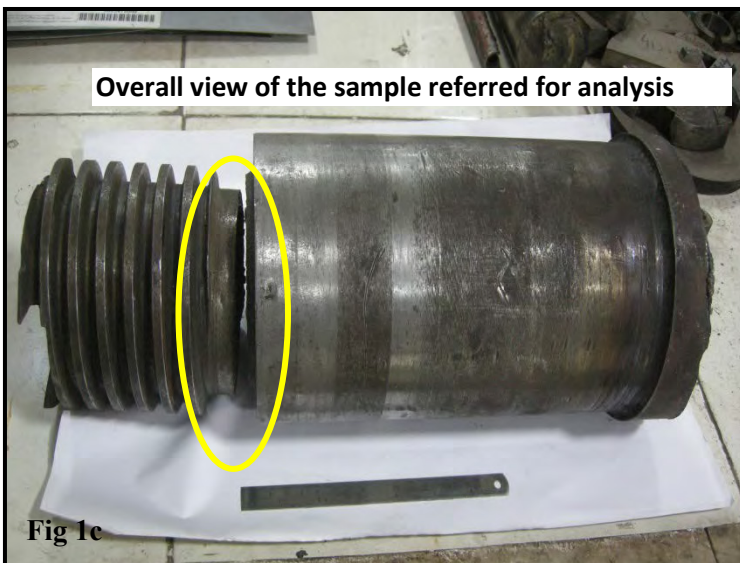
Fig. 1(c) Overall view of the sample referred for analysis, (d) Closer view of fracture surface of hook

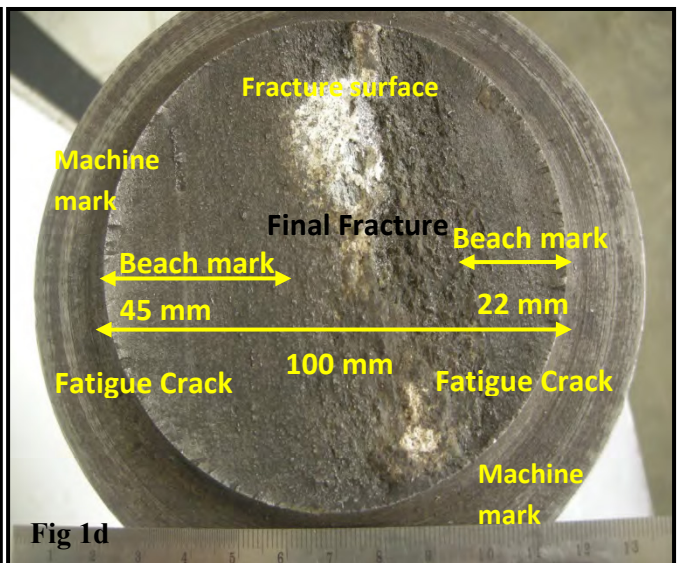
There have been accounts of repeated failure of crane hooks at the coil yard of Hot Strip Mill which pose a serious threat to safety in the area. More than 4 hooks failed in less than 5 years. Fracture surfaces of broken pieces of hook reveal initiation of beach marks from both sides

with granular rough surface at the middle of fracture zone. Beach marks initiated from both sides (Area 1 and Area 2) indicate origin of reverse bending fatigue.

Thus the area of final fracture is small, approximately 30% of total area, indicating that the material was in-adequate for the applications.

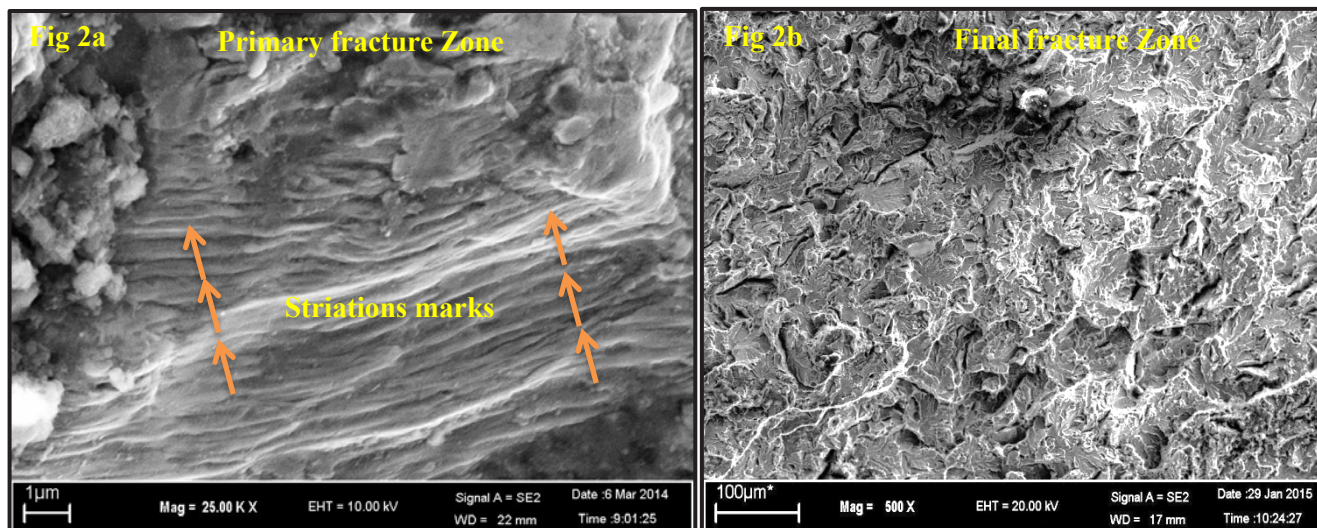
Field Emission Gun Scanning Electron Microscopy (FEG-SEM) of the samples was also carried out for fractography analysis to find out the mode of failure. The analyses were performed at 15 keV accelerating voltage and 5¹⁰⁻⁸ A probe current. The extent of fatigue zone and striation spacing is consistent to high cycle fatigue (HCF). FEG-SEM revealed cleavage nature of the final fracture surface suggesting brittle fracture due to over load.

Fig 2a. FEG-SEM analysis shows fatigue striations marks in the primary fracture surface, (b) showing the microstructure of final overload area (fast crack growth zone).

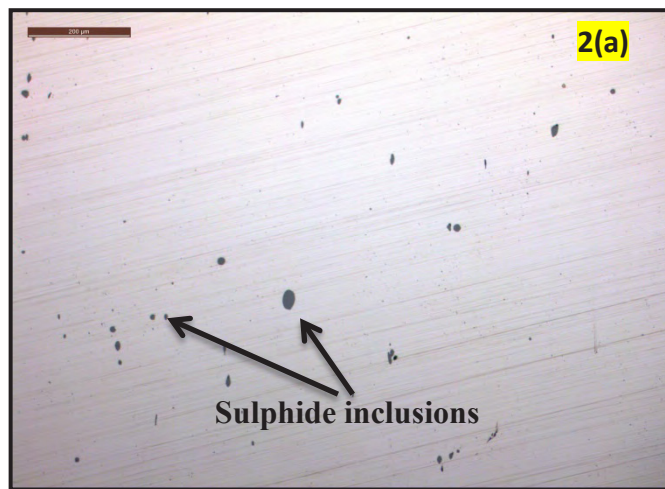
Microstructure of the polished sample revealed numerous inclusions which indicate that the steel was not clean (Fig. 3a). Such a huge number of inclusions (as shown in Table 2) are not desirable as they can act as stress concentration sites and may lead to fatigue crack initiation.

Inclusion rating of the failed component was carried out as per ASTM E-45. Un-etched microstructure of hook shows that thin and thick sulfide (Type A) inclusions (Conformed by

EDS analysis) are present with a severity of 2.0 and 1.0 respectively. Some inclusions of Type D (oxides) are observed with a severity of 0.5.

Fig. 3: (a) Un-etched microstructure of hook (b -c) Etched microstructures of hook sample at different magnifications.

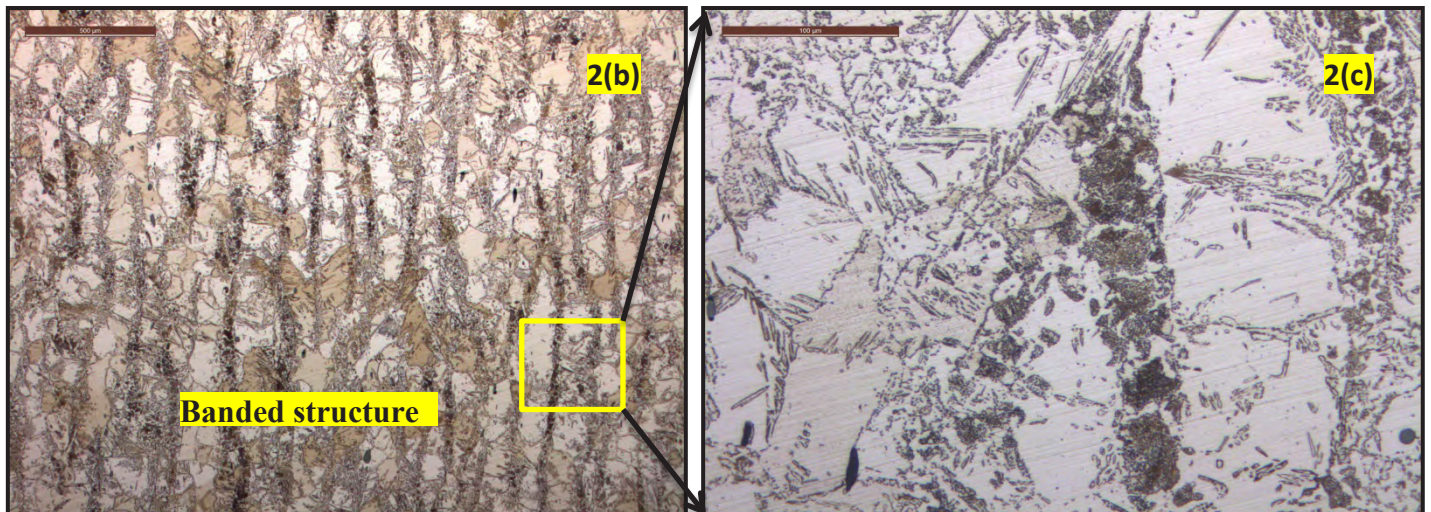
Etched microstructure of failed hook as shown in Fig. 3(b-c) reveals coarse cast structure having inhomogeneous microstructure with a mixture of ferrite and pearlite. This inhomogeneous coarser cast structure is outcome of lower reduction ratio during rolling followed by improper heat treatment process.

- **Heat Treatment:** The crane hook should normalize properly after forging to produce the most desirable structure.
- **Health monitoring of plant equipment:** Preventive maintenance and condition monitoring procedures should be applied to identify and minimize the risk(s) Establishment of an NDT procedure for regular basis inspection of the structural members (welded joints and hook-shaped steel rods during incoming inspection and in-service).

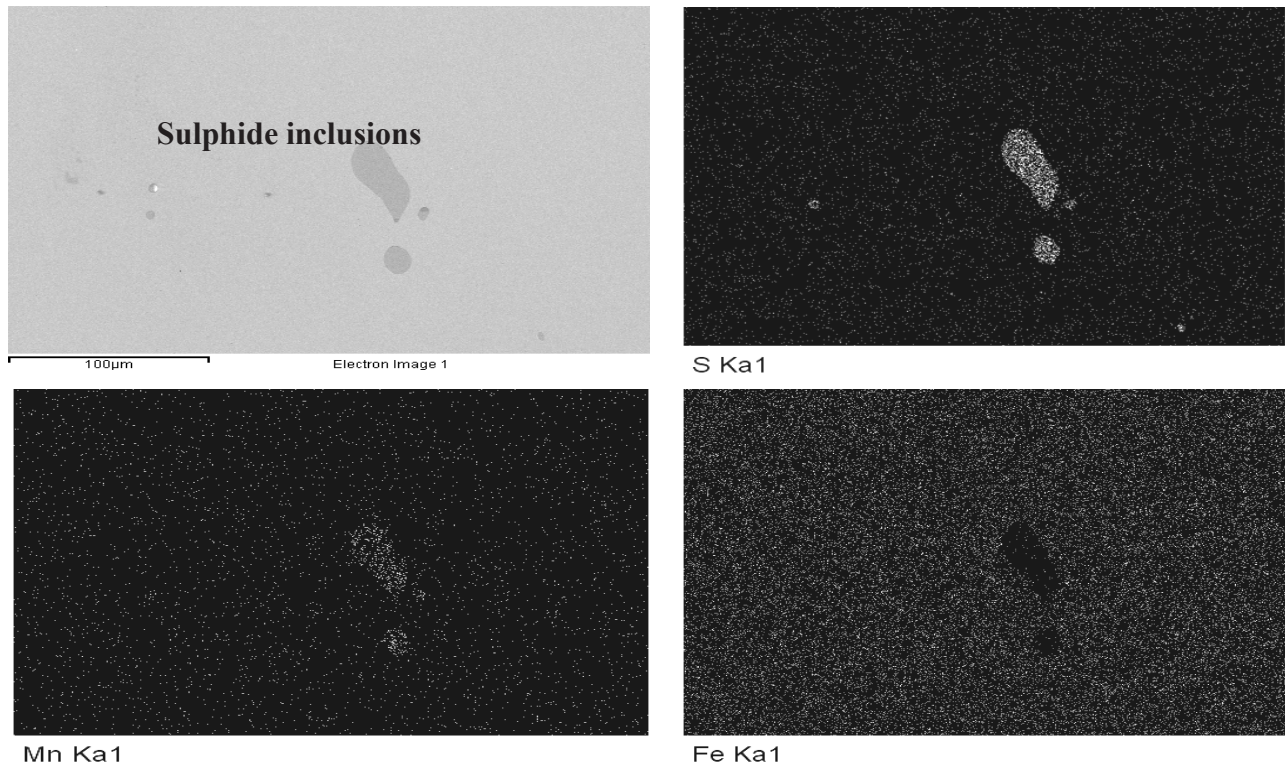
X-ray mapping was carried out on the failed hook sample to determine the elemental concentration in the inclusion (Fig. 4). Elemental analysis under SEM reveals that the inclusions were observed to be rich in Sulphur (S) and Manganese (Mn) indicating them to be manganese sulphide inclusions.

Fig. 4 showing X-ray mapping of failed hook sample.

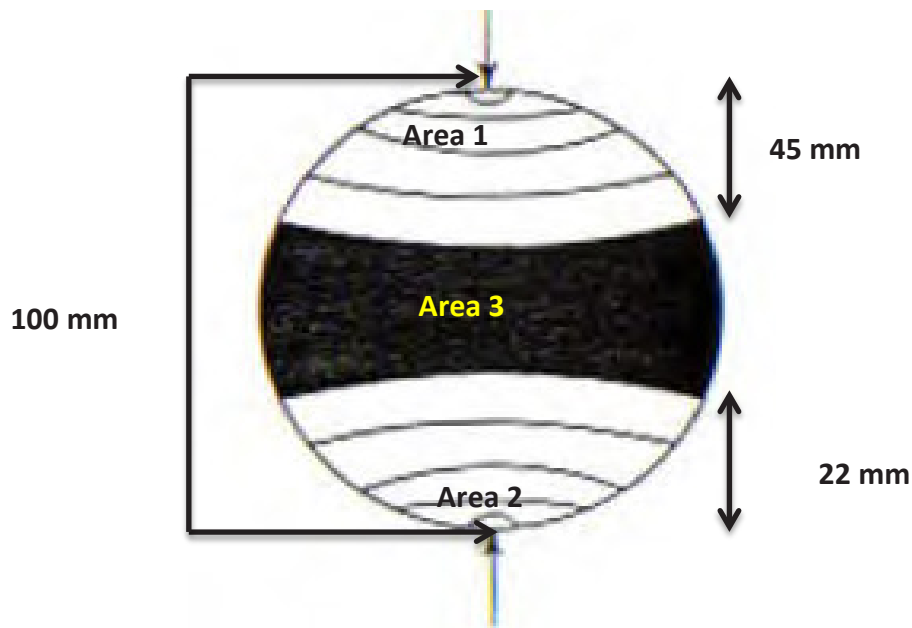
Fig 5: Schematic illustration of the failed hook showing the approximate location of the fracture
Calculation of Area 1 (Fatigue Failure)

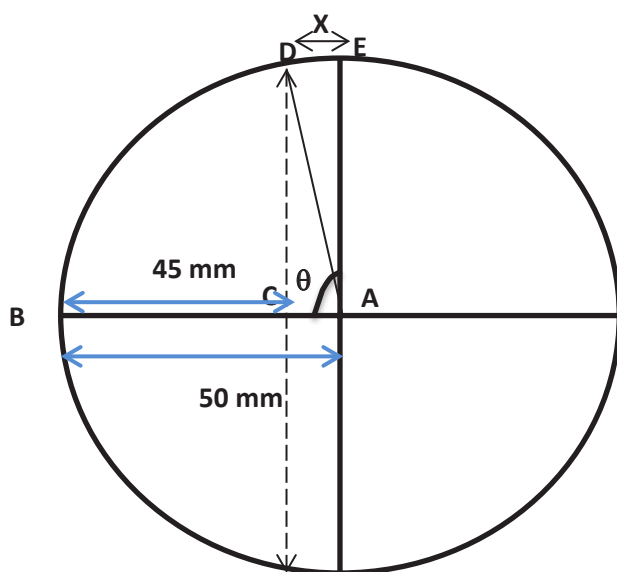
From the drawing we found the radius of the failed sample is 50 mm and the length of the first fatigue 1 is 45 mm (BC). Lets take distance of x to be zero. Thus D is equal to E

Thus total area of Fatigue **Area 1** is 3414 mm².

Form this way we have calculated the total area of Fatigue **Area 2** is 1456 mm².

Now Brittle fracture Area is (Area 3) = $\pi \times 502 - (\text{Area 1} + \text{Area 2})$
 $= 2980$ mm².
