# Energy Dispersive X-ray technique applied to fatigue fracture surfaces oxidation to provide information on growth rate

<sup>1</sup>, Industria de Turbopropulsores, SAU, Materials & Processes Department, Parque tecnológico nº300, 48170 Zamudio, Spain

<sup>2</sup>, Rolls-Royce plc, Materials – Failure Investigation, Bristol BS34 7QE, United Kingdom

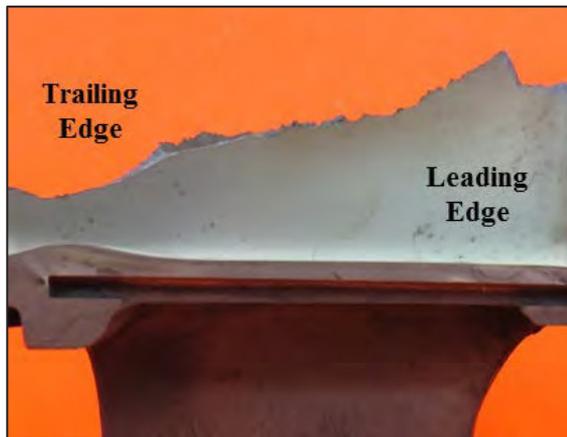
The fracture surface of the blade was produced near the inner shroud of the component, about 10-15% of the aerofoil span (see figure 1).

**Fig. 1.** Pressure side view of the broken blade.

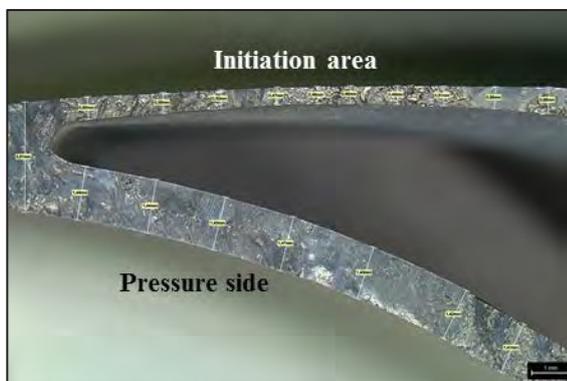
The fracture of the blade started in the suction side of the aerofoil profile close to the trailing edge (see Fig.2). An area approximately 11mm long with thin thickness (about 0,45mm) in that particular region of the surface was detected. That related to a thickness reduction in that area from nominal of around 65-70%, whilst the remainder of the section in the blade was close to nominal (see figure 2).

**Fig. 2.** Initiation in a thickness reduction area at suction side.

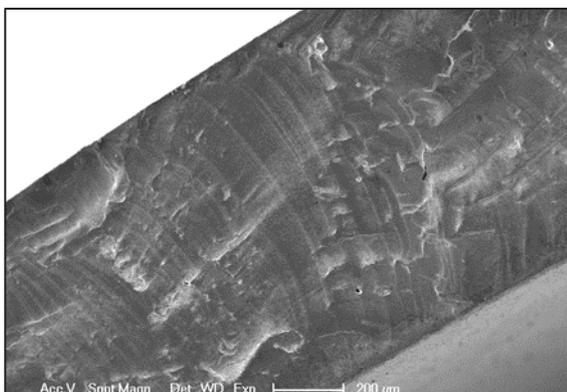
Beach and river marks typical of fatigue mechanisms were observed on the fracture surface in both directions from the initiation area of the crack (see Fig.3). Additionally, fatigue striations were observed only at the end of the fracture surface (see Fig.4). The features observed were commensurate with fatigue propagation in predominantly high cycle modes.

**Fig. 3.** Beach and river marks observed along the fatigue propagation area.

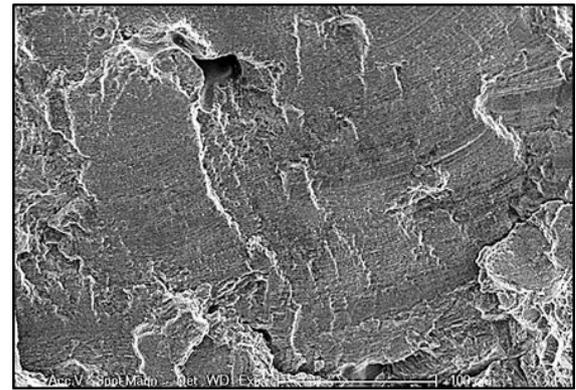
**Fig. 4.** Fatigue striations at the end of the propagation area, close to leading edge static fracture surface.

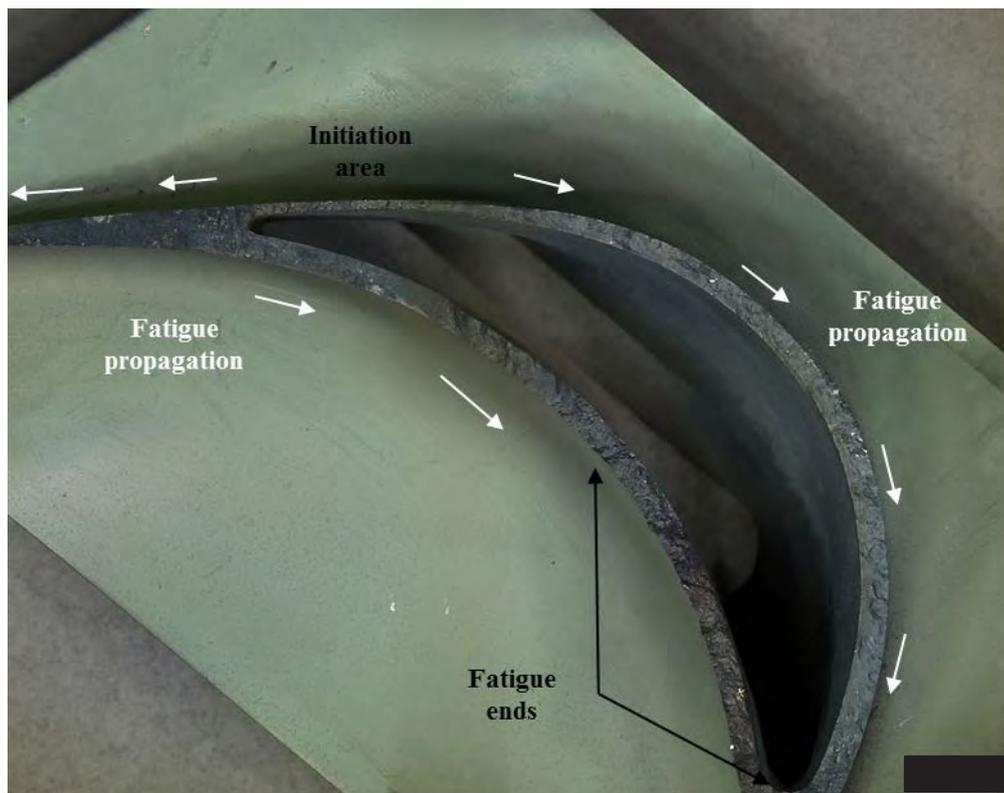
Summarizing, the assessment of the broken blade fracture surface showed an initiation area at the suction side with a thin thickness comparing to the rest of the aerofoil walls. Fatigue propagated from that position in both directions, toward leading and trailing edges, and going forward through a partial area of the pressure side. Accordingly, the fracture surface of the leading edge area and part of the pressure face showed ductile fracture features typical from static and sudden breakage (see Fig. 5).

**Fig. 5.** General view of blade fracture surface.

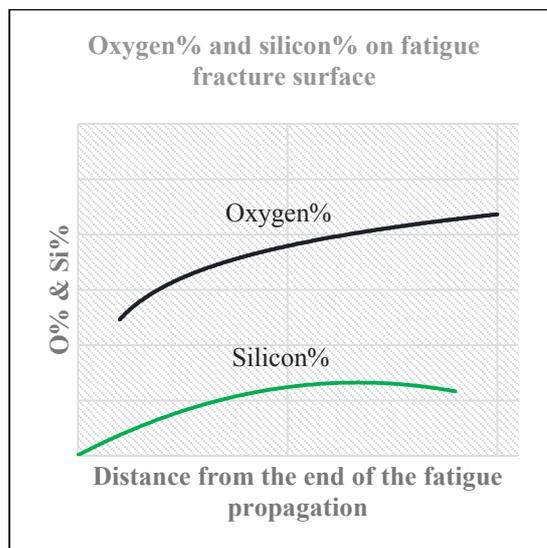
A clear increasing oxygen percentage was observed starting from the end of the fatigue propagation limit to the origin of the crack (see Fig. 6). Silicon, from surface contamination, showed a similar behaviour, although the quantity of this element was lower. Oxidation, therefore, had been evolving with time and in this particular way was “measurable”.

**Fig. 6.** Oxygen and silicon percentage along fatigue fracture surface.

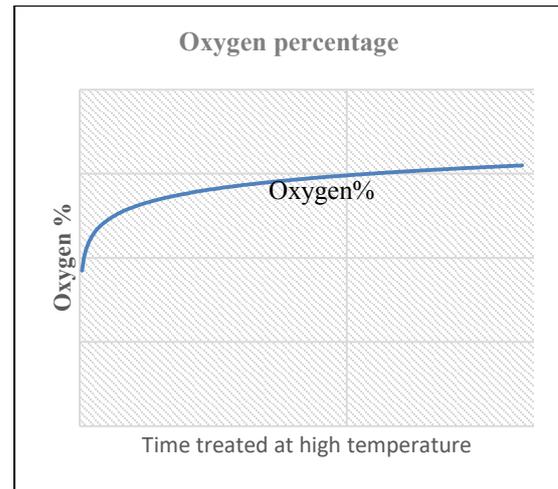
The results of the tests again showed a clear increase in O% content as the sample is exposure for longer times, although the level of O% content after long exposed times was found to be lower than the O% content calculated in areas near the fatigue initiation in the broken blade (see Fig. 7).

It was observed that, the tendency of increasing O% content as the fracture is exposed for longer times at relatively high temperature is similar to the change in O% content observed on the fracture surface of the broken blade. The difference of the O% content could be explained by several reasons:

Fig.7. Oxygen percentage on test samples treated long exposure time.
