High-temperature reaction of sodium vapour with quartz glass

Abstract. Heat pipes are one of the most efficient ways to transfer thermal energy hundred times more efficiently than copper. In this work, we present the investigation of sodium terminal velocity inside a glass pulsating heat pipe. Velocity measurements were conducted under operating conditions within the range of 500 – 1 100 °C. Since sodium is generally able to etch glass and ceramic materials, its presence resulted in glass reduction and sodium oxidation. From the XPS analysis of specimens extracted from a glass pipe after sodium explosion, it can be concluded that the reaction products are sodium oxide Na₂O and a thin layer of carbon, which is localized on the SiO₂ glass. The character of damage induced by chemical reactions is analysed in this manuscript.

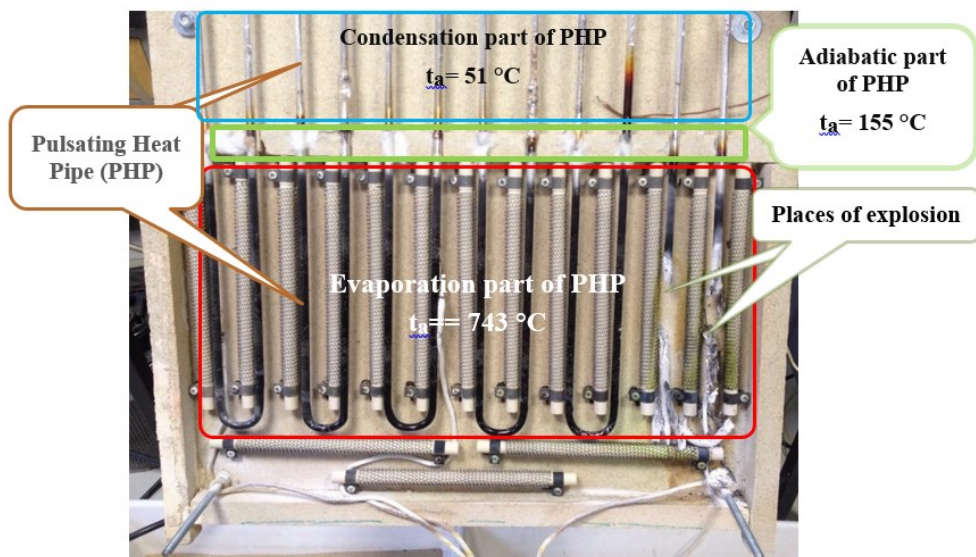
Fig. 1. Detail of the PHP experimental setup and the damage caused by explosion.

It is visible that the character of compounds inside the PHP changes over different parts (condensation – adiabatic transfer – evaporation) is caused by different temperatures. The average temperature (t_a) in each PHP part is shown in Figure 1. For the identification of the black substance covering the pipe walls, the Scanning Electron Microscopy (SEM) equipped with Energy Dispersive X-Ray Spectroscopy (EDS) and X-Ray photoelectron

Based on the XPS results, the explosion was caused by the high temperature followed by the devitrification of fused silica pipe due to sodium [4] and heterogeneity of reactions inside the experimental system. Increasing of sodium diffusion through the weakened walls and the structural failure were followed by chemical reaction of sodium with components of ambient atmosphere.

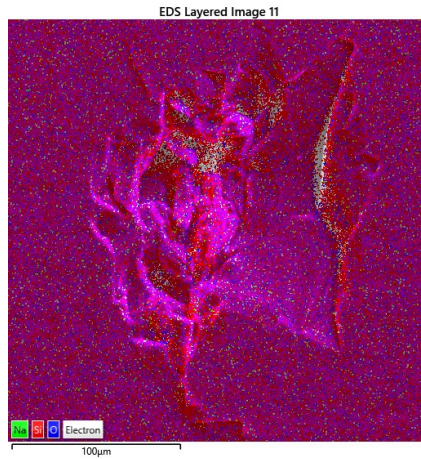
Fig. 3. Sample 1 – EDS mapping of sodium (green channel), silicon (red channel) and oxygen (blue channel) elements.

The sodium contamination of samples 1 and 2 was lower than 1 at.% and the sodium-exposed surface was smooth and free of deep cracks. The cracks observed were probably caused by excessive load at a time of explosion.

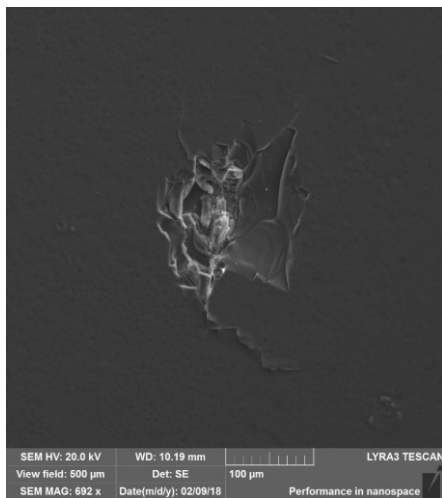
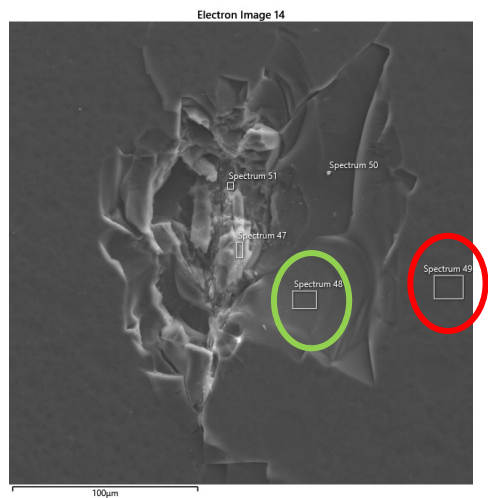
Fig. 4. Sample 1 – SEM imaging of the inner surface (a). Detailed SEM image of the crack in the inner surface with analysed regions emphasized (b).

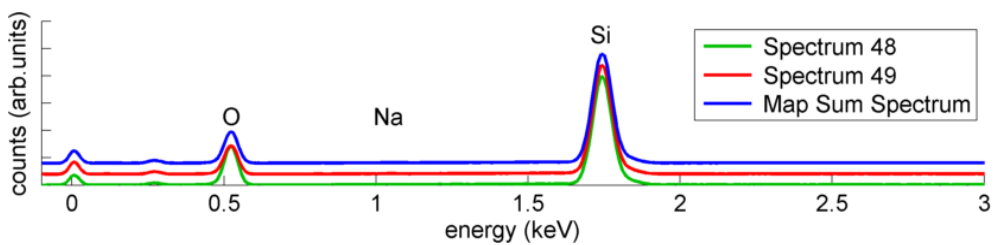
Fig. 5. Sample 1 – EDS spectrum of the region in Fig. 4a (blue line), the sodium-exposed surface (red line) and the uncovered surface (green line).

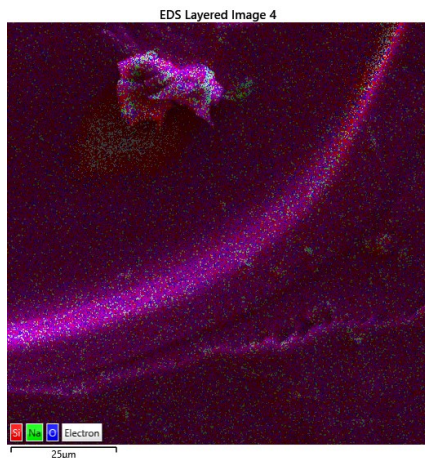
Fig. 6. Sample 3 – EDS element mapping.

The sodium contamination of sample 3 is significantly higher and deeper compared to contamination of samples 1 and 2. The topmost sodium-exposed layer contains 21 at.% of sodium while the deepest region uncovered contains 1.2 at.% of sodium. As displayed in Figures 9-12, the sodium attack is highly localized by forming sodium-rich fibers (17-23 at.% Na) distributed in a silicon-rich (4-5 at.% Na) matrix. Such fibers form diffusion channels for further sodium contamination and act as vitrification and crack initiators.

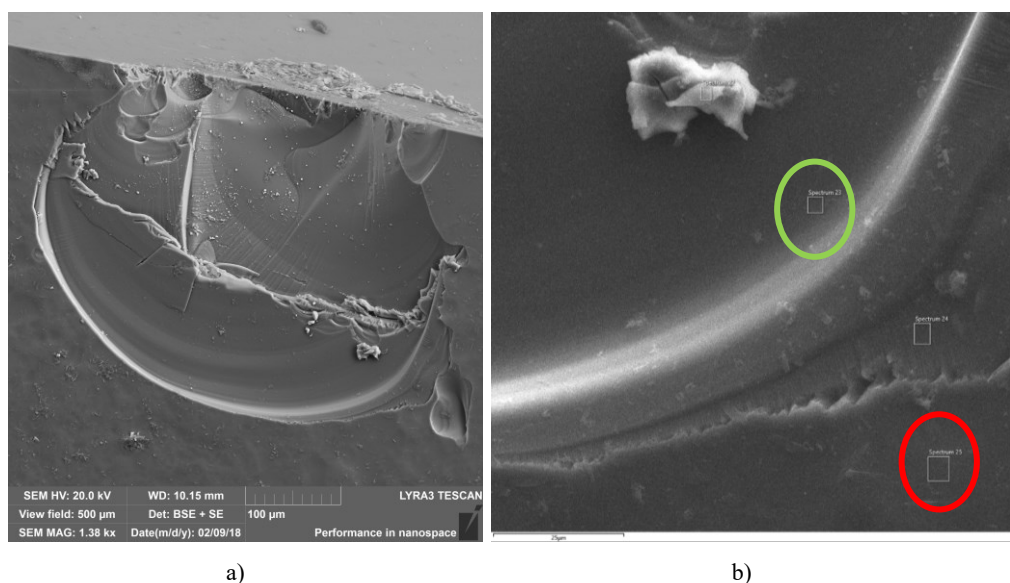
Fig. 7. Sample 2 – SEM imaging of sample surface (a) and crack detail with labelled areas of EDS analysis (b).

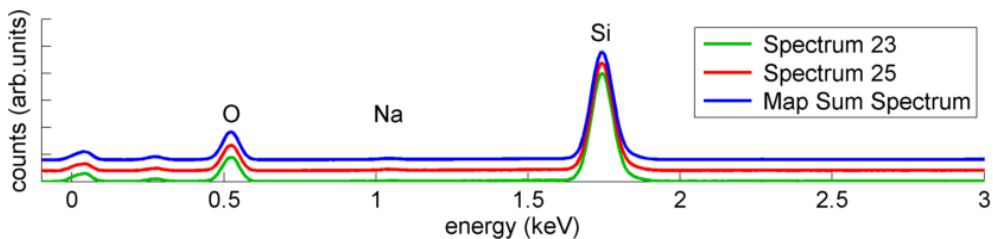
Fig. 8. Sample 2 – EDS spectrum of selected areas of the exposed material (Spectrum 23), the inner surface of the PHP (Spectrum 25) and EDS spectrum from the whole image (Map Sum Spectrum).

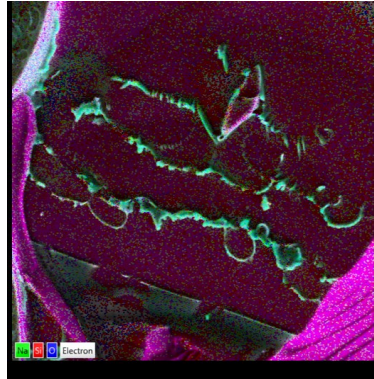
Fig. 9. Sample 2 – EDS element mapping.

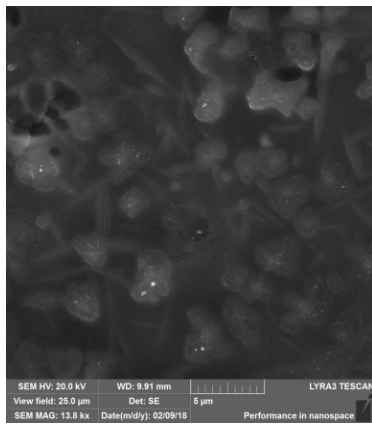
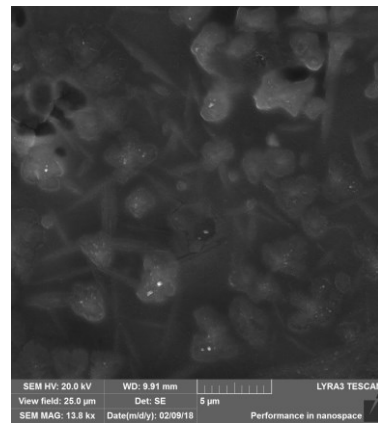
Fig. 10. Sample 3 – Detailed image of high sodium concentration.

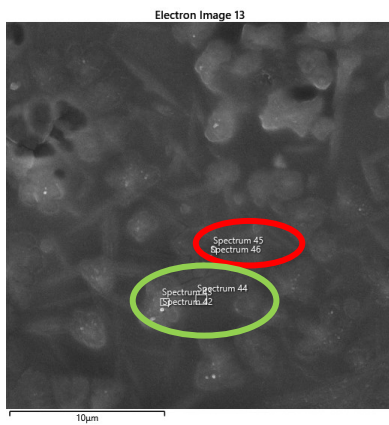
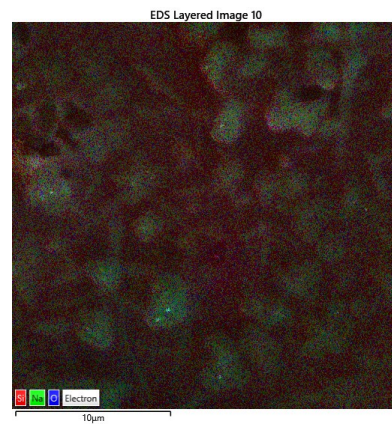
Fig. 11. Sample 3 – Detailed image of high sodium concentration with marked areas of EDS analysis.

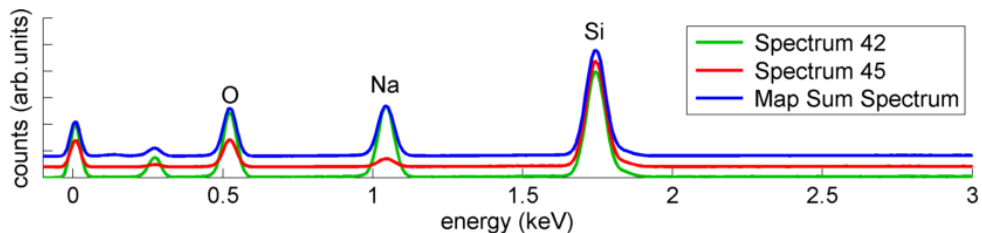
Fig. 12. Sample 3 – EDS spectra of selected areas of exposed material (Spectrum 42), the inner surface of the PHP (Spectrum 45) and spectrum from the whole image (Map Sum Spectrum).

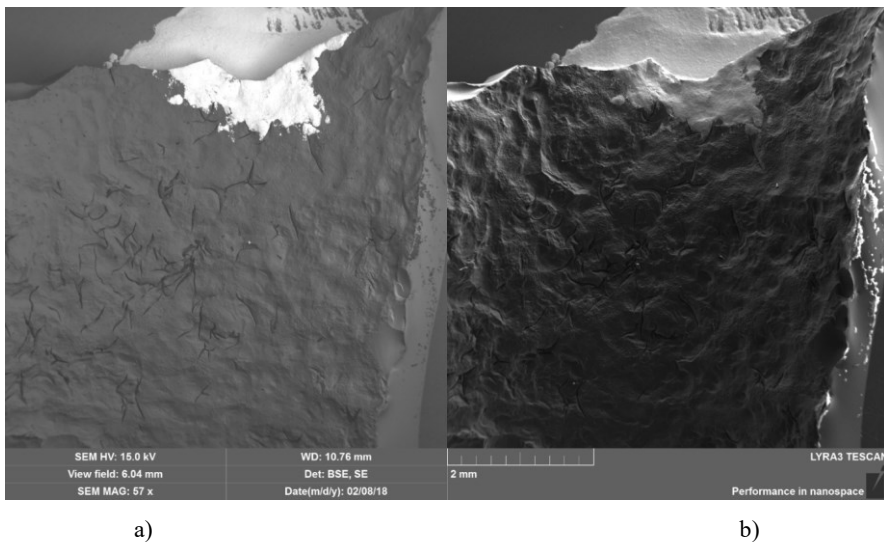
Fig. 13. Sample 4 – The inner material of the PHP. a) BSE image, b) SE image.

Sample 4 exhibits the surface morphology completely different from samples 1 – 3. The sample is characterized by a rough surface full of deep cracks. (Note: Chemical analyses were not performed due to inappropriate sample sizes - the raised parts of the tube removed the signal for the EDS).

The black surface of sample 4 can be explained as a very intensive sodium attack on the amorphous SiO₂ structure by a molten sodium. The thermal effect gradient on the devitrification process shall be considered. Sample 4 was localized in the heated part of the experimental apparatus. In this area, heat is conducted through the wall in the molten sodium at higher temperatures, whereas samples 1 – 3 were localized in cooled part of the experimental apparatus where the thermal gradient is in opposite direction and temperatures are significantly lower.

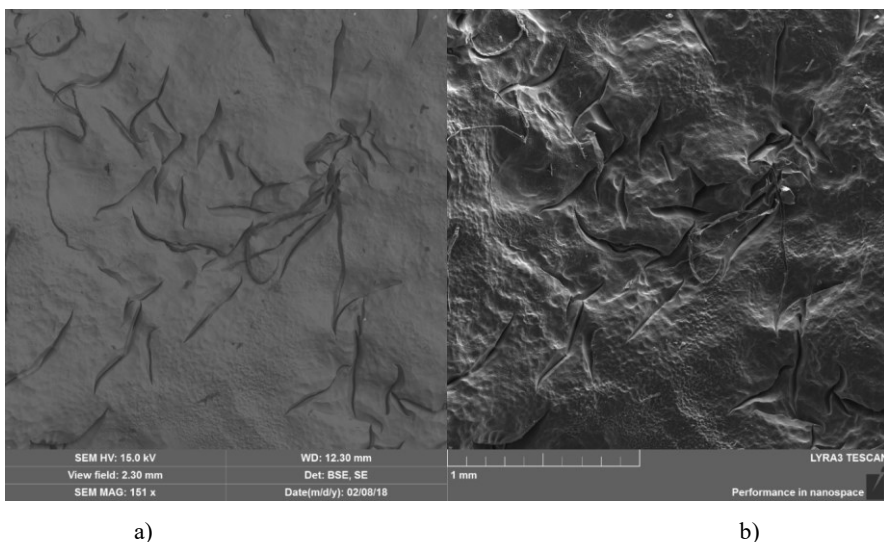
Fig. 14. Sample 4 – Crack detail. a) BSE image, b) SE image.
