Pre-project evaluations of All-Russian Exhibition Center landscape park ponds condition

Lyudmila Frishter^{1,1}

¹ Moscow State University of Civil Engineering, Yaroslavskoe shosse, 26, Moscow, 129337, Russia

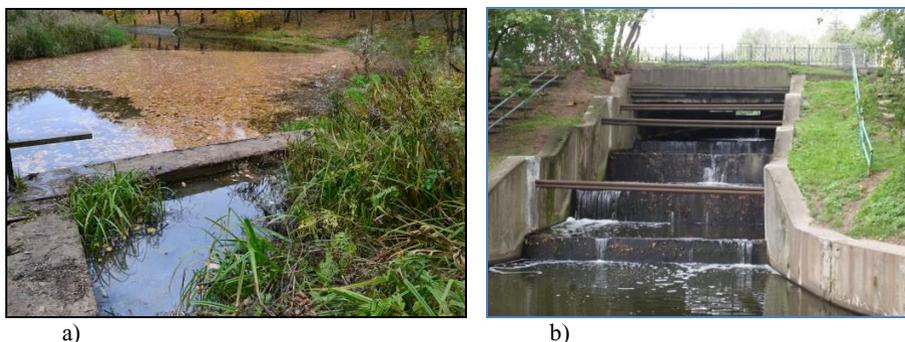
Silting (reeds, grass) is observed in the dam tail water area. Fig.1a shows silting area of the pond No.3 viewed from the dam No. 2 lower slope near the bottom outlet.

Fig.1. a) Fragments of the dam No. 2 lower slope. Scour at the bottom outlet wall, Staged water outlet of the dam No.3 spillway viewed from the tail water.

There are bottom sludge deposits in front of the spillway tower. The deposits measured layer is 1.6 m thick. Silting and swampiness are also noted at the outlet in the tail water (Fig.1a).

The third stage of cascade between the ponds No. 3 and No. 4 includes an earth dam, an open controlled overflow spillway in the dam body with a staged water outlet (Fig1.b) and a non-functioning shaft spillway with bottom outlet.

The cascade has 3 stages of about 6.0 m wide. The stages are made in the form of a water cushion. The distance bars (Fig1.b) across the stage width made of the pipe of 100 mm in diameter were installed later.

The following main damages to the spillway 3-4 are revealed: opening of expansion joints, horizontal displacement of the left wall lower area along the expansion joint of up to 40 mm; corrosion of reinforcement in the area of expansion joints opening.

| Structures | Technical condition; Safety level | Recommendations |
|--|--|---|
| Dam No. 2 | Satisfactory; Unsatisfactory | 1. Repair of the road surface along the dam crest. 2. Repair of the scours and grassing on the dam lower slope. |
| Dam No. 3 | Unsatisfactory; Low, near to unsatisfactory | 1. Repair of the road surface along the dam crest. 2. Repair of the scours and grassing on the dam lower slope. |
| Overflow spillway 3-4 | Satisfactory; Low | Repair of structures in the damaged areas with a reliable design of expansion joints in the cascade walls. |

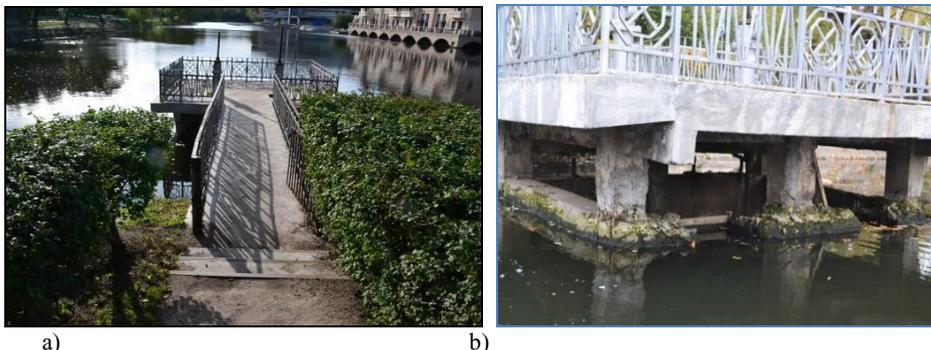
till present. The original spillway design, including bridge guard grating, sluice board lifting mechanisms, has been preserved (Fig3).

Fig.3. a) General view of the spillway 4-5 on the side of the pond No. 4 head water from the crest of the dam No. 4; b) Shaft spillway of the dam No. 4. Two water inlets. Destroyed concrete of water intake head and bridge supports. Original grating was designed in 1950.

The following main damages of the spillway 4-5 are revealed (Fig 3): damage to head reinforced concrete structures: destroyed protective concrete layer, reinforcement corrosion damage of up to 20%; significant damage to the shaft wall upper part concrete with bare reinforcement in certain areas in variable water level zone.

| Structures | Technical condition; Safety level | Recommendations |
|--|--|---|
| Spillway 4-5 | Unacceptable; Dangerous | Overhaul with replacement of the head wall and bridge structure. |
