Interpretation of the results of monitoring of the displacement of the Tresna dam in 2016

Stanisław Lach*

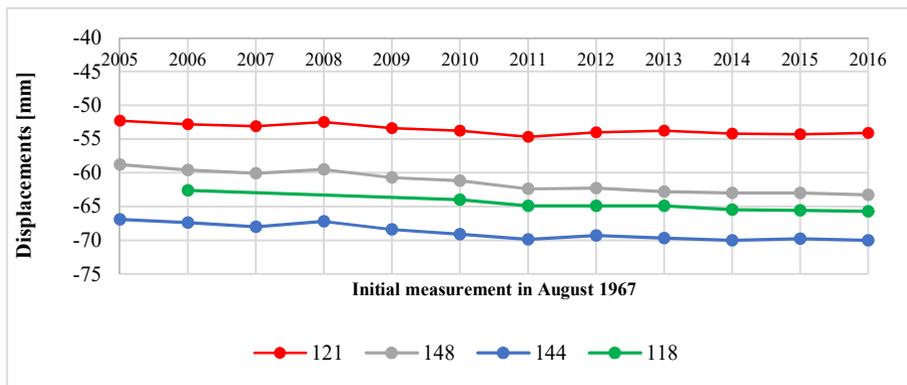
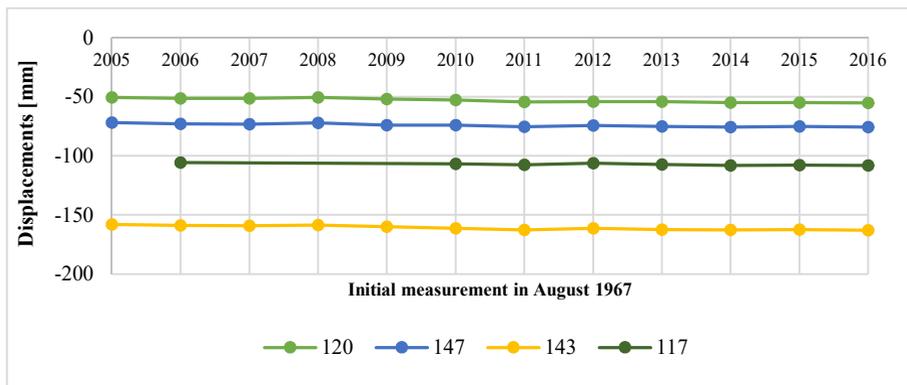
caused further gaps in the survey results, breaking the continuity in the obtained data set (Fig. 3, Fig. 4). The smallest subsidence increments, compared to 2015, were recorded for the benchmark 119 (0.0 mm) and for the benchmark 142 (0.0 mm). The largest ones were noted for the benchmark 116 (0.8 mm). Due to the values of displacements of specific elevation points, there are no grounds to talk about their negative influence on the safety of the dam. A significant factor favoring the occurrence of subsidence is most probably the load on the structure related to water impounding and, to a large extent, the ambient temperature.

Fig. 3. Total vertical displacements of frontal dam in Tresna.

Fig. 4. Total vertical displacements of frontal dam in Tresna, follow-up.

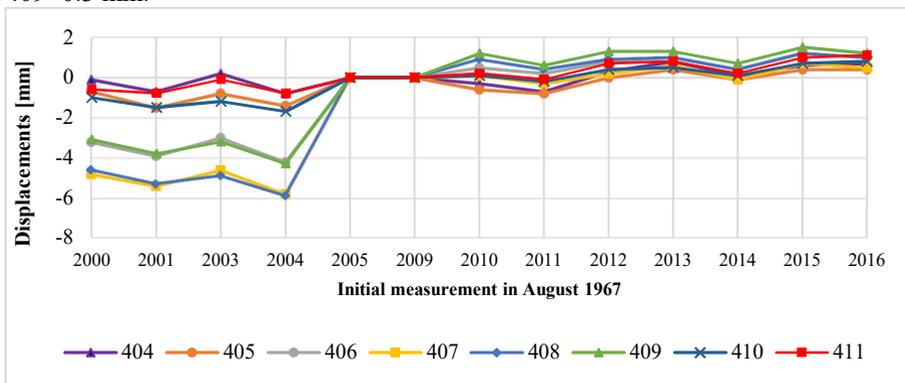
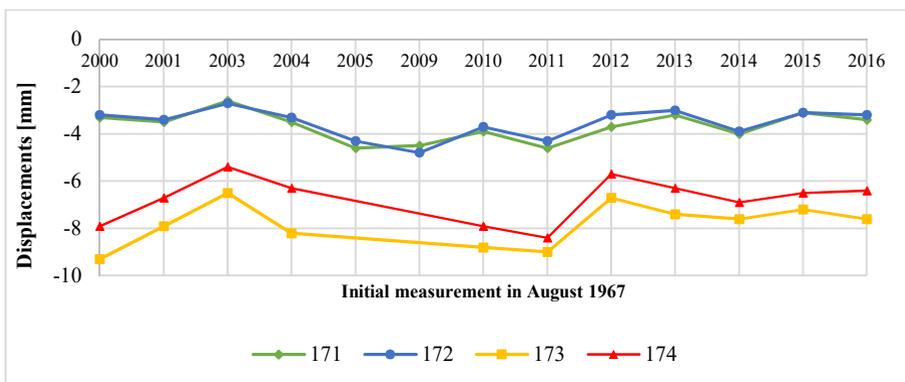
The analysis of subsidence of the benchmarks located within the bottom outlet, similarly to the ones located on the shell of the dam, exhibited minimal displacements (Fig. 5, Fig. 6). The benchmarks 173 and 174, placed above the lock chamber, were unavailable in 2005 and 2009. Despite this gap in the measurement data, no displacements, which would be exceptionally large when compared to others, occurred in 2010. It can be concluded that within these two years, the structure with the lock chamber was subject to a slight, but progressing, subsidence. The benchmarks 171 and 172, located at the spillway of the bottom outlet, also exhibited minimal movements. Since the dam was constructed, the surveys were performed each year, and the total subsidence of the benchmarks, which results from continuous measurements since 1966, has been -3.4 mm for the benchmark 171, and -3.2 mm for the benchmark 172. The elevation points 404-411 were again monumented in 2009. The smallest subsidence increments, compared to 2015, were recorded for the benchmark 405

(0.0 mm). The largest values of +0.1 mm were noted for the benchmarks 404, 410, 411 and for 409 -0.3 mm.

Fig. 5. Total vertical displacement of bottom outlet of Tresna dam.

Fig. 6. Total vertical displacement of bottom outlet of Tresna dam, follow-up.

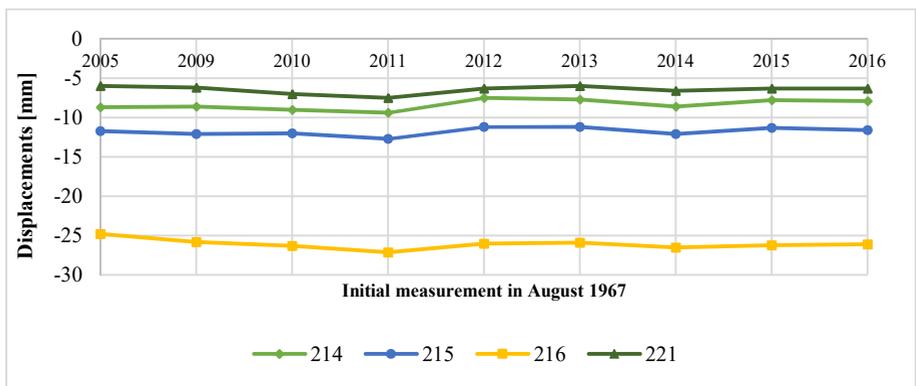
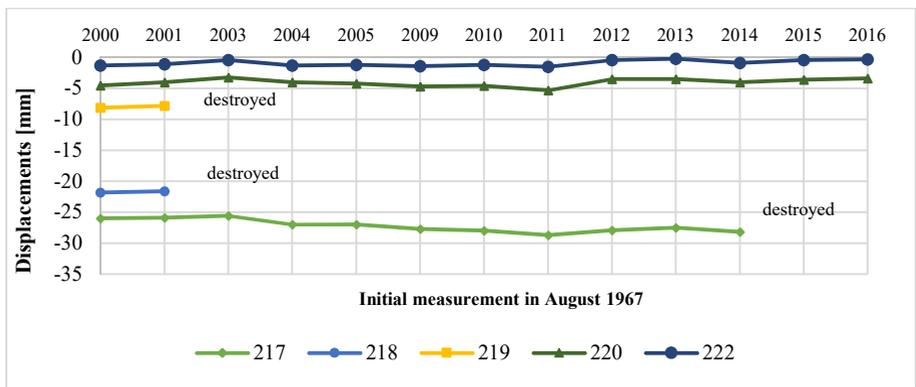
Based on the displacement results obtained from the power plant building, it was easy to observe a large scatter in the total subsidence values (Fig. 7, Fig. 8). The maximum value of displacement (-26.1 mm) was noted for the benchmark 216, while the minimum subsidence of -0.3 mm, i.e. the difference of several dozen mm, was exhibited by the benchmark 222. The noticeable difference is large, however, the values of the obtained results are small enough, so that there are no grounds to consider these displacements as a threat to the safety of the analyzed structure. Three of the available benchmarks located on the power plant building were destroyed. As it can be seen in Figure 4.6, the interpretation of progressing displacements is hindered, which makes it difficult to predict and prevent possible adverse effects of subsidence that may appear in the future. First of all, it is necessary to restore the benchmark 217, which exhibited the highest subsidence value (in 2014, displacements of -28.2 mm were recorded). In 2016, the benchmarks on the power plant building exhibited subsidence of -0.3 mm and elevation of up to +0.1 mm.

Fig. 7. Total vertical displacement of Tresna power plant.

Fig. 8. Total vertical displacement of Tresna power plant, follow-up.

Restoration of the damaged benchmarks, which were revealed during the performance of the displacement surveys, is an important issue as well. The reference points 1010 and 1011 as well as the monitored benchmark 217 located on the power plant building are important for the accurate monitoring of displacements of the dam. In the landslide No. 3, the benchmark 152 located along the road appears to be very important, as well as other benchmarks requiring protection and located in this cross-section.

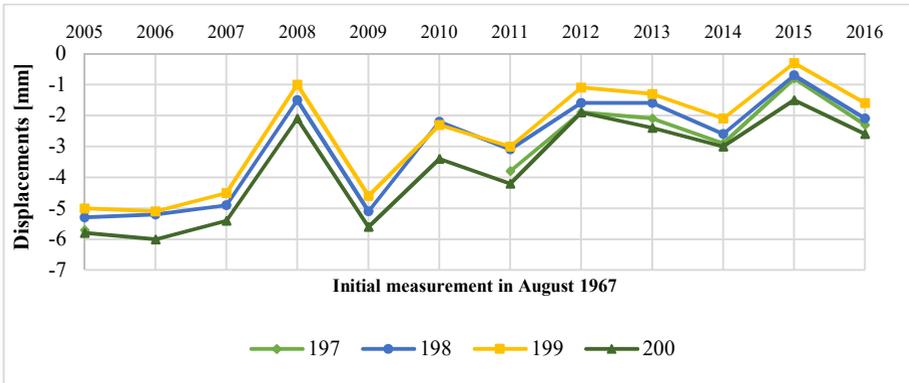
Four benchmarks were placed on the intake tower: 197, 198, 199, 200 (Fig. 9). They have been used in surveys since the dam was constructed (except in 1992, when the reservoir was emptied, which resulted in a data gap). In the years 2006-2010, the lack of measurement results for the benchmark 197 can be observed, which resulted from the destruction of this elevation point. Regardless of all the data gaps, when analyzing total subsidence of the structure over the years, slight displacements have been noted (from -1.6 mm to -2.6 mm). This is undoubtedly a proof of stable conditions for the foundation of the intake tower. On the other hand, taking into account displacements which occurred only in the previous year (2006), subsidence values were observed from -1.1 mm (benchmark 200) to -1.5 mm (benchmark 197).

Fig. 9. Total vertical displacement of intake tower of Tresna dam.

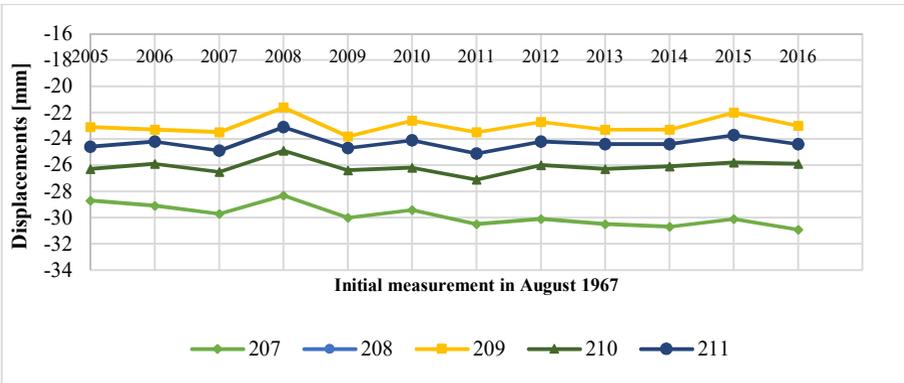
The benchmarks located on the retaining wall have been used in surveys since 1965 (Fig. 10). The elevation points 204, 205, 206 stand out from the others with a clear discontinuity of the data. Moreover, the benchmark 206 was destroyed in 2010, and has not been used in surveys ever since. In 2006, there were displacements of benchmarks ranging from -1.0 mm (benchmark 209) to +0.4 mm (benchmark 205). The largest subsidence of the retaining wall could be observed in the first years after the erection of the structure. Their increments were decreased and adjusted over time. While analyzing the total subsidence, the displacements which were recorded ranged from -11.8 mm (benchmark 205) to -38.5 mm (benchmark 208).

Fig. 10. Total vertical displacement of retaining wall of Tresna dam.

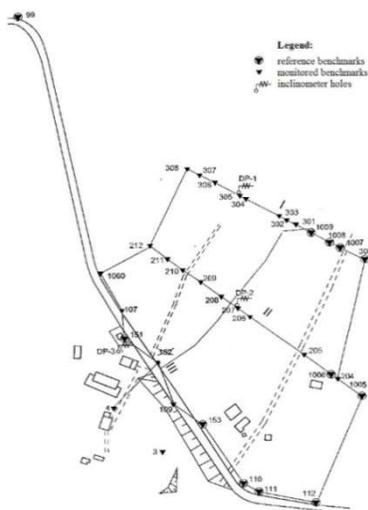
Fig. 11. Sketch of benchmark network for determining vertical displacements for landslide No. 3 [11].

In the area of the I-I cross-section (upper one), measurements of subsidence increments for most benchmarks were commenced in 1983. The elevation point 300 was the only one for which the year 1986 was adopted as the reference year for the estimation of displacements. Since 1983, no damage was noted to any of the elevation points, nor any circumstances occurred throughout the entire period when subsidence increments were being determined that could affect the surveying procedure. The measurement data demonstrates that each of the benchmarks has a complete set of recorded values. The only missing information that could result in difficulties in interpretation of the displacements are the gaps in the recorded measurement years (before 2005). For example, in the period from September 1993 to September 1999, there is a large scatter in the values of the surveyed displacements. These significant discrepancies occur for the benchmarks 308-301 and range from -26.0 mm (benchmark 308) to -41.0 mm (benchmark 306). It can be assumed, however, that in this period the displacements of the landslide No. 3 were evenly distributed, which cannot be seen exactly due to the lack of data in this time interval. It has been found that benchmarks 308-301 have a general tendency to subside. In the period from November 2015 to November 2016, which is the most important in the interpretation for this research paper, the largest increments in displacements which were recorded during these two years were +4.0 mm (for benchmarks 302, 301, 300).

The middle cross-section II-II of the landslide No. 3 covers the network of benchmarks 212-1005. The displacement surveys were carried out at the same values of temperature and upper water levels, as for the cross-section I-I. The displacement surveys did not start at the same time for all the elevation points included in the network. Some of them (as in the case of the cross-section I-I) began to be monitored as late as in 1986. Since the first measurements of displacements in the landslide No. 3, a tendency to slow, but permanent subsidence of the ground could be observed. In the last period (November 2015-November 2016), the maximum displacements observed in the analyzed area did not exceed -4.0 mm. Two of the benchmarks (1005 and 1006), did not exhibit any displacement.

The displacements measured for particular benchmarks within the cross-section III-III (bottom one, along the road) were distributed very unevenly. First of all, it is due to the fact that not all elevation points were measured at the same time (benchmarks 1060, 151, 152, 153 were monumented later than the others). In addition, there are a lot of gaps in the

to the lack of data since 2006, points 99 and 100 have been useless in the general analysis of displacement distribution. Similarly, benchmark 152 was destroyed in 2012 and has never been restored. The remaining benchmarks exhibit the subsidence values at the levels from -8.0 mm (benchmark 109) to -11.0 mm (benchmarks 151 and 153).

The cross section IV-IV covers the benchmarks located under the road. The elevation points 2, 1003, 1002, 1001, 1, were destroyed in 2005 and no attempt was made to have them restored. In the control network of the cross-section IV-IV, there are two benchmarks (4 and 3), but distribution of their displacements is possible to be analyzed only for the control No. 4. In the period from November 2015 to November 2016, this benchmark has displaced by -10.0 mm.
