Case study of negative impact of concave coal basin on long ribbon building development

*Beata Parkasiewicz**, and *Marian Kawulok*

Building Research Institute (ITB), Filtrowa 1 00-611 Warsaw, Poland

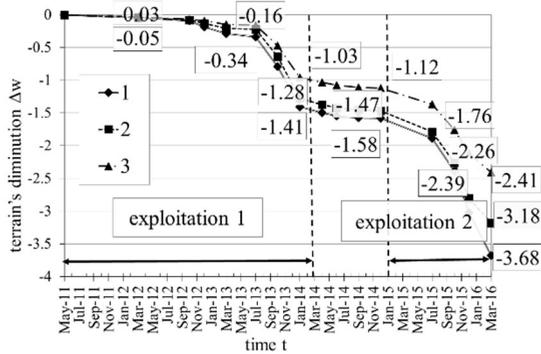
Fig. 6. Increase of terrain’s diminution in time from 05.2011 to 03.2016 in sections 1, 3 and 5. Made on the basis of [5].

- maximum terrain depression equal to -3.68 m (point 1, fig. 6),
- maximum terrain deformation equal to -6.14 mm/m (section 2-3, fig. 8),
- maximum terrain tilt equal to 19.22 mm/m (section 3-5, fig 9).

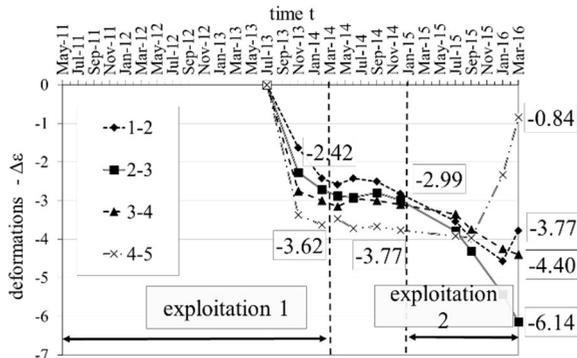
Fig. 8. Deformations between sections in time from 07.2013 to 03.2016 – measuring line 1 – 5. Made on the basis of [5].

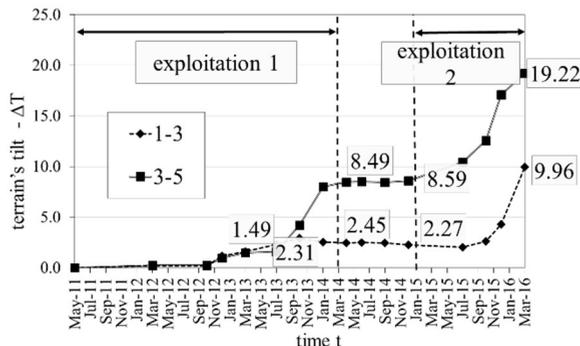
Fig. 9. Increase of terrain's tilt in time from 05.2011 to 03.2016 in sections 1, 3 and 5. Made on the basis of [5].

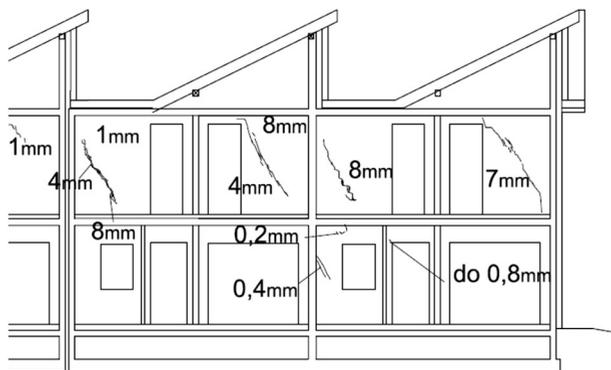
- a) group I - mostly structural damage (row a–c):
 - damage to longitudinal curtain walls, stiffening walls, division walls in the form of diagonal cracks and chips; the width of these cracks was up to 1 cm on first floor level (fig. 10–12),

Fig. 10. Damage to external longitudinal curtain walls in the example of an extreme southern segment of the row a. Source [5].

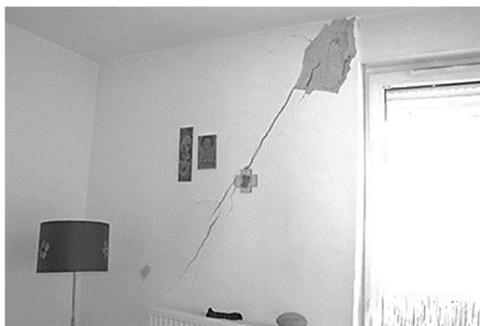
Fig. 11. Cracks in the east outer cover wall on the 1st floor in the first segment in the row b. Source [5].

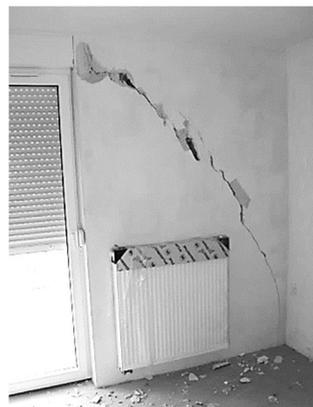
Fig. 12. Cracks in the east outer cover wall on the 1st floor in the first segment in the row a. Source [4].

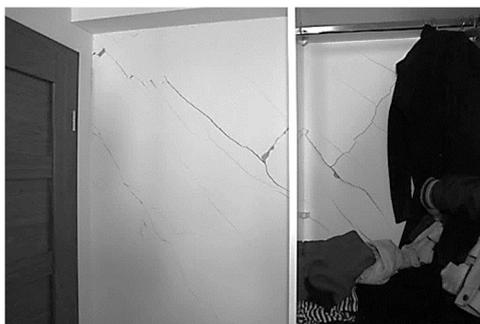
- cracks and chips of transverse load bearing walls with a width of up to 1 cm,
 - damage to transverse division walls in the form of diagonal and horizontal cracks and chips with a width of up to 8 mm (fig. 13),

Fig. 13. Cracks in the longitudinal wall of the staircase on the 1st floor in the row b. Source [5].

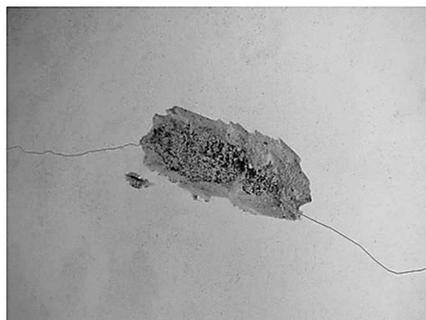
- cracks coupled with convex deformation of the walls adjacent to the joints, at half height, horizontal, occasionally slightly diagonal, up to c. 1 mm wide; this damage had already been present before, as described in [4] (fig. 14),

Fig. 14. Scratch a wall Transverse at dilatation On the 1st floor in the row a. Source [5].

Group II damage appeared during exploitation of deposit 1 [4]. Based on analyses carried out in 2014 it was determined that the damage may have occurred as a result of additional pressure exerted on the transverse load bearing walls and the layers of compressed EPS in the movement joints. Using the EPS was not correct. This situation may have led to convex deformation and horizontal cracks with a slight diagonal slope on the walls.
