# The battery of silos for rapeseed - the impact of the building quality and exploitation conditions on the technical state of the object

*Krystyna Wróbel\**, and *Wiesław Kubiszyn*

**Abstract.** The subject of the paper is a battery of silos for rapeseed located in Oil Factory in Bodaczów. It consists of 24 cylindrical silos with capacity of 500 tons and 14 star-shaped chambers between them with a capacity of 100 tons each. The silos were supported on the supporting structure in the form of permeating ring beams and columns. The height of a single silo is 25 m, and the diameter about 6.0 m. Detailed macroscopic tests were performed on the battery of silos. Destructive and sclerometric in-situ quality tests and pull-off test were performed on the concrete, the degree of concrete carbonation was estimated. The position of the reinforcement in the concrete structure and the corrosion of the reinforcement steel were determined. Static and strength calculations were carried out. Based on the results the technical condition of the object was estimated as poor, locally due to the significant loss of concrete and structural reinforcement it was estimated as imminent failure. The article

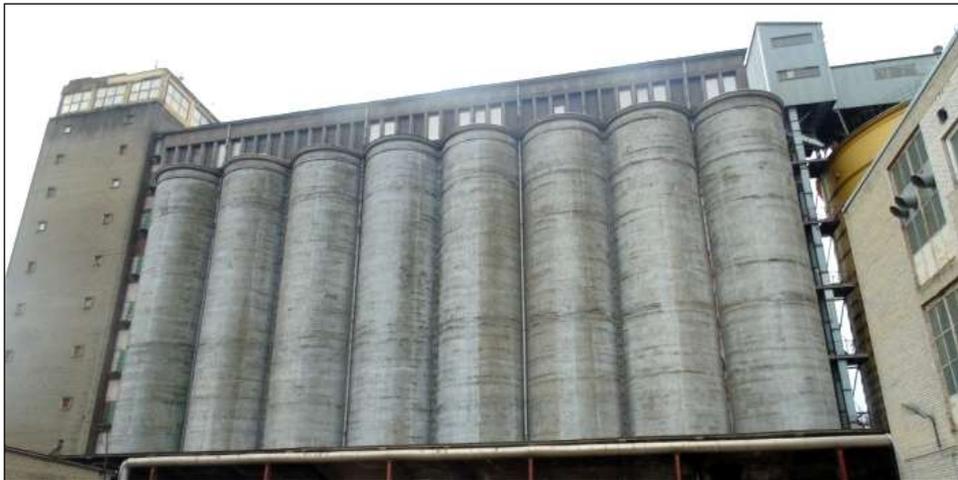
The walls from the outside - a general view of the silos battery is shown in Fig. 3. The damage was determined on the basis of detailed macroscopic examinations and revision holes. The detailed macroscopic tests were carried out for silos No. 5, 8, 10, 15, 25, 38-40. These test were made from the external staircase, climbing and climbing scaffolding. Throughout the external surface of the silos, circumferential damage was found every 0.3 to 0.7 m along the height of the silos, resulting from improper lifting of formwork during concreting (Fig. 4). In the areas of leaks, the structure of the concrete has been disturbed and additionally weakened due to the long-term impact of adverse weather conditions. The range of losses and loosening of the concrete lagging of horizontal and vertical reinforcement bars has significantly increased. Founded advanced corrosion of reinforcement bars.

**Fig. 3.** General view of the silos battery from the north side

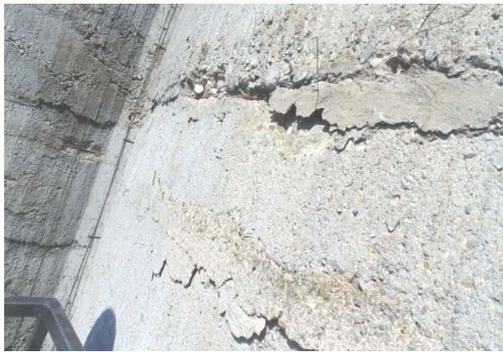
Corrosion products of the reinforcement damaged the concrete (Fig. 4-9). In the areas of the above mentioned damage there is no adhesion of concrete and reinforcement bars. Concrete structural defects were also found, consisting in segregating the concrete mix components (Fig. 9). The repair mortar falls in the areas of improper repairs of the damaged concrete structure. These repairs were made without proper substrate preparation, the weak concrete was not removed to a sufficient extent. As a result, a strong repair mortar falls off together with a layer of weak concrete (which was supposed to be repaired).

**Fig. 4.** Separation of concrete cover at the level of working gaps

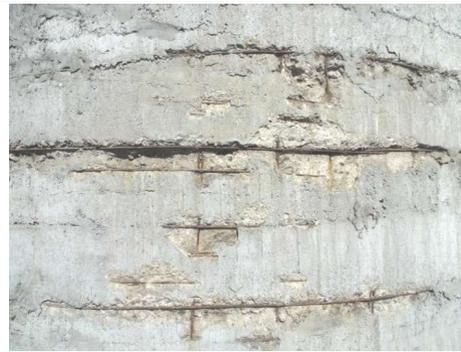
**Fig. 5.** Surface corrosion of concrete, locally there is a lack of reinforcement cover

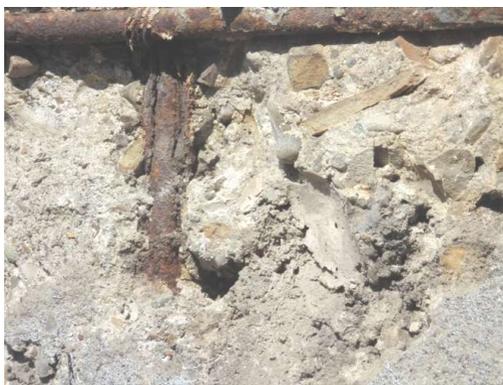
**Fig. 6.** Advanced surface corrosion of vertical reinforcement

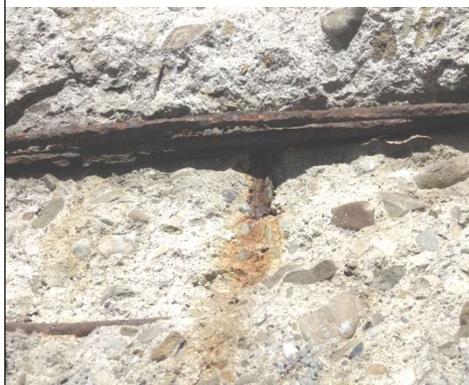
**Fig. 7.** Completely corroded vertical bar, advanced surface and pitting corrosion of horizontal reinforcement, no adhesion of concrete to reinforcement

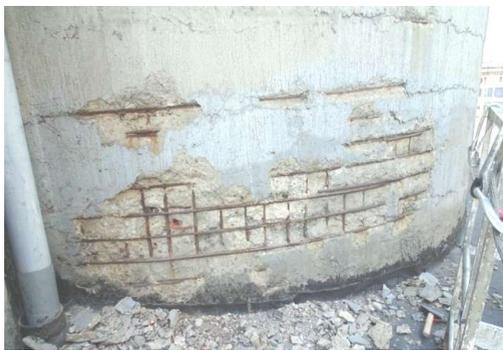
The thickness of the spontaneously falling concrete layer reaches up to around 7 cm in many places. Disintegrating pieces of concrete pose a threat to life and health of people and property. Corrosion damage is greatest in the lower part of the silos, over the supporting ring coat (Fig. 8, 9) – there is extensive surface corrosion of concrete, poor quality or

**Fig. 8.** Extensive surface corrosion of concrete, large corrosion defects of reinforcement

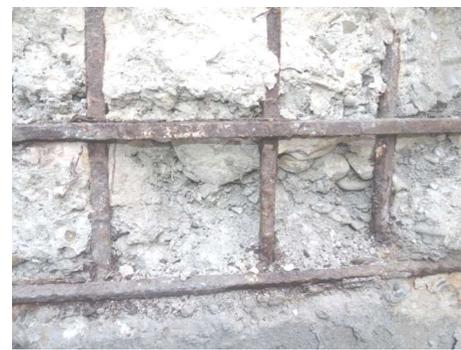
**Fig. 9.** Details of Fig. No. 8

carbonated concrete. Non-concretes and segregation of concrete components during concreting were found. River aggregate contaminated with clay was locally used for the construction of silos. Cereal moths and other vermins were observed nested in the wall of one of the silos.

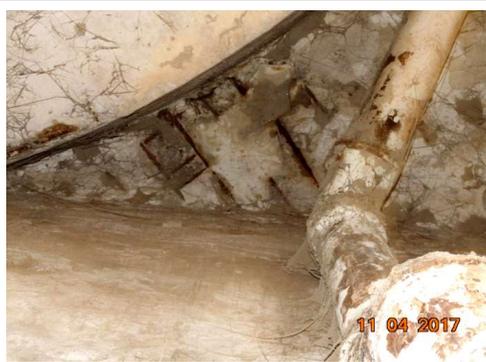
The cover of the part below the level of + 2.90 m is destroyed and technically worn. The roofing plate of the part which is beyond the outline of the silos is corroded (Fig. 10). The rainwater drainage system was made inside the building. It is leaking and incomplete. Rainwater flowing into the building caused corrosion damage to supporting structures of silos (ring beams and columns) and hoppers (Figures 10, 11). Outer walls of brick are damp and moldy. There is no horizontal and vertical waterproofing.

**Fig. 10.** Corrosion of the floor slab at the level of + 2.90 m

- 1) Renovation of roofing in the +2.90 m level.
- 2) Execution of ventilation chimneys with a minimum height of 2.0 m above the roofing at +2, 90 m.
- 3) Renovation of external masonry walls.
- 4) Making vertical and horizontal damp-proof insulation of underground part of the object.

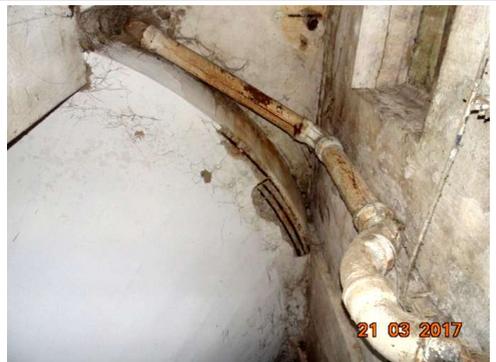
**Fig. 11.** Examples of corrosion damage of the silo support structure

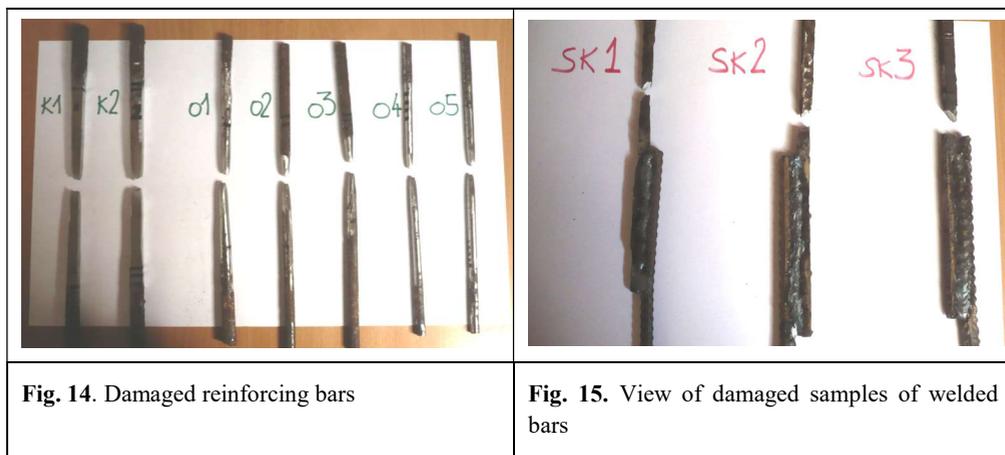
Due to the significant corrosion losses of reinforcement of silos and the necessity to supplement them, laboratory tests of this steel were carried out. The tests covered the determination of the reinforcing bars yield stress (bars were cut out of the structure) and the weldability of these bars to reinforcing bars made of B500SP steel.

The real steel parameters obtained from laboratory destructive tests of reinforcing bars taken from the structure are:

- for round bars:  $R_{e, \min} = 255 \text{ MPa}$ ,
- for square bars:  $R_{e, \min} = 315 \text{ MPa}$ .

Reinforcing bars used for the structure of the silo are weldable to steel B500SP. The breaking of all bars occurred outside the area of welds
