Building diagnostics versus effectiveness of repairs

Bohdan Stawiski^{1,*}, and *Tomasz Kania*²

2 Preliminary evaluation of technical condition of walls in the damaged building

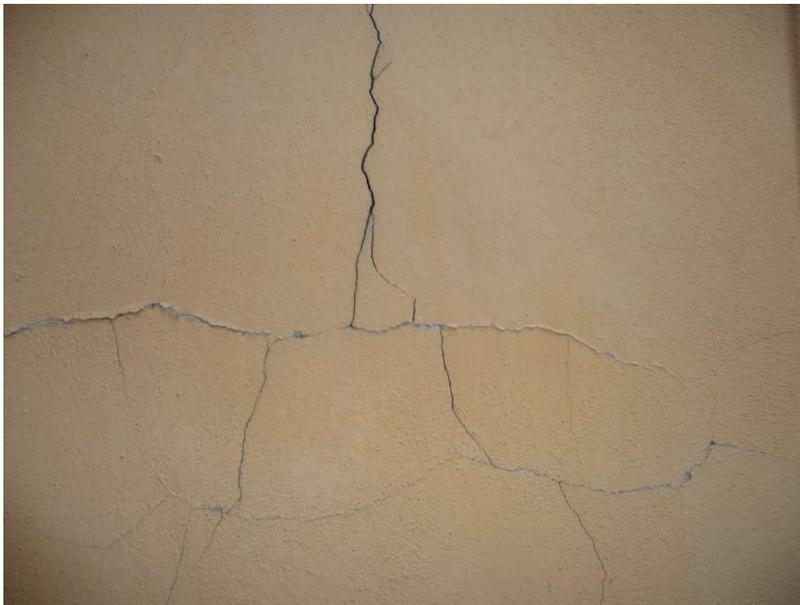
Fig. 1. Cracked surface of the wall above the windows.

Figure 1 shows cracking in the elevation layer of the wall above the window lintel. The picture shows transverse cracking in the window lintel at the level of the tie beam above the first floor of the building and the network of cracks in the elevation layer of the three-layer brick wall appearing below the tie beam.

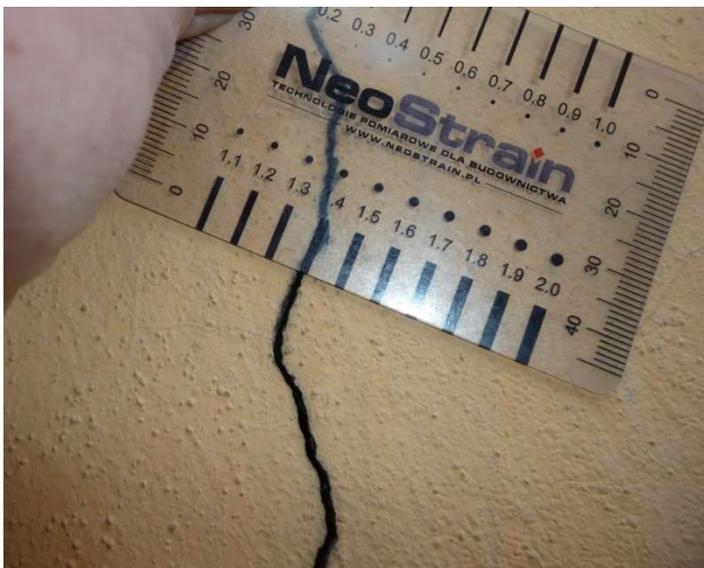
Figure 2 shows cracking 1.4 mm wide in the walls at the level of the tie beam.

Fig. 2. Width of crack 1.4 mm

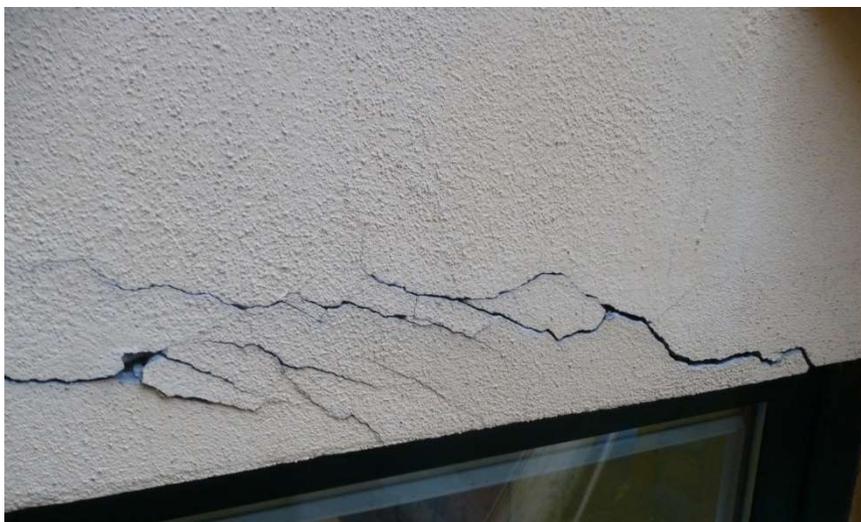
Figure 3 shows the condition of fissures in the lintel above the window near the passage under the building.

Fig. 3. Cracked lintel above the window.

Fissures of considerable width resulted in local crumbling of external plasters which caused additional concern for the apartment's owner.

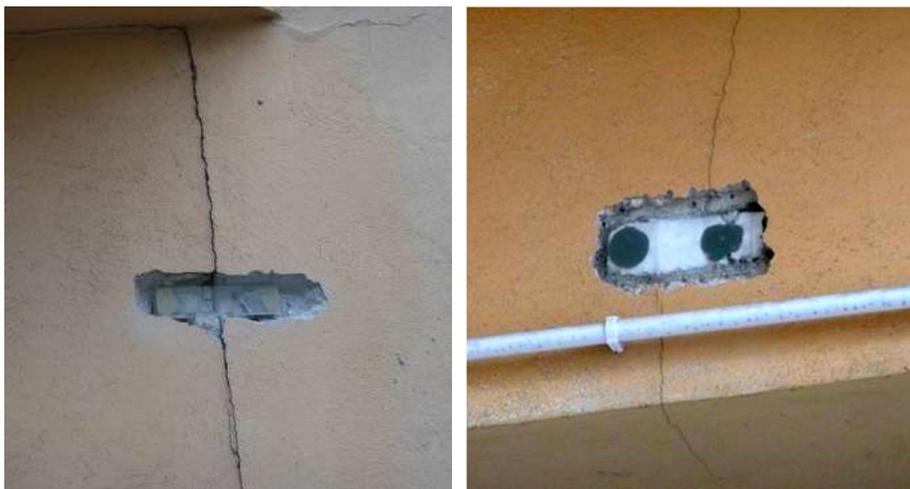
In the period preceding the site inspection in the facility, fissure activity tests were performed. This is indicated by glass 'seals' glued to the walls at the points of damage (fig. 4).

Fig. 4. Glass plates glued perpendicularly to vertical fissures in the external wall of the building.

The 'glass seals' were attached during previous diagnostic work on the building's condition. After a period of several years the glass did not break but the fissures did not stop causing concern. In order to analyse the causes of the damage, changes made in the building after the earlier diagnostic and expert work were examined and the elevation layer of the wall in the places which were damaged was exposed.

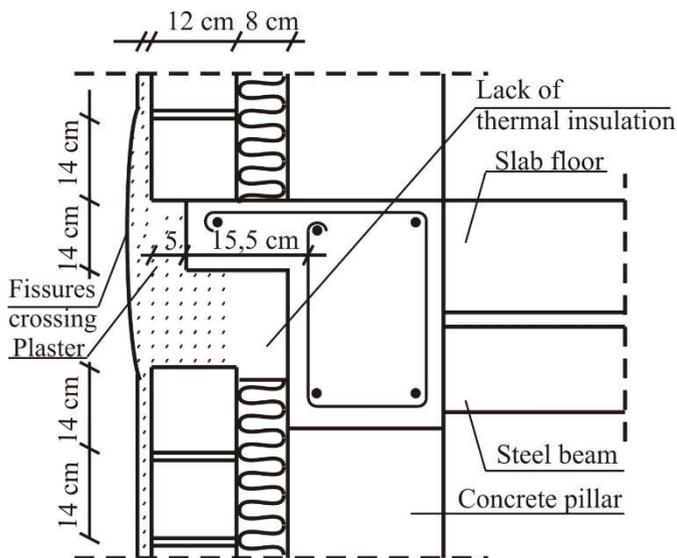
The exposures made in the locations of numerous cracks showed faulty support of the elevation layer of the wall positioned on a support monolithically connected with the reinforced concrete beam of the joist above the passage and with the tie beam above the ground floor of the building. The centre of gravity of the elevation layer is at the end of the support on which this layer is based (fig. 5). Supplementation of the support with plaster, thickness more than 5 cm, cannot be deemed sufficient to transfer distributed load from the external layer of the brick wall.

The exposure made outside of the outline of the tie beam and joist showed an improper method of anchoring the load bearing and curtain layers of the wall. Connection of the wall layers was made using only 2 – 3 steel connecting pieces, diameter 5 mm, per 1 m² of the wall. Please note that the elevation layer of the wall is not only a protective element with aesthetic function. It is affected by considerable forces which are the result of wind thrust and suction and the applied method of connecting it with the load bearing wall must ensure the possibility of transferring horizontal force to the internal layer of the wall. In order to connect the external layer of the wall with the internal one, steel anchors of appropriate plasticity, strength and corrosion resistance should be used. According to the principles of engineering knowledge, in this case the connection of layers with at least 5 steel anchors, minimum diameter 4 mm, should be used. Their number should be concentrated around window and door openings and in corner zones of the building [6].

Fig. 5. Unsatisfactory support of the external layer of the curtain wall based on the support of the reinforced concrete beam above the passage under the building.

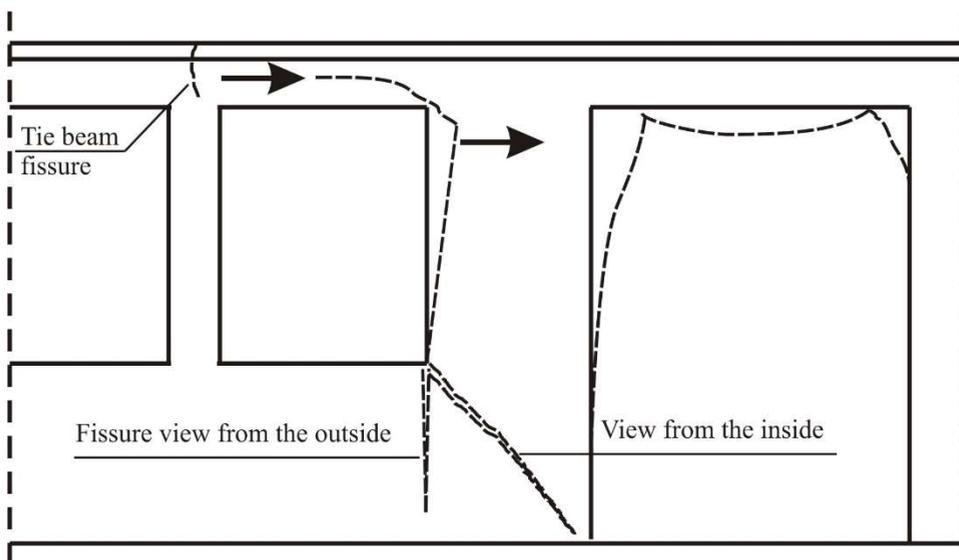
The long joist, six meters length with cross-section of 60x90 cm was connected (monolithized) using tie beams with smaller cross-section. The deflection of joist above the passage through the building has been tested with use of the optical leveler. Measured deformation value of this element $f_a = 2.16$ cm is equivalent to $1/277$ of its length. Deflection of the reinforced concrete beam above the passage through the building also caused deformation of the tie beams monolithized by it on which curtain layers of the external wall were based. As a result of the cooperation of these elements, fissures appeared above the narrow pillar between the windows (fig. 6).

Fig. 6. Progress of fissures in curtain wall of the building in the area of the passage through the building and the pillar between the windows

Deflection of the girder above the passage caused rotation and cracking of the elevation wall of the extreme pillar (between the window and passage) and the wall above the small pillar between the windows. The author of the building repair design concluded that these cracks caused a safety risk to the small pillar between the windows (the narrower one in fig. 6), probably because of the partition wall located perpendicularly to it and based on the floor from which loads are transferred to the wall, including also to the small pillar. In connection with the cause of the problem as understood in this way, the designer recommended construction of a huge support consisting of two steel poles (each of them consists of two welded 100 channel sections) on both sides of the wall, based on the monolithic bottom floor. Two 220 channel sections were based on the poles (on both sides of the wall) to take over the load from the wall of the higher floor. The poles were anchored with the tie beam using steel expanding bolts and spandrel beams were welded to the poles. Therefore, a stiff steel frame, 6,0 m wide, was made. The steel frame was mounted in the temporarily unused room at a temperature of +5.0 °C. When its utilisation started, its usable temperature increased up to +22.0 °C. Assuming the linear thermal expansion coefficient for steel $\alpha = 12 \cdot 10^{-6} [1/^{\circ}\text{C}]$, following the formula (1) the change of the length anchored with the steel frame tie beam can be calculated.

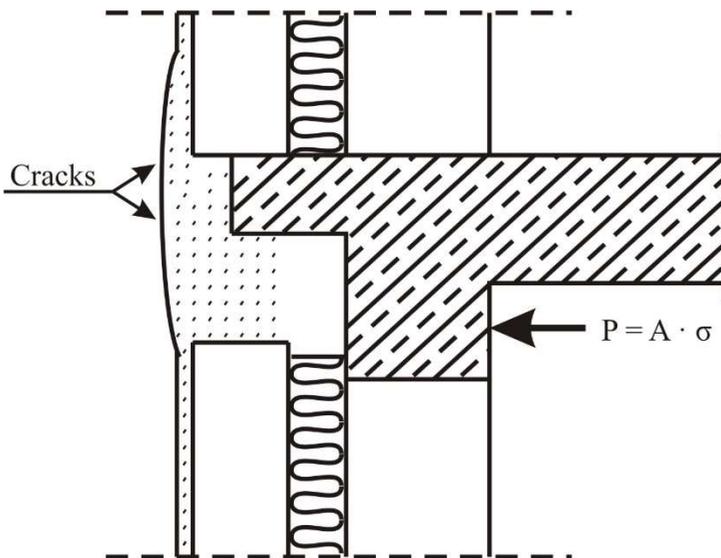
According to the calculations presented, the steel frame, 6,0 m long, stiffly anchored using expanding bolts with tie beam, at a temperature gain $\Delta t = 17.0 \text{ }^{\circ}\text{C}$ changed its length by 1.2 mm. This caused pushing of the tie beam together with the wall in the direction of the outside of the building (fig. 7).

Fig. 7. Deflection of the girder above the passage caused rotation and fissures of the extreme pillar, cracking of this wall and cracking above the small pillar between the windows.

In the tie beam, in the extension of the mounted steel beams, a fissure, 1.5 mm wide, appeared. In order to relieve the structure from destructive thermal deformations, it was necessary to separate the tie beam from the steel frame using movement joints, making a gap between the tie beam and the frame.
