# Renovation of the historic building after damage connected with foundations subsidence – case study

**Abstract.** The paper delineates the study of a historic building renovation. It was built in 1900 and completed in 1939. Its both parts consist of different constructions. The old part was founded very deeply whereas the level of the younger part foundations was higher than the old one. After large floods, the walls started to crack, elements of the ceilings and roof under the extended part of the building slipped. It was expected that in the future a construction disaster would pose a serious probability of occurrence. In the study it was necessary to recognize the entire construction with a thorough investigation of the underground, old part of it and also the soil types density were examined. The main objective of the new research was to define the real reasons of the damage and to determine the possibility of repairing this building. The elaboration of the study results revealed a conception of supporting the walls of the building. The results indicated that the need to verify the reasons of the occurring damage in a complex and thorough way is tremendous, especially when a

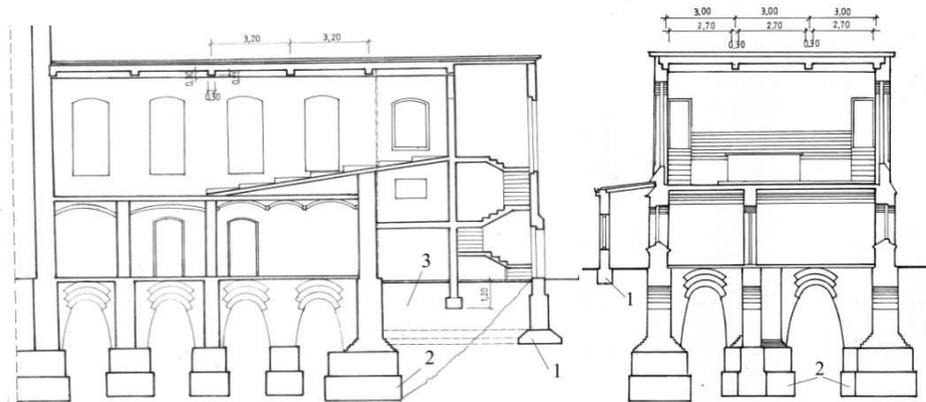
- b) the Extension was placed about 2.20m higher than the original building. Its foundations were much thinner (by about 0.45m) despite placing it on the ground

- d) because of the fact that the level of the Extension foundations placement was much higher than the riverbed and the basement of the original building, it enabled the phenomenon of suffosion of foundational frame to take place. Such an issue may occur with any significant river level volatility ranging from flood level to low level (twice a year on average). Suffosion, appearing collectively with the malconstructions discussed above, is regarded to be the main reason of uneven subsidence of the building elements as well as the occurring damage.

**Fig. 2.** Vertical cross-sections of the north wing of the building (the Lecture hall – Part no.1 and the Extension - Part no. 3; 1 – foundations of the Extension; 2- simple column footing of the Lecture hall; 3- foundation wall of the Extension).

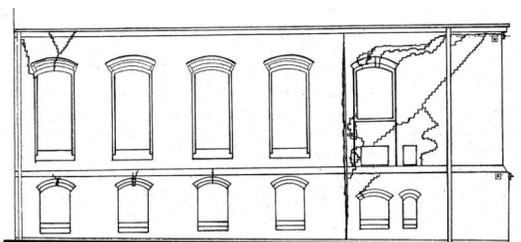
This part of the pathological anatomy building was constructed before the II World War (years 1936-1938) and constituted the major destabilization cause for the entire studied object. A whole range of misconceptions concerning the foundations settlement of the Extension accounted for the preconditions of the emerging destruction phenomena (Part no.3) and they can be characterised as follows:

- the dilatation between the Extension (Part no.3) and the original building (Part no.1) was performed unprofessionally despite various settlement conditions and ground parameters. It induced uneven subsidence events of non-dilatated building parts resulting in the occurrence of wall cracking from the very beginning,

a) Tear lines and crackings of the north part of the building on its east facade

**Fig. 4.** The building damage caused by uneven foundation subsidence (1- shape of vertical walls deformation, 2- shape of the foundation deformation).

- d) The remaining damage of the building, in the form of tear lines and cracks, was repaired with the injection system after the completion of the above discussed structure strengthening.

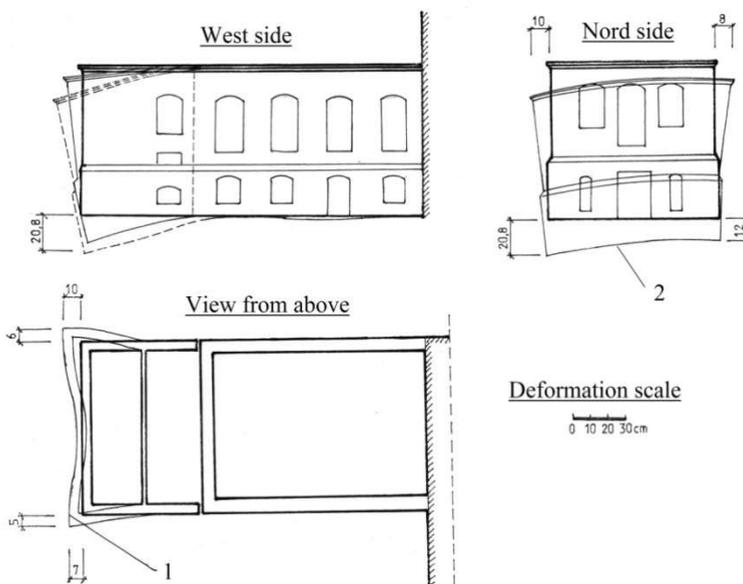
- the impact of the ground water levels fluctuation depending on the Odra river level was not taken into account. The changeability of the river levels boosted uneven ground subsidence under both parts of the premise which was, additionally, subject to diverse load bearing values and was settled on the soil with different load capacities and subsidence values.

b) Wall and foundation deformations of the north part of the building

- a) Relocation of excessive stress of load-bearing walls foundations from inadequate ground layer NM according to its load bearing capacity onto a solid substrate with adequate load bearing capacity PNS with the use of supporting construction (Fig. 5) involving: (i) production of piles with a widened footing columns (load bearing capacity about 300 kN) – drilled in pairs on both sides of the foundations – to a depth of about 1.0-1.5m below the load bearing roof of the soil (PNS) but over the ground water table, (ii) production of pile elements in order to be able to insert the ground strengthening injection under pressure at the level of the pile column footing. Next, it was recommended to manufacture the reinforced pile shaft of liquid concrete under pressure (Wolfsholtz's system) up to a level of a girder passing through a slot in a wall, (iii) setting steel girders passing through the produced slots in the walls and cropped up via wedges on previously prepared pairs of piles, (iv) production of a composite (steel – reinforced concrete) construction taking the loads over from the walls and transmitting them onto the pile pairs.

- b) Due to multiple crackings of walls, roof and ceilings, it was also necessary to perform an additional wall bracing of the Extension structure.
- c) For this purpose, placed nine additional anchors envisaged, in the way shown in Fig.5.
