The Construction History and Assessment of Two Heritage Industrial Buildings in Wrocław

Piotr Berkowski*, Grzegorz Dmochowski, Jacek Barański, and Jerzy Szołomicki

In the following chapters, on the example of two old reinforced concrete industrial buildings, some results of the assessment of their technical condition are presented. The aim of the performed diagnostic procedure was to evaluate the possibility of adaptation of these buildings to new service functions.

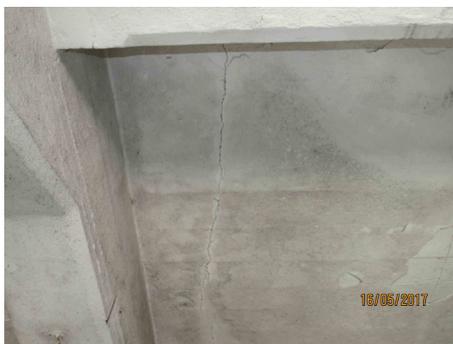
Numerous different examples of damage, typical for concrete structures of such an age and history of exploitation, were found during a visual inspection of both buildings. For example, all the floor slabs in the flour warehouse building, as well as roof coverings, have cracks in many places (Fig. 16). Generally, they were caused by the corrosion of reinforcing bars, the large spacing of bars in relation to the small thickness of the slabs and also the lack of top or diagonal reinforcement at the side supports.

Fig. 16. Cracks in the RC roof slab over the 6th floor in the flour warehouse.

None of this damage is currently dangerous for the structural safety of the presented buildings, however, repair work will be necessary during the refurbishment process.

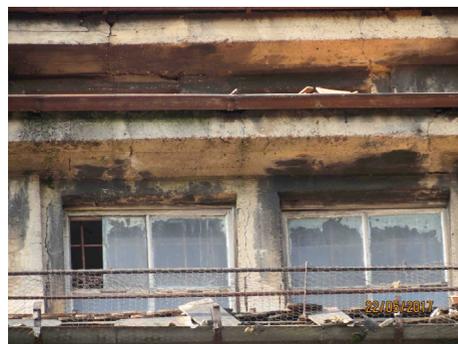
Fig. 17. Corrosion of the outer surface of concrete window frames in the flour warehouse.

Concrete elements that were exposed to environmental hazards, such as water penetration, freezing or atmospheric pollution, etc., were obviously damaged the most. This damage was found in the flour warehouse’s window frames (Fig. 17) on the attic floor and in several parts of the connecting building’s frames (Figs. 18, 19).

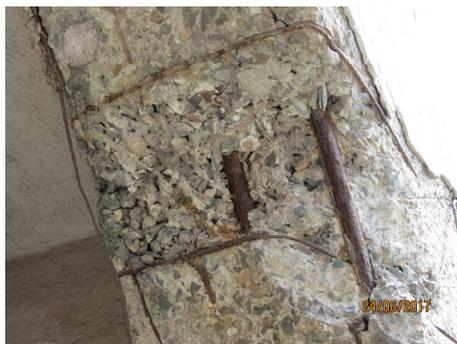
Fig. 18. Concrete destruction in the bearing frame of the connecting building.

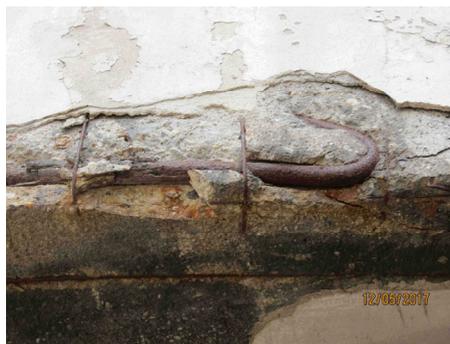
Fig. 19. Concrete and steel corrosion in the bearing frame of the connecting building.

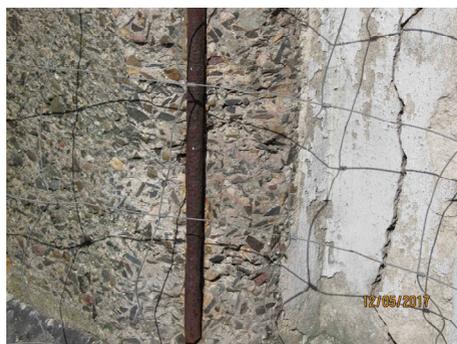
The results of simple sclerometer tests showed that the reinforced concrete elements in the buildings were made of concrete of very different quality. In these elements, such as the ceilings as well as pillars, concrete from C12/15 to C30/37 was found. The low quality of concrete (especially due to aggregate segregation and a lack of proper compaction) was also confirmed by direct observations carried out during a visual inspection (Fig. 20). On the basis of the sclerometric tests, it was assumed in the control calculations that the concrete in the ceilings and pillars corresponds to at least a class of C16/20.

Fig. 20. Concrete structure in the bearing frame of the connecting building.

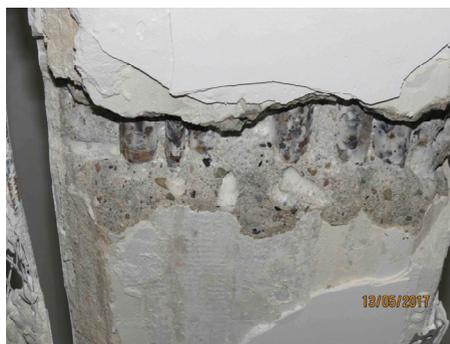
Fig. 21. Reinforcement in the main slab beams of the flour warehouse.

According to studies presented in [9, 10], at the beginning of the 20th century cast iron with a tensile strength of $R_m = 370-460$ MPa was used as a reinforcement. The results of reinforcing steel tests carried out in recent years in several buildings in Wroclaw confirmed this data [10]. Therefore, to determine the strength of the reinforcing steel used in the assessed objects (Fig. 21), some specimens of reinforcing bars were taken and broken in

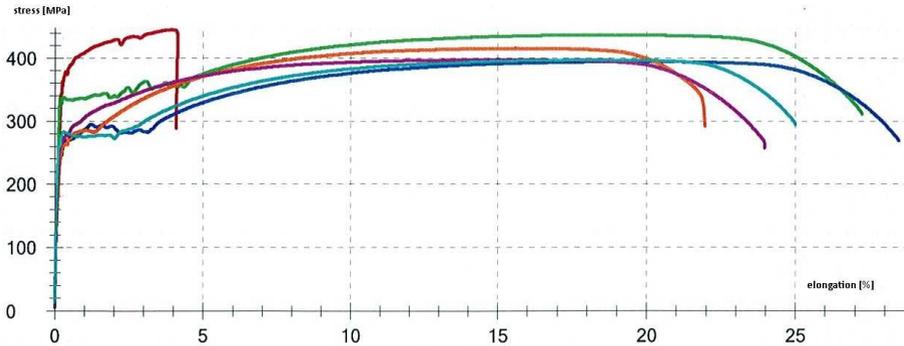
a testing machine. The results of some tests are shown in Figure 22. The following tensile strength results were obtained: $R_{m1} = 445$ MPa, $R_{m2} = 436$ MPa, $R_{m3} = 394$ MPa, $R_{m4} = 415$ MPa, $R_{m5} = 397$ MPa, $R_{m6} = 397$ MPa. To determine the design yield value, a systematic calculation was used for the same concrete structures. The obtained results were as follows: $R_{mav} = 414$ MPa, $s = 22$ MPa, $R_G = 414 - 1.64 \cdot 22 = 378$ MPa, $f_{yk} = 0.8 \cdot 378 = 302$ MPa, $f_{yd} = 302 / 1.5 = 201$ MPa. The calculation yield limit $f_{yd} = 210$ MPa, corresponding to the Polish AI class of reinforcement steel, was adopted for the verification calculations.

Fig. 22. The results of the reinforcement steel strength examination.
