Analysis of retaining wall stability in areas specified in register of objects of cultural heritage

Abstract. The case study of the assurance of retaining wall stability in densely urbanized conservation and cultural heritage areas are described in this paper. During The Second World War many of these historic buildings in Warsaw were completely or partially destroyed and until these days their remains constitute elements of the existing building development of the capital of Poland. This may be connected with a change in the nature of applied loads as well as current functions of these buildings. The results of expert opinions and investigations are presented, regarding the operational and technical state of two retaining walls submitted to an expert before the repair works. When designing the design concept, both the historic character of structures, the technical feasibility of performing construction works in the densely urbanized area, as well as determined water and ground conditions were considered. The first of the analysed cases concerns the retaining wall localised in the vicinity of the Ordynacka Street and the Tamka street. After analysing the historical aerial photogr

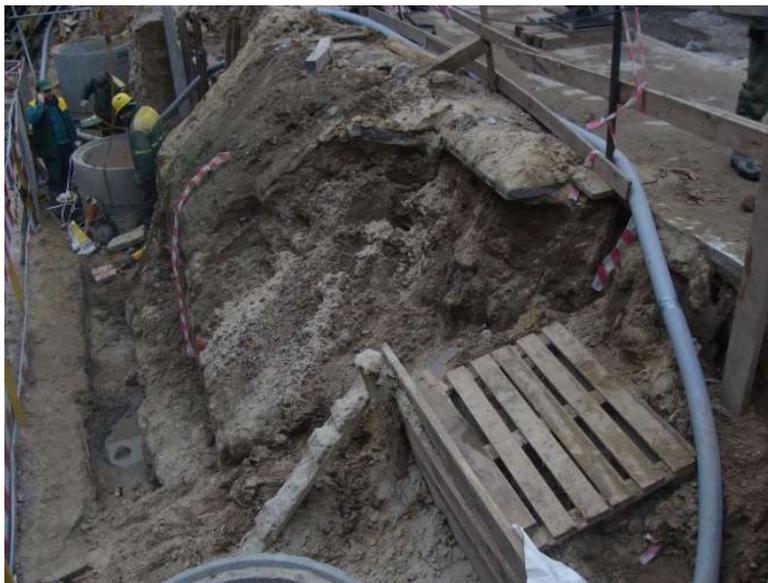
The analysis of archival documentation, the assessment of the technical condition of the wall and inventory measurements allowed to conclude that the analysed object was a part of three tenement houses debris destroyed during The World War II - Fig. 1. The aerial photographs and diagrams show that there were three tenement houses in the area adjacent to the retaining wall – building objects marked with number 1 ÷ 3. Only one house remained in this location in 1945 - object 1. Presently, there are no facilities or buildings in this area. The remains of apartment house marked with No. 1 could be observed during conducting earthworks for the Chopin Centre built in 2009 - Fig. 2.

Fig. 2. The debris of the basement walls of facility No. 1 taken in 2009 during earthworks.

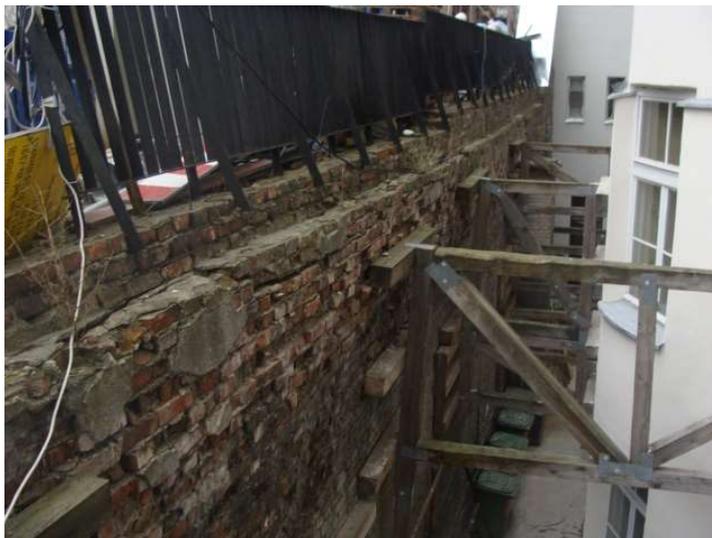
Fig. 3. Buckled and secured eastern part of the retaining wall.

The technical condition of the retaining wall should be specified as “an emergency”. Diagnosed and observed damages as well as measured deformations had posed a direct hazard to the safety of use and the safety of the load-bearing structure. In order to protect the damaged wall structure and prevent from further propagation of damages, wooden struts were used. Their basic task was to support the buckled and damaged part of the wall. These struts were left until the total completion of construction works related with refurbishment of the retaining wall. It should be stressed that due to the historic character of the structure, it was necessary to ensure that the retaining wall was reconstructed with the least possible interference in this object.

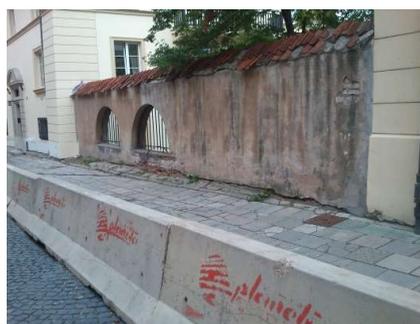
During the post-war reconstruction of the city, this wall was rebuilt with the use of solid brick and cement-lime mortar. The wall is topped with a fragment of a fence wall with two hemispherical openings and covered with ceramic tiles. The technical condition of the built-in materials was determined as “bad”. Chipped elements of bricks could be seen in the cross-section. Moreover lime mortar was completely corroded and did not ensure binding of bricks - Fig. 5. The poor quality of the construction works for reconstruction of the retaining wall is also evidenced by the clear delamination and bulging of the wall - Fig. 6.

Fig. 5. View of the retaining wall from Brzozowa street.

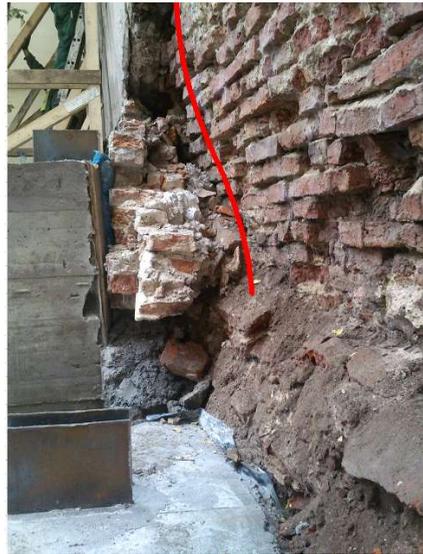
Fig. 6. Observed delamination and buckling of the wall.

In order to protect the damaged wall structure, it was recommended to make temporary wooden struts, whose task was to support the buckled and damaged part of the wall. These struts were used until the entire wall was renovated.

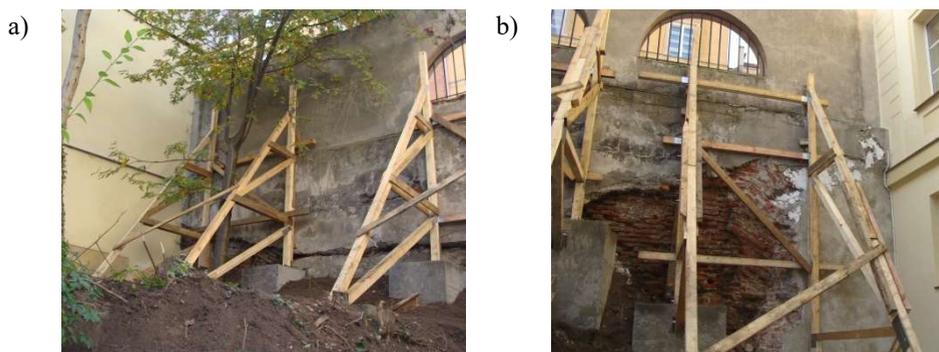
The technical condition of the retaining wall was defined as "emergency". For this reason, temporary support construction was carried out using solid concrete blocks connected with steel struts. Moreover a timber wall supporting structure was performed – Fig. 9.

Fig. 9. Temporary construction supporting the retaining wall.

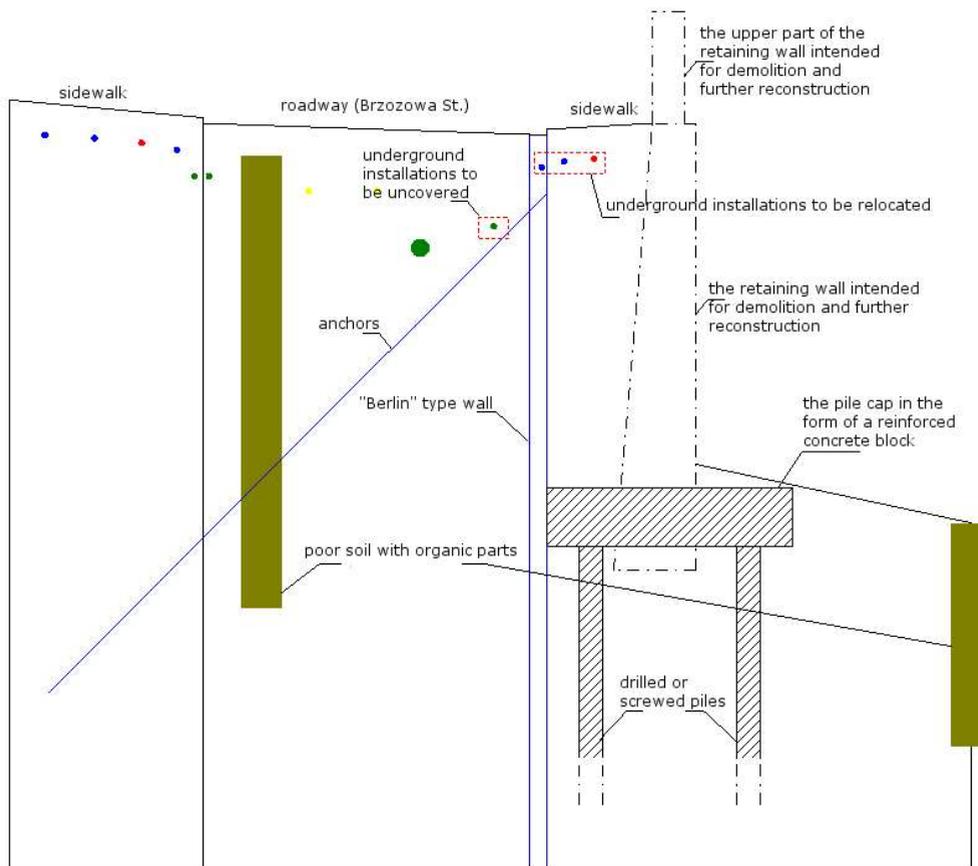
A dense network of underground installations was without any doubt additional difficulty during conducting the repair works. Over thirteen different types of utility installations and urban network services on the width of 7,0 m were identified underneath the adjacent Brzozowa St. Poor technical condition of the retaining wall as well as built-in building materials implied the necessity of immediate proposal a repair technology. In the first stage, the a protective structure in the form of a "Berlin" type wall was designed. The structure had to be anchored in the subsoil - the estimated length of the anchors was at least 20 m. The next step proposed was the removal of the soil between the existing retaining wall and the Berlin wall as well as the gradual demolition of the damaged retaining wall. Drilled or screwed piles arranged into two rows were proposed - the first row between the Berlin wall and the damaged retaining wall, the second one at a distance of ~ 1,0 m from the face of the damaged retaining wall. The pile bent was topped with a pile cap in the form of a reinforced concrete block ~ 1,0 m thick (the width of the pile was 4,2 m). At the final stage, the dismantled brick retaining wall was reconstructed, water-proof insulation and drainage system was designed, as well as the space between the existing retaining wall and the Berlin was filled with light weight aggregate (eg. expanded clay aggregate). The scheme of the proposed technical solution is shown in Figure 10.

Fig. 10. The proposed solution for repairing the retaining wall.
