Technical diagnostics of the historic apartment house located at No. 31 in Dobra street in Warsaw

Abstract. This paper presents a case study of investigating damage and assessing the current detailed technical state of the historic apartment house located at No. 31 in Dobra Street in Warsaw. The purpose of this assessment is to determine the possibility of the reconstruction of its last overground storey and the utility attic. Moreover, the impact of the second underground line construction process and the influence of transport vibrations caused by both the street traffic and the underground on the damage of the supporting structure of the building is determined. The study was conducted in order to prepare the design for the planned last overground storey reconstruction considering the influence of the construction process on the adjacent buildings and the surrounding urbanized area. The study of the building documentation and the field investigation on damage in the existing building allow the authors to conclude that the current technical condition of this building does not exclude the possibility of making the superstructure of this building. Moreover, the results of the carri

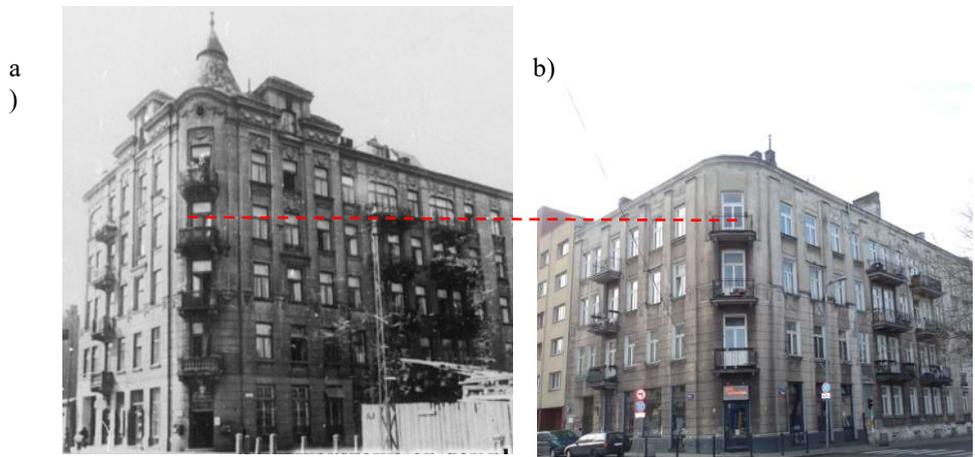
During the Second World War the building was partially destroyed. After the war, the apartment house was rebuilt, reduced by one floor and it also lost the crowning of the corner in the form of a turret – Fig. 3. Then it was operated as a municipal building.

Fig. 3. The general view of the building from the crossroads of Dobra and Zajęcza Streets: a) the pre-war state [4], b) the state in 2016, [the author's photographs].

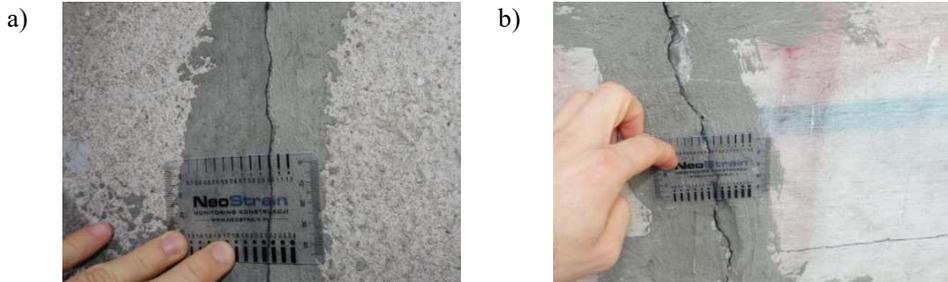
In order to assess the technical state of the building and to prepare the design for the planned last overground storey reconstruction, a detailed technical inspection of the building as well as macroscopic "in situ" tests were conducted by the authors. The damage of structural elements and numerous vertical cracks in the brick walls with a width of approx. $1 \div 3$ mm that could have a significant impact on the building's safety during the repair works were found. Figure 4 presents measured cracks on the front elevation from the side of Dobra and Zajęcza Streets. Moreover, cracks in the front-wall piers (Fig. 5), as well as cracks around the lintels (about $1 \div 3$ mm), and in the window sills (about $1 \div 3$ mm) - Fig. 6, were observed.

Fig. 4. The examples of the cracks on the façade from Zajęcza Street side: a) with a width of approx. 1 mm, b) with a width of approx. 2 mm.

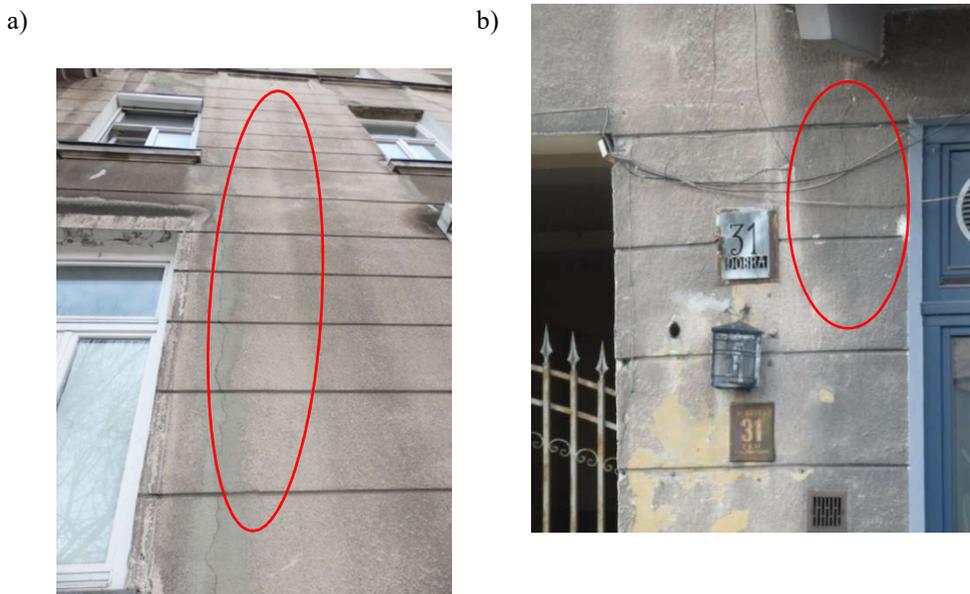
Fig. 5. The cracks observed: a) in the front-wall pier in Zajęcza Street (having the character of a reflected - secondary crack), b) a crack near the entrance gate from the side of Dobra Street.

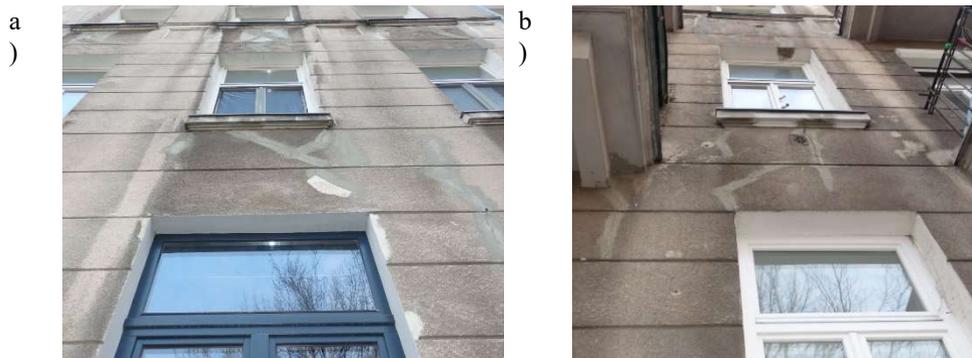
Fig. 6. The examples of scratches and cracks near the window lintels, the sub-front walls and near the balconies.

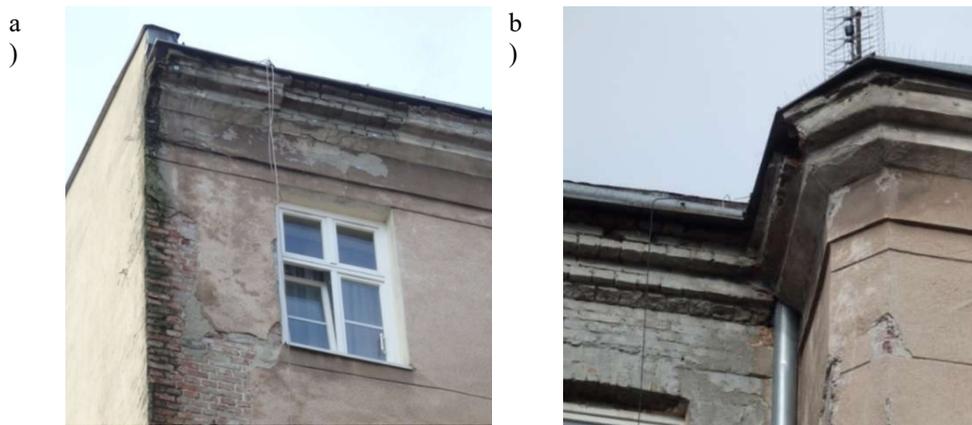
On the façade from the courtyard side, cornice cracks - both in the the plaster and the construction material were found (Fig. 7). Moreover, the vertical crack of the supporting wall from the backyard with a width of approx. $5 \div 8$ mm (at the interface between the side wall and the outbuilding) - Fig. 8, the cracks and the delamination along the steel edge beams of the balcony slabs (Fig. 9), the cracks in load-bearing walls and the window lintels with a width of approx. $2 \div 3$ mm, as well as the damaged and damp pedestals (the cracks, the cavities, the exposed walls, the places with the advanced corrosion) were noticed.

Fig. 7. Observed cracks in brick cornices.

The technical state of the elevation is found to be very poor due to the cracks and the chipping of the cornice plasters. Dampness and seepage under the cornices and balcony slabs were also observed, as well as plaster losses and the chipping of plinths. However, both above mentioned damages do not pose a threat to the safety of the structure.

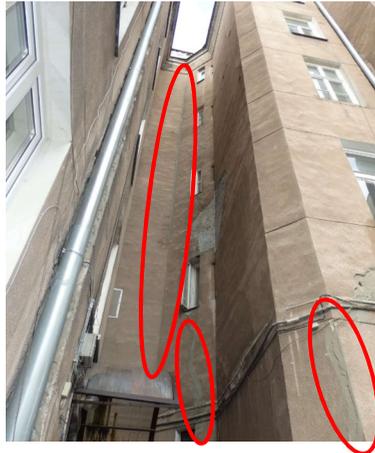
Fig. 8. The vertical crack of the supporting wall from the backyard with a width of approx. $5 \div 8$ mm. In addition, other visible cracks are also marked.

- the reinforcement of the subsoil under the foundations to avoid excessive settlement - the jet-grounding method is proposed,
- re-walling the damaged sections of the masonry supporting wall,
- the reinforcement of damaged elements of the supporting structure of this building,
- the reinforcement of load-bearing walls by their surface reinforcement – the surface reinforcement with steel bars in the shape of the spiral is recommended for all observed cracks. This method is described in detail in paper [11],
- tensioning the supporting structure with horizontal and vertical clasps,
- the positive recommendation for conducting planned construction works in the form of expertise of both adjacent buildings, including their inspections concerning their technical state.

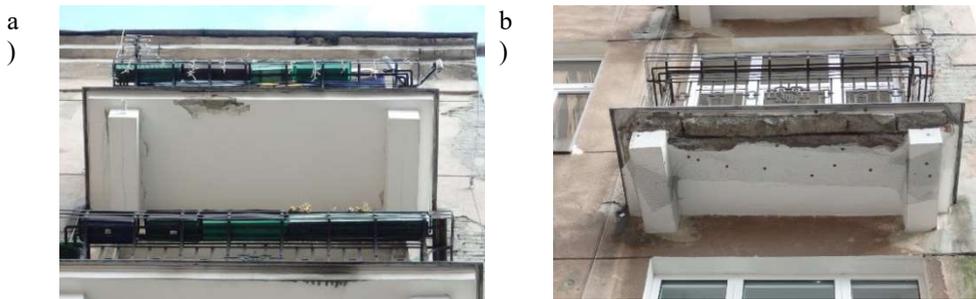
Fig. 9. Cracks and delamination along steel edge beams of balcony slabs.

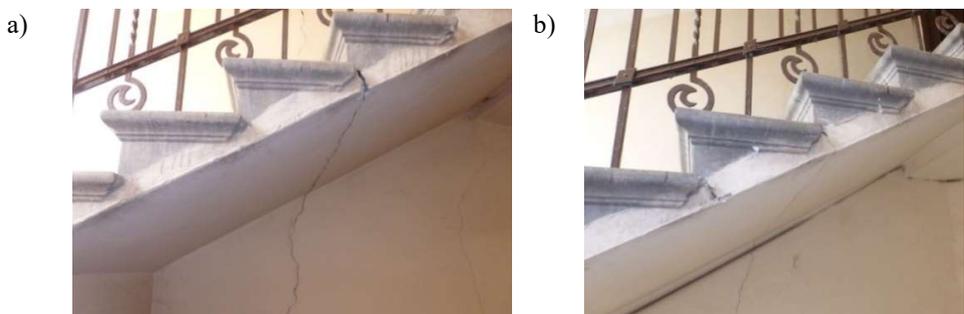
With regard to staircases, the detailed inspections and conducted examinations confirmed the presence of the vertical and diagonal cracks in the structural walls of staircases with a width of approx. $1 \div 2$ mm (Fig. 10) and a longitudinal crack in the staircase covered with grinded terrazzo with a width of approx. $2 \div 4$ mm (Fig. 11).

Fig. 11. The longitudinal crack in the staircase covered with grinded terrazzo with a width of approx. $2 \div 4$ mm – the staircase in the front part of the building with the entrance from the main gate.

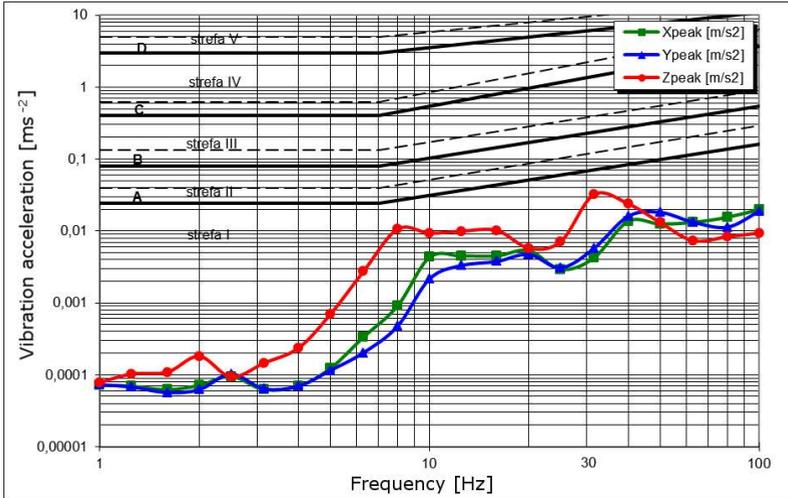
harmful effect on the building elements and its structure. At point PD1, i.e. in the basement of the building from the side of Zajęcza Street, the values of vibration accelerations are ranged in zone I of the scale of dynamic influences SWD II (vibrations not perceptible by the building). – Fig. 12.

Fig. 12. The results of measurements of the impact of vibrations on building in 1/3-octave bands for all axes at point PD1 (SWD II scale).

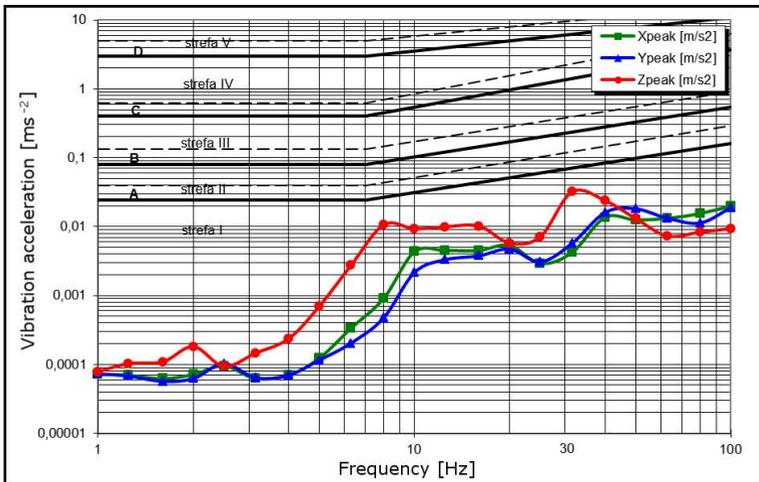
At point PD2, i.e. in the basement of the building from Dobra Street (cafe), vibrations of 50 Hz frequency are included in zone II of the SWD II scale (vibrations perceptible by the building, but harmless to the structure, accelerated building wear and first cracks in the plasters, etc.) – Fig. 13.

Fig. 13. The results of measurements of the impact of vibrations on building in 1/3-octave bands for all axes at point PD2 (SWD II scale).
