Reinforcement of brick historic buildings threatened by structural damages or by failure

*Leopold Kruszka**

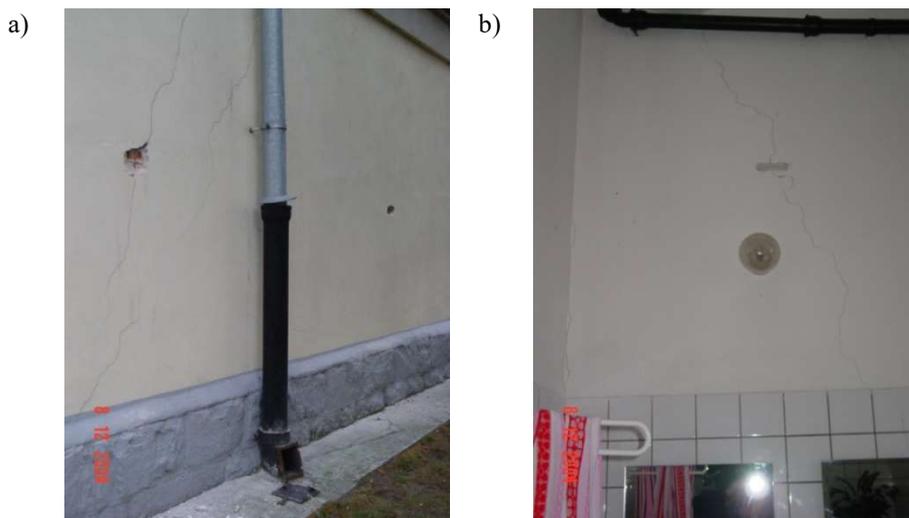
Fig. 1. Examples of damages to the barracks building in Przasnysz: a) on the gable wall facade, b) in the sanitary room.

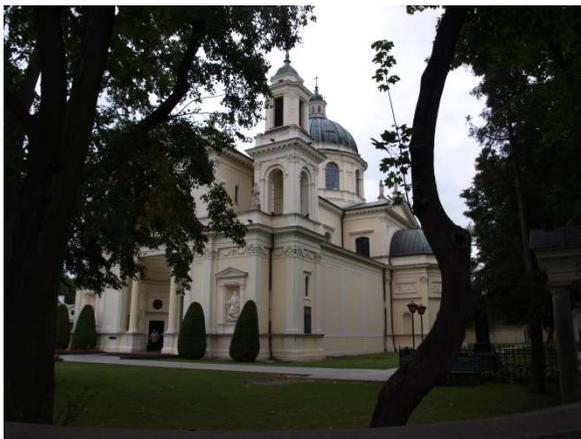
Fig. 2. Church of St. Anna in Warsaw (Wilanów district).

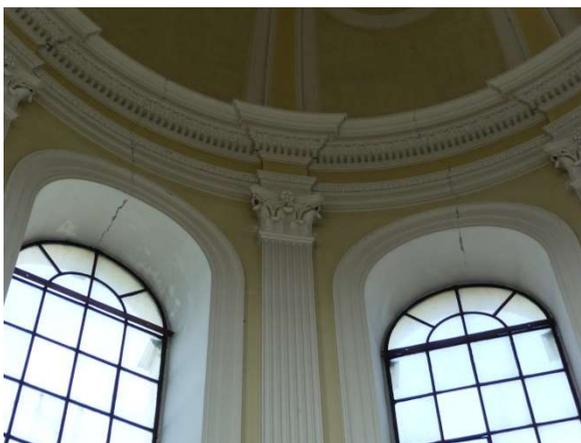
Fig. 3. Cracks in arched window vaults of the church of St. Anne in Wilanów.

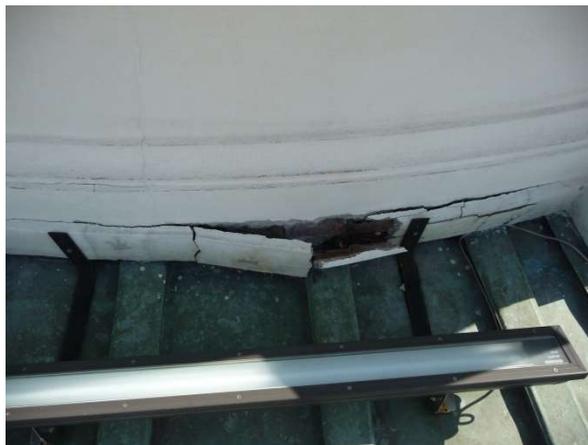
Fig. 4. Cracks of cornices and cracks on the facade of the dome of the church of St. Anne in Wilanów.

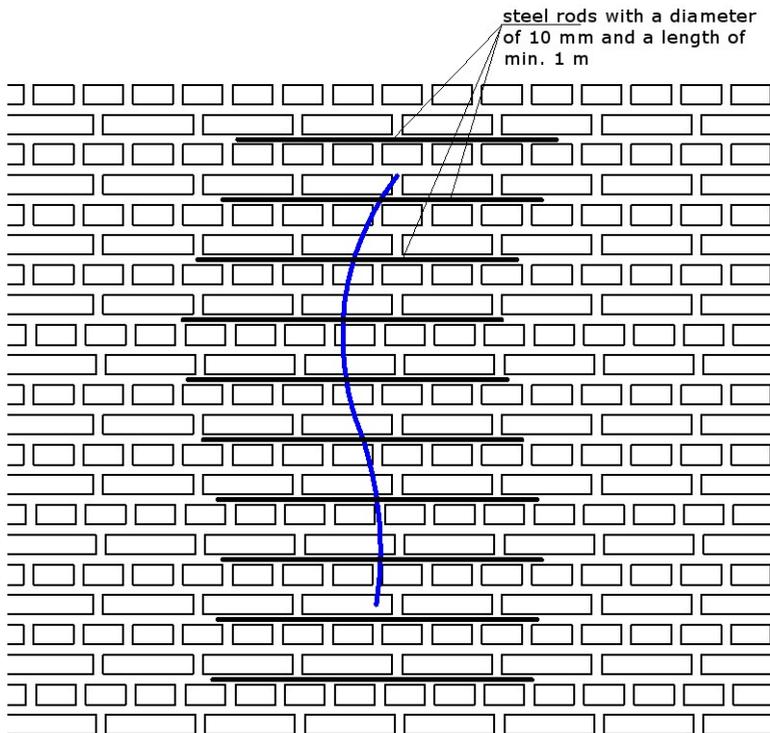
Fig. 5. The method of the surface reinforcement of the cracked load-bearing walls of the building.

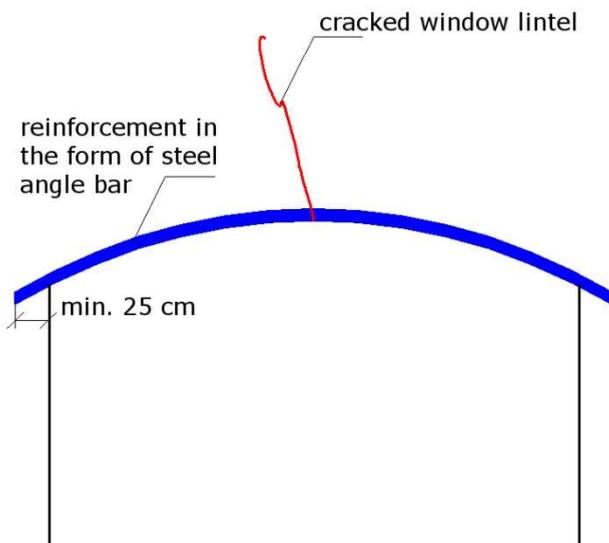
Fig. 6. The method of the reinforcement of the cracked window lintel.

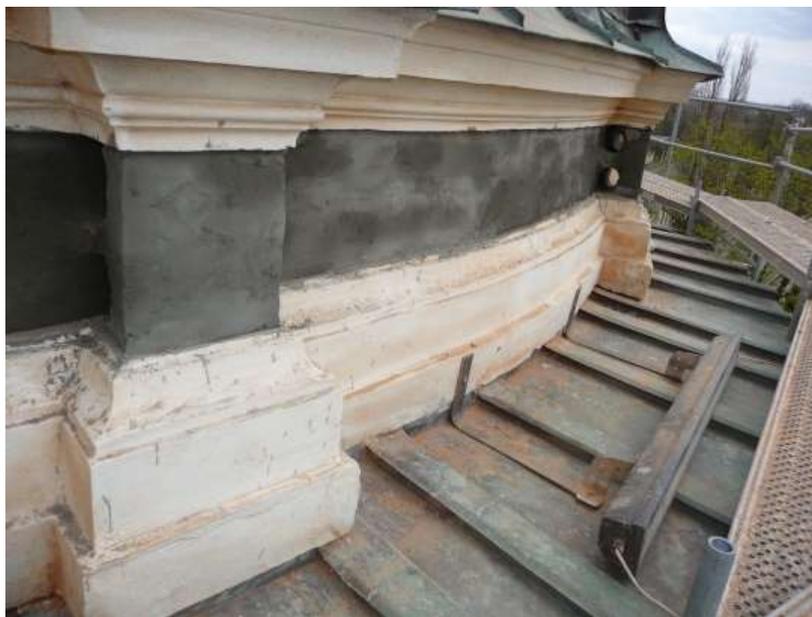
Fig. 7. The preparation of the church dome's drum for placing CFRP strips.

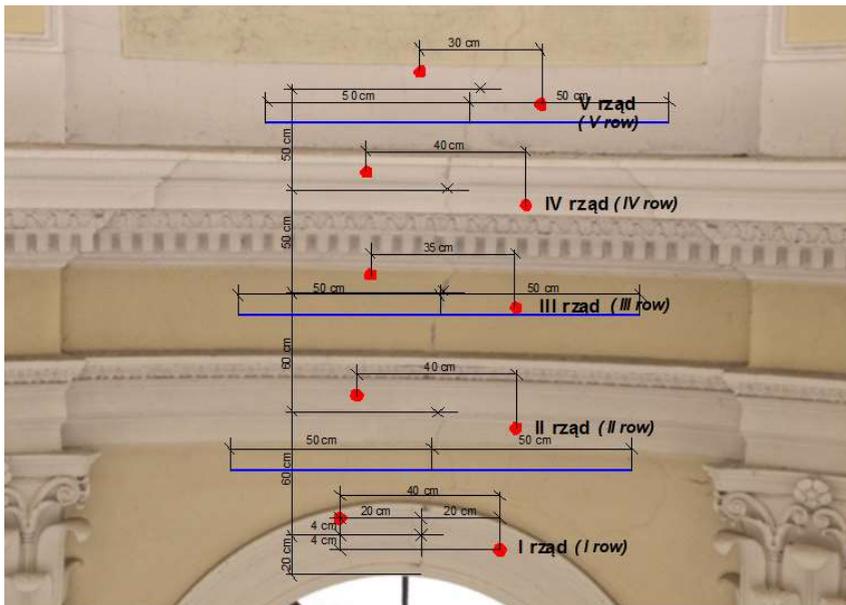
Fig. 8. Scheme of the arrangement of the reinforcement (steel spiral rods) of the cracked wall above the window arches.

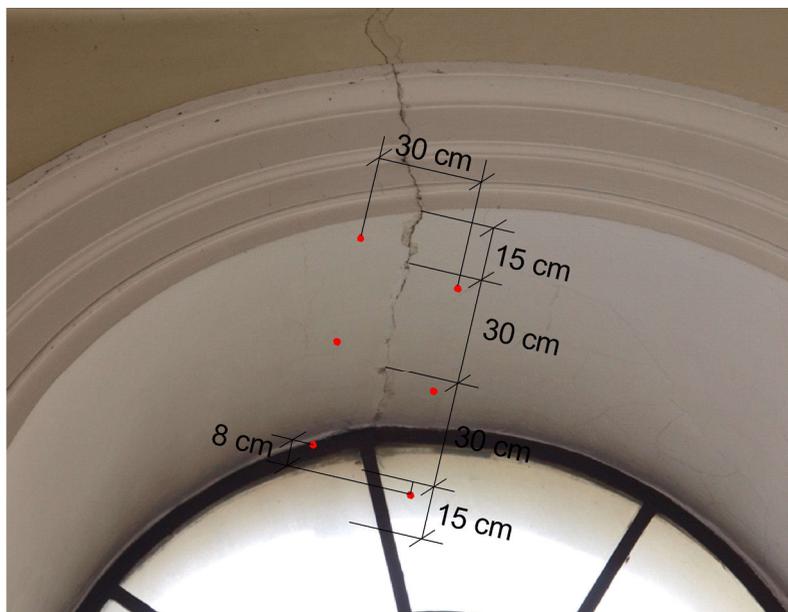
Fig. 9. Schematic layout of the reinforcement bars of the window vaults.

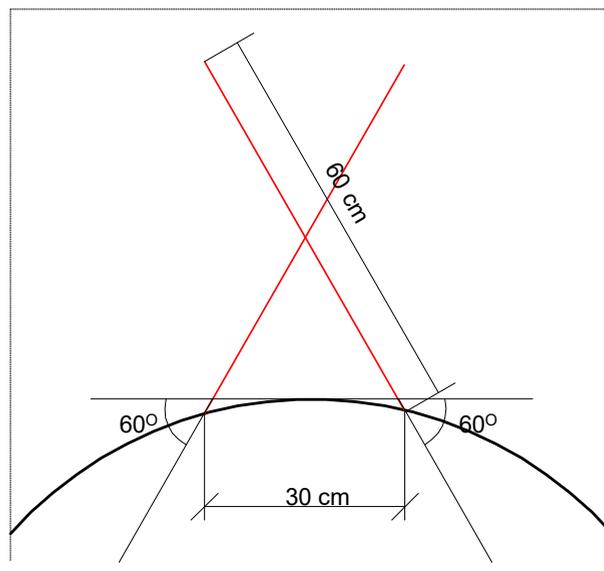
Fig. 10. Cross-section of reinforcement of the vault over window openings
