Unconscious decisions causing a failure condition of the 19th century brick ceiling

Dariusz Bajno, Agnieszka Grzybowska and Rafał Tews*

Abstract. The article describes a hazard caused by deformation of a brick vault located under the dungeons of the gate tower of Zamek Górny in Opole at the turn of the 13th and the 14th centuries, which was used as a school building until 2017. The hazard identified in 2013 was found on the ground level of the building in a communication route of the heavy traffic load. Visual inspections and tests have demonstrated that the existing situation was caused by civil works performed at the dungeon level nearly 6 years earlier due to an unconsidered decision on removing debris and a backfill which filled entirely the lower tower storeys. The above actions resulted in removal of the base of the floor ‘laid on the ground’ in the 19th century [2][4]. In this article, an analysis was carried out to verify possibilities of unbelievable strength of the artificially formed flat vault, which was previously the floor supported on a debris and sand base.

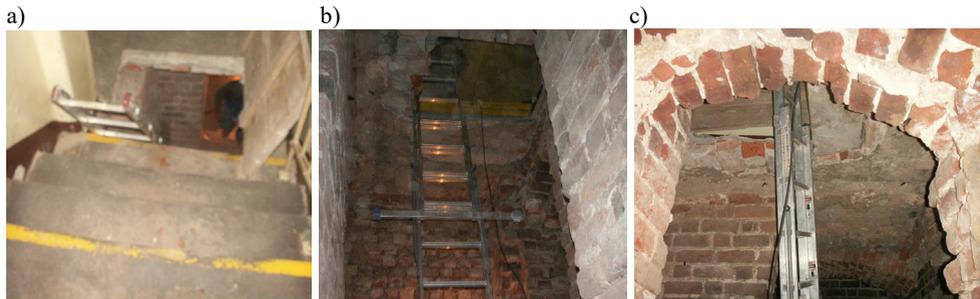
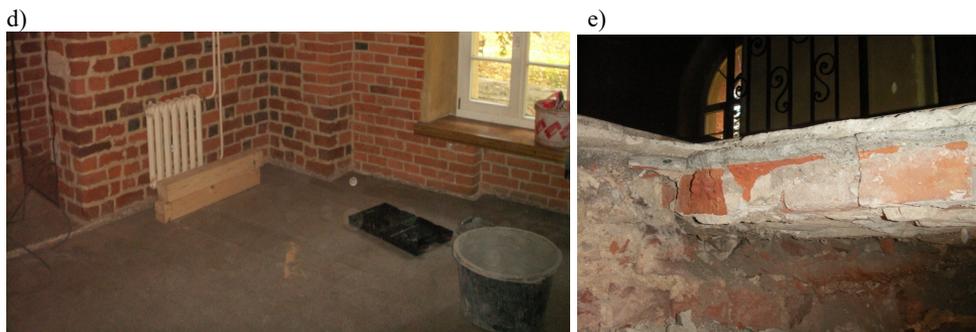
In September 2013, the deformations of the floor fragment in the ‘passage’ between the main school building and the physics educational building (the gate access level – Fig. 2a) were observed, i.e. in the place constituting the element of the communication route of the variable load which raised a building owner’s concern about the use safety.

Fig. 2. Location of damage: a) in the passage between the buildings, b) in the passage between the buildings, c) bottom view, d) location of the second damage, e) ceiling layer exposure

Visual inspections carried out in September 2013 revealed damage to the ceiling structure which made it necessary to expose the site in the days that followed [Fig. 2e]. The examination demonstrated that the structure consisted only of a flat fragment of a ceramic brick board without any reinforcement and not connected with the remaining basement vaults. Probably, it was made in the 19th century using full ceramic bricks laid on the debris and sand base with with gaps filled with mortar containing lime and cement [2]. Without reinforcement, this board could not have been a load-bearing component of a single-span ceiling, even at such a short span of ~1.25 m. As it was mentioned above, this is a component subject to a variable load, since it is located in a place where students move between two educational buildings of the Mechanical School. The location of damaged ceiling fragments is shown in Fig. 3.

selecting a backfill for the ‘dungeons’ of the tower, the base of the above-mentioned floor and the floor of the adjacent room (basements – the dungeons were filled with debris and sand) was also removed. The static scheme of the board leaning against the base (being a fill) with its entire surface changed to a board structure supported on two edges only. An interesting fact is that the building was used for about 6 years without any symptoms of its deformation or risk. When reviewing the basement units, a disturbing situation was discovered in the adjacent room (identical to that described above – Fig. 2d), however, the builder had applied a provisional structure to protect the ceiling/floor by covering single bars and fragments of fireboards. In this case, the ceiling span was much higher, so was the risk of losing its stability. That fragment of the ceiling, which had been used previously as a floor ‘laid on the ground’, did not show any deformation. A construction disaster was prevented by introducing provisional ceiling shoring (reinforced in 2013) and due to the fact that this fragment of the ceiling was outside the area of heavy traffic [Fig. 2d].

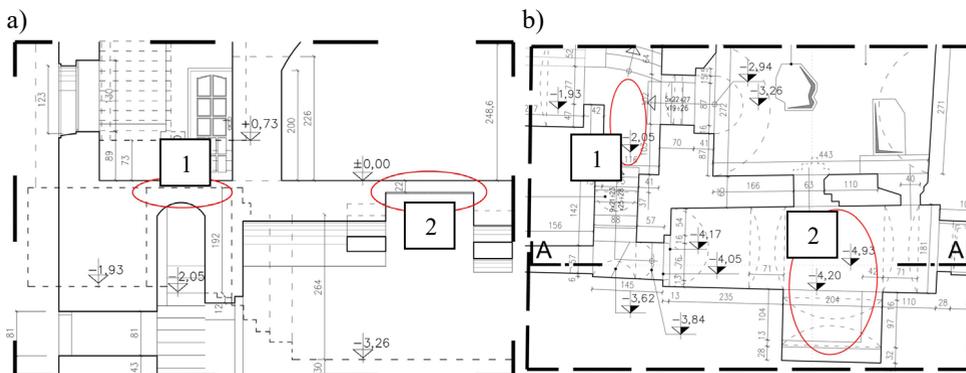
Fig. 3. Location of damage 1 and 2 (marked with red ellipses): a) A-A vertical section, b) basement floor plan

Based on the exposure, it was found that the floor had been made with an assumption that it would serve as a flat girder laid on the ‘ground’ with its entire surface. After

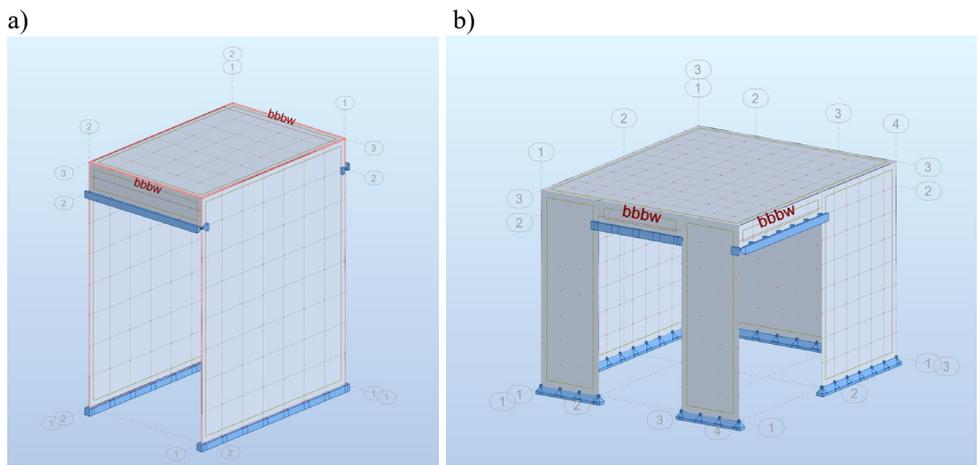
Fig. 4. View of vault models: a) corridor (damage 1 as per Fig. 3), b) second rooms (damage 2 as per Fig. 3)

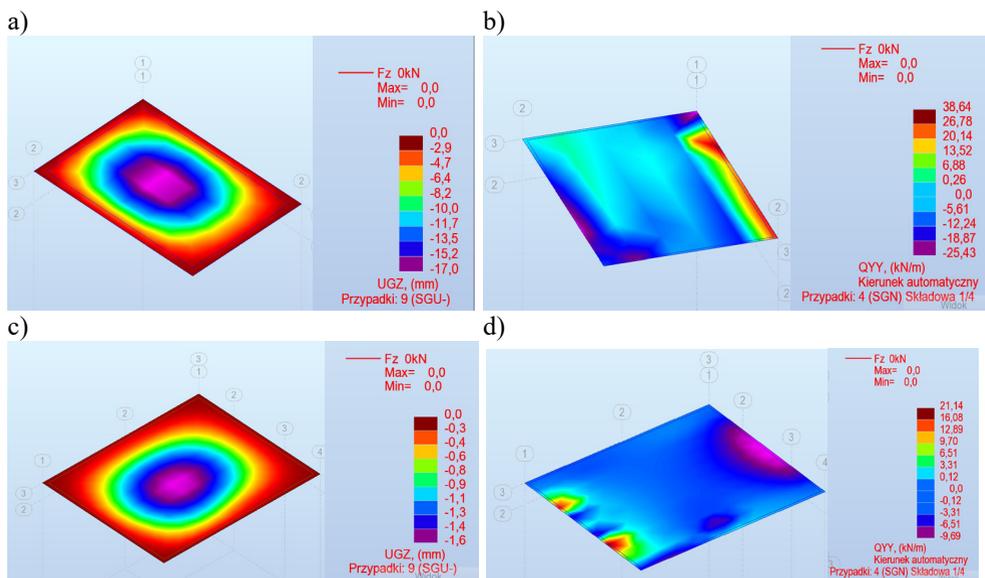
Fig. 5. View of the model: a) global displacement relative to the Z axis defined for damage 1, b) τ_y shearing forces defined for damage 1, c) global displacement relative to the Z axis defined for damage 2, d) τ_y shearing forces defined for damage 2

A certain analogy can be found in the analysed case in the context of Kleinesche Decke ceiling or Pomorze-type ceiling [5,6], whereas, it should be emphasised that the considered ‘vault’ has not been reinforced. A vertical weld cannot carry tensile stresses which take extreme values in the point of maximum bending (Fig. 5a, c) and excessive shearing forces in the wall interface (Fig. 5b, d).

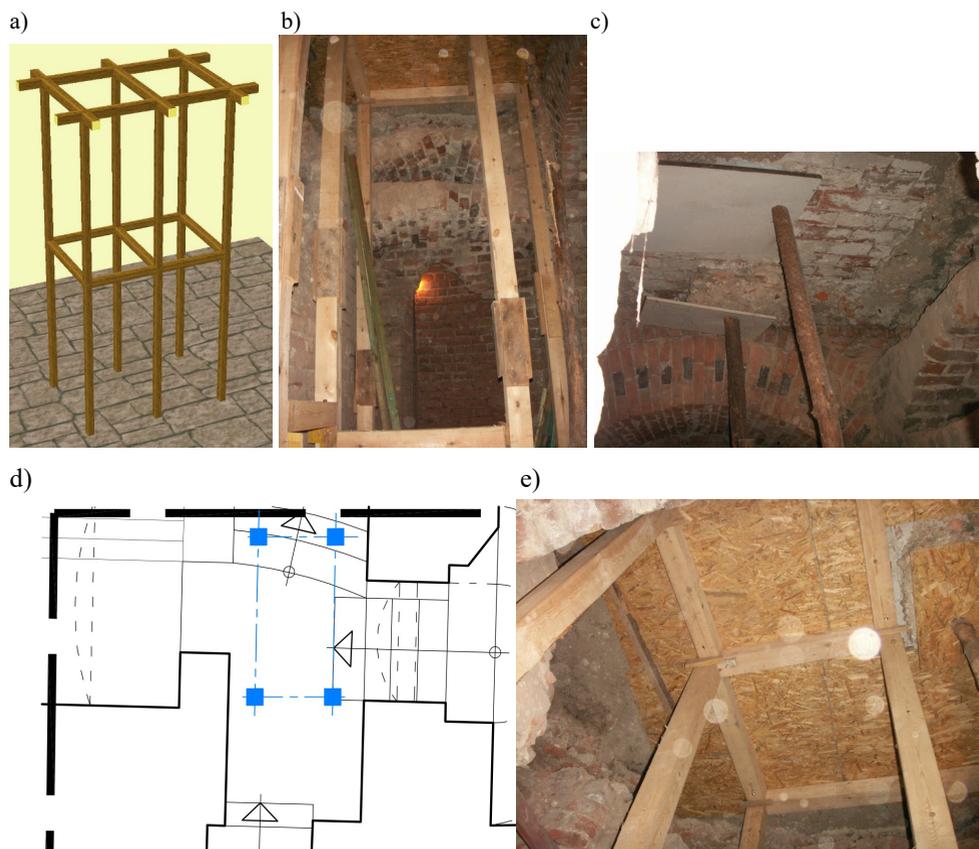
Fig. 4. Temporary supports: a) visualisation, b) view, c) inserted by the contractor in the place of 2, d) location, e) view

Due to the condition of the basement (dungeon) ceiling, it was necessary to immediate exclude it out of use, i.e. to protect it from access by any persons and make a temporary reinforcement and finally to consult the problem with the Opole Province Monument

Conservatory. An explicit statement was made that the described fragments of the ceiling above the ‘dungeons’ - not serving as vaults - are not self-bearing components and have to be urgently reinforced or replaced by new ones. Further use of the same in an unaltered condition posed a risk of a construction disaster and a direct threat to life and health of building users. In September 2013, a temporary support of the ceiling was designed and made to operate until its final reinforcement. This has not been changed to date [Fig. 6b]. Currently, the target solution is being developed on the basis of a construction design, so actually there is no final reinforcement made in consultation with the Opole Province Monument.
