# Restoration of the interior of the Summer Lubomirski Palace in Rzeszow

**Abstract.** The Lubomirski Summer Palace is one of the most valuable not sacred monuments of Rzeszow architecture. It was erected in the late baroque style at the end of the 17th century by Hieronim Augustyn Lubomirski as part of a large garden complex around the castle. Times of his glory fall in the mid-18th century. At that time, palace with the surrounding park was extended by Jerzy Ignacy Lubomirski and became a residence willingly visited for recreational purposes. The last private owners of the Palace were Nieć family who sold it to the Regional Medical Chamber in Rzeszów. Since 2014, the palace and its surroundings have been renovated for the seat of the Chamber. The subject of this article is a detailed presentation of the scope and method of the palace interior renovation. This renovation was carried out between 2014 and 2016 on the basis of previously prepared architectural building documentation and detailed renovation technology developed by the author of the article (adapted to the technical condition of the object). The article describes in detail the technical condition of the building befor

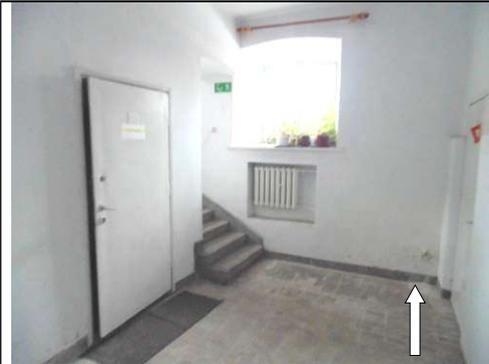
The interior renovation started at the end of January 2014 with the removal of all technically worn finishing elements that do not have a historical value. Then it turned out that the previous renovation was carried out in a very superficial way. All defects of the walls, including those in the basement, were masked with plasterboard. The issue of the most vital importance for the durability of the object was omitted, which is a damp insulation of the underground part of the building and external basements (located outside the outline of the aboveground part) (Fig. 3 - 8). Rainwater and snowmelt reached the basement from concrete window casings located below the ground level, through the leakage of their walls and the windows themselves which were in poor technical condition.

**Fig. 3.** Moistening of the wall - basements, level "-1" near the stairs to the ground floor

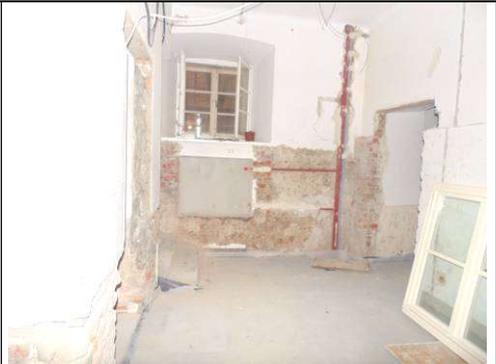
**Fig. 4.** Like in the previous picture - walls after removal of damp plaster

Plasters from entire damp surfaces were removed with a flange min. 80 cm above (Figures 4, 8, 9). Large damages in the pedestal and underground parts of the building were also caused by leaky and incomplete drainage pipes (Figures 11-13). Damage shown in Fig. 11 and 12 is the result of the above-mentioned disadvantages. Over 30 years old internal installations were dismantled. The ventilation chimneys of the underground part of building have been opened. Basement prepared in this way was left to self-dry for about a year and a half. Supplementation of too shallowly placed foundations from the inner side were made. In the summer, with favorable weather conditions, damp insulation and supplementation of too shallow foundations from the outside were made.

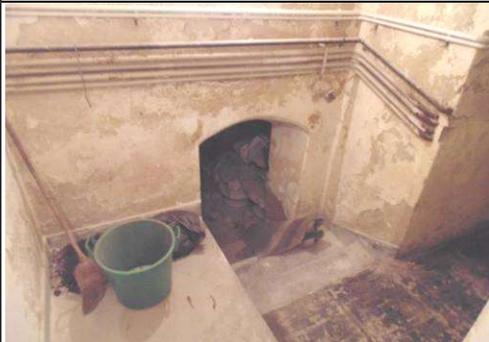
**Fig. 5.** Wall moisturization and corrosion of the installation at the entrance to the eastern outer besement

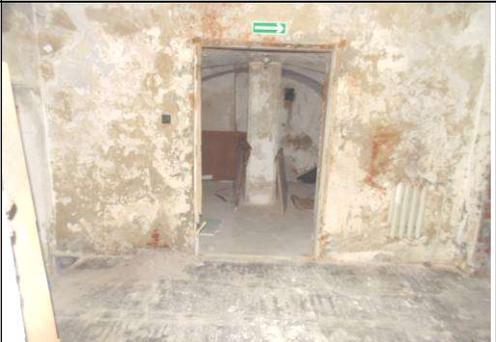
**Fig. 6.** Outer southern basement, level "-2" - biological corrosion of the entire enclosure

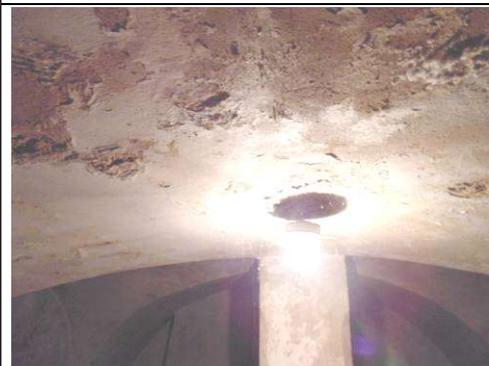
**Fig. 7.** Moisture of the ceiling and salt efflorescence around the column visible in Fig. 6

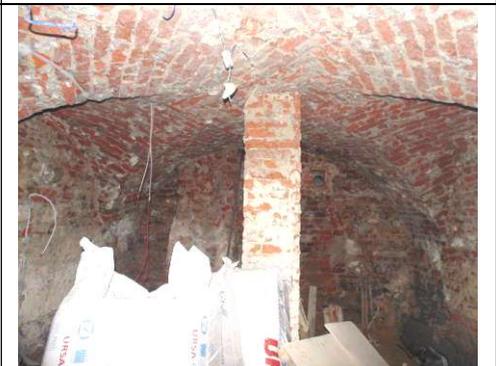
**Fig. 8.** View of a completely damped floor from Fig. 8 - after plastering

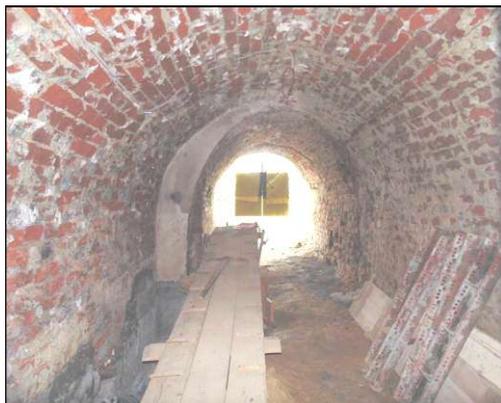
**Fig. 9.** Exit towards the fountain - completely damp vault and walls after plastering

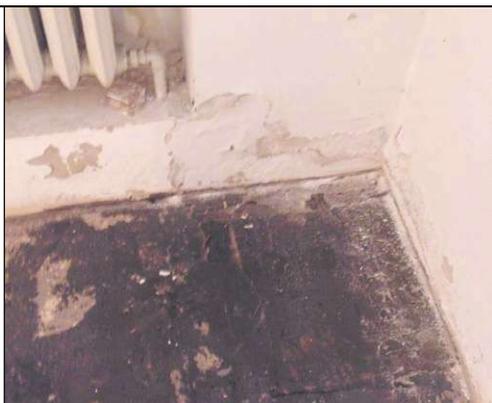
**Fig. 10.** Corrosion damage in the north-east corner of basement.

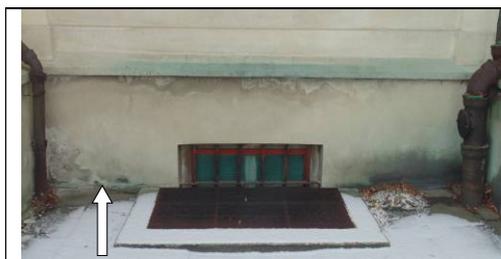
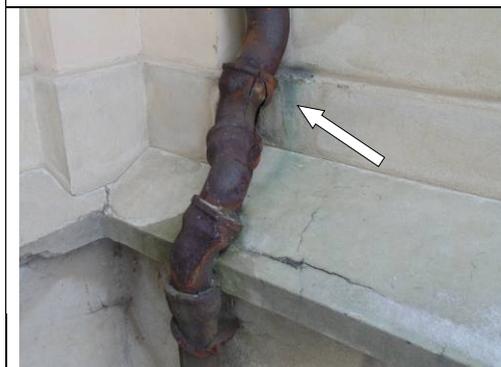
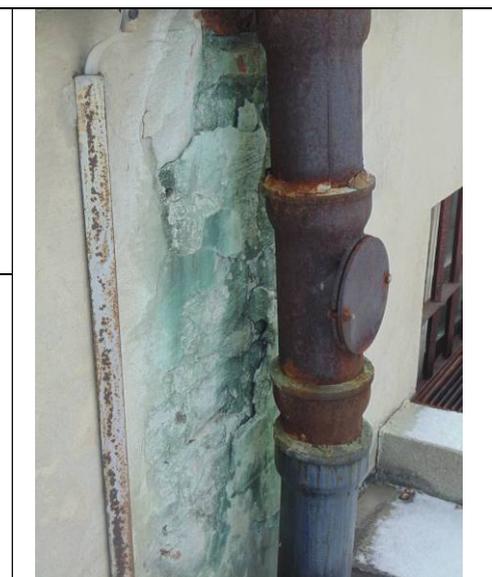
**Fig. 11, 12, 13.** Water stains and damage caused by leakage of downpipes

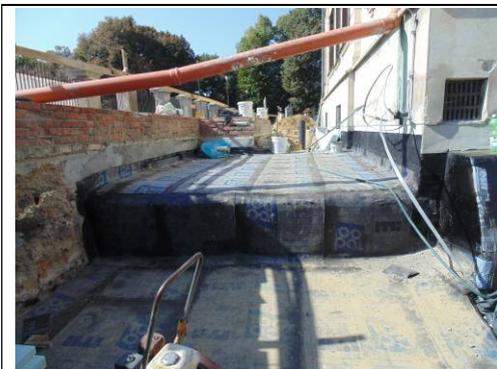
**Fig. 14.** Insulation of walls and external basements during the stage I

External basements were also insulated. Due to the poor technical condition of walls and vaults of these basements, insulation works were preceded by the execution of the casing in the form of an outer cladding (reinforced concrete walls and floors) (Fig. 14, 15).

The purpose of this housing (dilatated from vaults and walls) is to transfer external loads from the internal road and car park located above the basement.

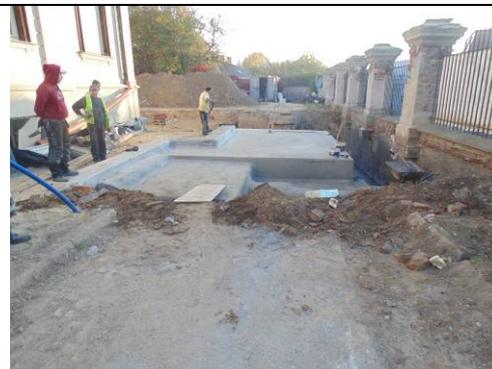
**Fig. 15.** Protective works of basements, stage II.

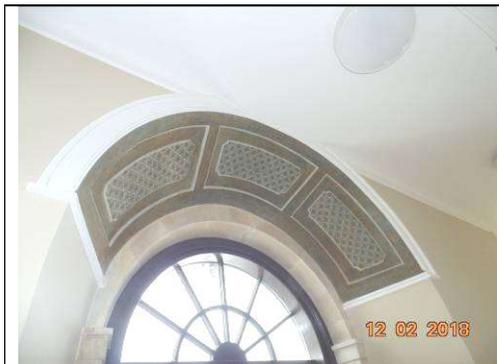
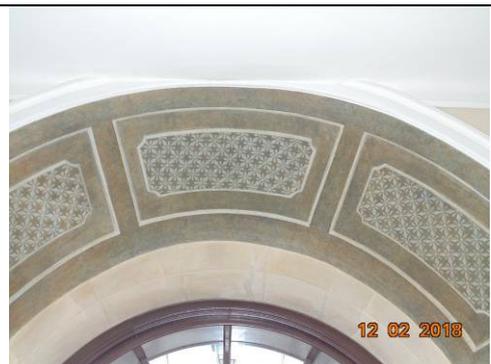
**Fig. 16.** Renewed polychrome above the main entrance

**Fig. 17.** As close as, zoom in the middle part

The polychrome was quite well preserved. It was gently cleaned with pulp of bread. The existing painting layer is protected with a solution of poly-alcohol. Next, the mineral paints based on poly-alcohol were applied. Way of applying paints - by scoring (in order to obtain the effect of vibration).

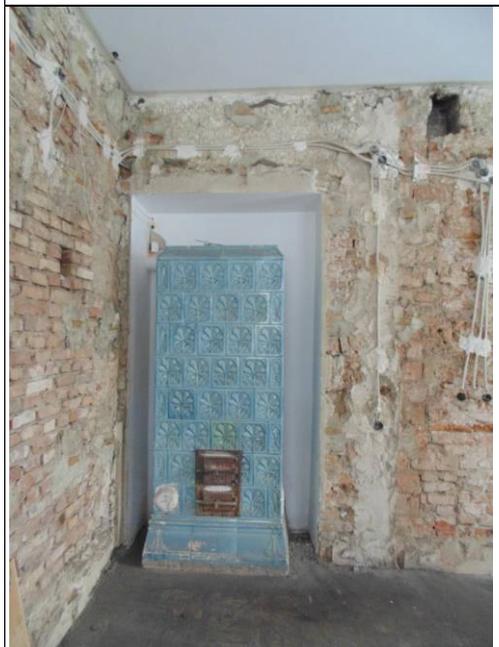
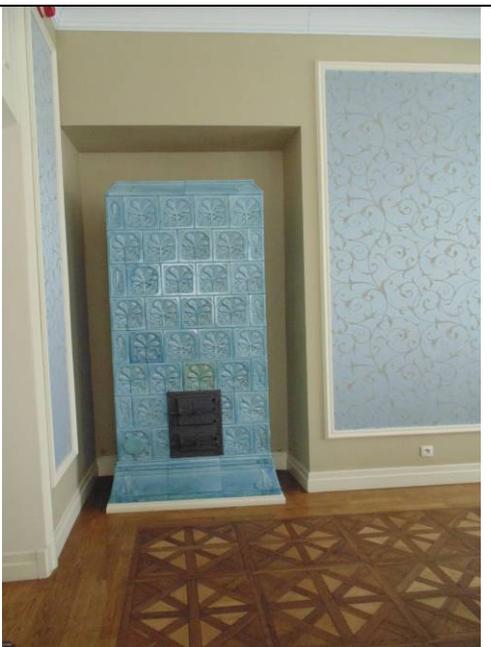
**Fig. 18.** View of the stove and stove room during renovation

**Fig. 19.** As the next, current status

There were quite a few small cavities on the furnace surface. The cavities were supplemented with cerami mass with the reconstruction of the tile sculpture. One tile was replaced with a new, burnt-out one with faithful representation of the damaged tile pattern. The door has also been replaced. The whole surface of the tiles was painted with shiny ceramic paint. Way of applying paints - as above.
