Problems concerning reconstruction of old post-industrial building of a closed coal mine and its adaptation to a new utility function

Abstract. The waiting room and bath building is one of the two preserved industrial facilities of the former Gliwice Mine. It was built in the first years of the 20th century and fulfilled its function till mine liquidation in 2000. It was overhauled and modernized in 2005-2008 and currently fulfills a new function. The paper presents a summarized history of the Gliwice Mine, a detailed description of the building structure, its technical condition before the overhaul and problems encountered during the adaptation works. It also briefly indicates the causes of the observed damage as well as describes the scope of the basic modernization works related to the new function of the building as an education and office facility. Moreover, it presents the manner of conducting the overhaul and modernization works leading to restoration of the full utility values in the new function.

2 Description of the former waiting room and chain bath building

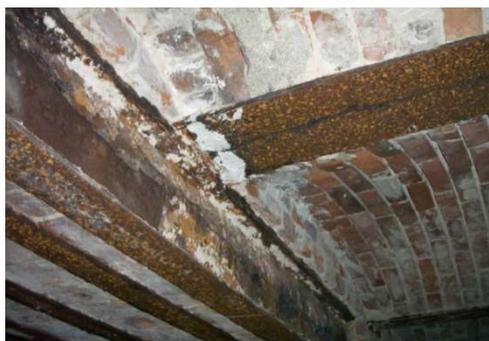
Fig. 3. The cellar ceiling: steel ribs and a binding joist fragment (note the corrosion of steel)

- intense local corrosion of certain steel beams (ribs and binding joists) in all ceilings; the strongest corrosion is found within the lower flange of the I-beam section (Fig. 3),

- strengthening of the corroded steel beams in the ceilings. Depending on the damage degree and beam location, steel supporting elements in the form of additional binding joists and pillars were installed; moreover, steel sections were locally supplemented;

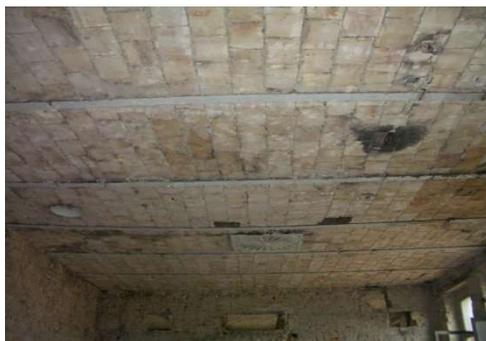
Fig. 4. The first floor ceiling: steel ribs and structural clay tiles (note the rib sagging)

- significant sagging of a part of ceilings above the first floor (Fig. 4),
- significant damage to the pillar heads in the cellars – vertical cracks running from the ends of the steel beams resting on the pillars (Fig. 9),

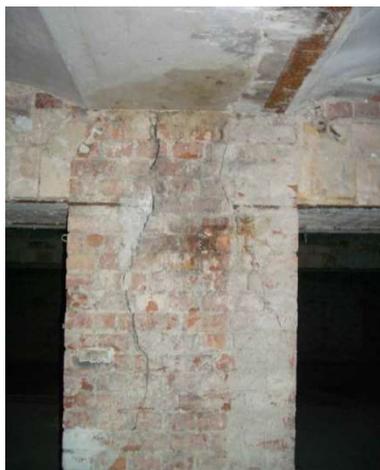
Fig. 9. An example of a cracked pillar in the cellar (see the description in the text)

- strengthening of the damaged brick pillars in the cellars by covering them with concrete and additional reinforcement or enclosing them with a steel structure. In both cases, the strengthening was carried out from the foundation coping to the steel beams resting on the pillar; the load-bearing capacity of the strengthening element ensured transfer of the entire force acting on the pillar;

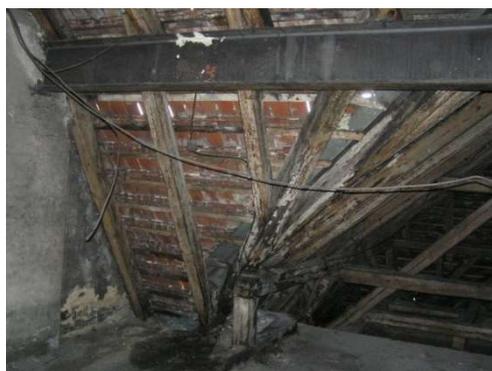
- numerous unprotected cut-through spots in the ceilings and walls,
- scratches on and damage to certain window heads,
- local corrosion of the roof structure – intense on the wooden elements (Fig. 10), especially those going beyond the wall outline, as well as on certain steel elements,

Fig. 10. An example of corrosion of the wooden elements in the roof structure

- replacement of the corroded wooden elements of the rafter framing as well as impregnation and fire protection of the remaining ones;

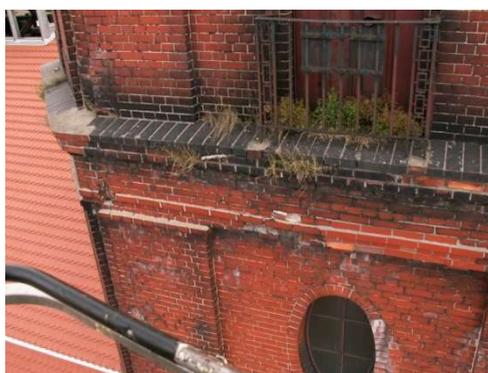
- damaged and leaking roofing (of varying intensity) – the roofing paper and the roofing tiles,
- damaged clinker facade layer with missing bricks (of varying intensity), especially on the tower (Fig. 11, 12),

Fig. 11. An example of damage to the clinker facade layer

- replacement of the roofing and a full repair of the facade, including replacement of the damaged shape bricks with original ones obtained from another disassembled facility from the same period.

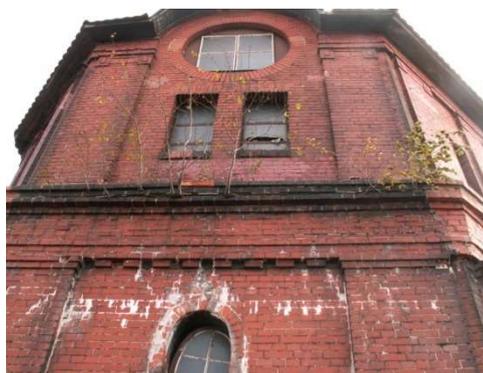
Fig. 12. An example of damage to the clinker facade layer

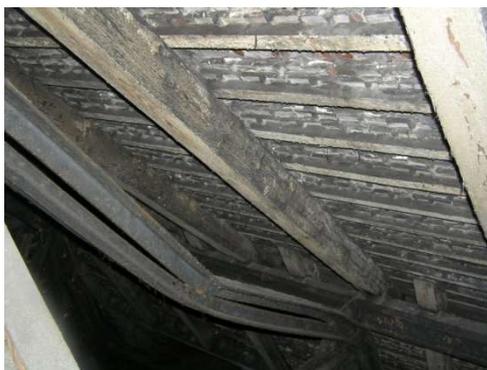
Regardless of the above, the soil and hydrographic conditions under the northern wing of the building changed at an unknown moment. It was probably related to the progressing liquidation of the mine waste heap located next to the facility, which caused partial decompression of the substrate. The result was significant cracking of the walls in the north-eastern corner of the building as well as clearly visible deformations of the roof structure elements – the outermost girder (Fig. 13) and the braces (Fig. 14). The lower part of the northern wall of the tower (within the attic of the northern wing) was also strongly cracked.

Fig. 13. A deformed upper flange of the girder on the northern side (description in the text)

An observation of the damaged building corner revealed that it was already stable. Therefore, it was recommended to rebrick the damaged wall fragments (including installation of horizontal reinforcement) and replace the deformed elements of the roof girder and the braces. A similar recommendation concerned rebricking of and installing additional reinforcement on the scratched fragment of the northern wall of the tower.

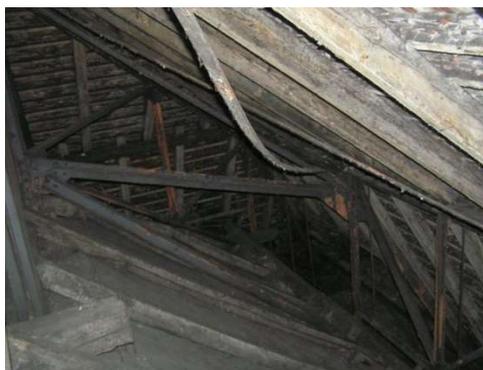
Fig. 14. A deformed brace on the northern side (description in the text)

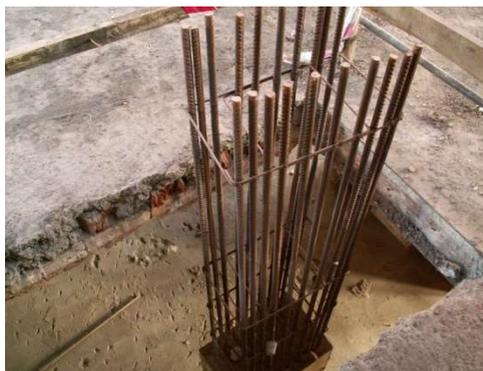
Fig. 16. Passage of a pillar of the new RC structure through the ceiling above the first floor

The construction of the new load-bearing structure involved appropriate recommendations in the scope of the technology of performing openings in the ceilings, including steel elements stabilizing the ceramic filling next to the openings.

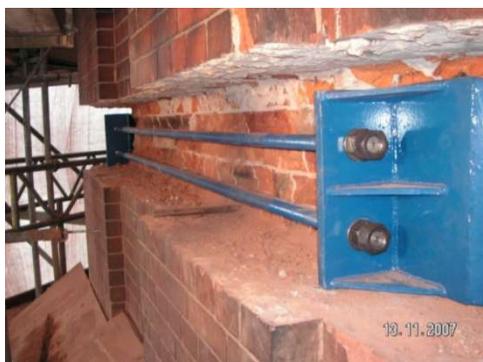
Fig. 18. Assembly of one of the encircling ties of the tower

It was also recommended to install encircling ties hidden under the clinker facade on the ceiling level of the tower (Fig. 18).
