Environmental interactions to composite elements of all-GFRP Kolding Footbridge

*Beata Stankiewicz**

Faculty of Civil Engineering and Architecture, Opole University of Technology, Opole, Poland.

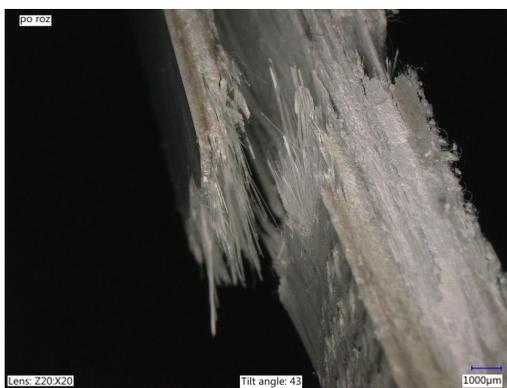
Fig. 2. The broken glass fibers in finally moment of tensile destructive test.

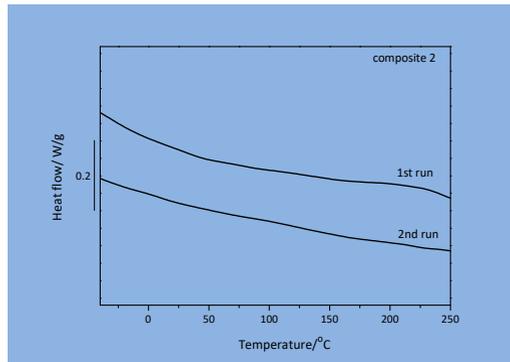
In the study, specimens of about 20 mg were cut to from reference GFRP (composite 1) and from the composite after 20 years of natural aging (composite 2) and were placed in the hermetically sealed aluminum crucibles with a pin. Samples were heated, during two cycles, from -40 to 250°C at a rate of 10 K/min. In the DSC analysis no phase transition was recorded. The DSC curves from the first and second runs were approximately the same, without exothermic effect, thus no post-curing reaction was observed. The addition of filler in both composites can influence thermal properties of samples and can mask possible phase transitions, especially the glass transition temperature.

Fig. 4. DSC thermograms of composite 2 (aging one) recorded at heating rate 20 K/min in nitrogen.

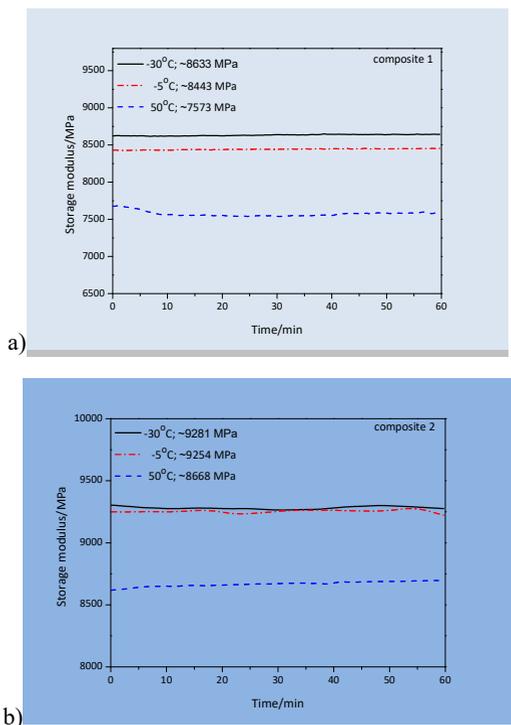
The thermomechanical properties of beams cut from both composites (virgin and aging) were also investigated in the DMA under isothermal conditions, i.e. the samples were deformed at the selected temperatures (at -30, -5 and 50°C) for one hour. The changes of the storage modulus as function of time are shown in Figure 6. The values of the storage modulus at a constant temperature were practically the same at the time of the measurement, but increased with the lowering of a temperature as shown in the Figure 6. In addition, for the sample from the bridge the modulus at the same temperature was slightly higher than the one for the reference sample. For example at 5°C the value of storage modulus is 8443 MPa for the virgin composite 1 and 9254 MPa for the aging composite 2 and at 25 °C, storage modulus for the first GFRP virgin fragment is 8636 MPa and 8981 MPa for the second, old one [16].

Fig. 6. Time dependence of storage modulus of virgin-new composite 1-(a) and aging-old composite 2-(b).

The values of the storage modulus (for virgin and aging composite) at a constant temperature were practically the same at the time of the measurement, but increased with the lowering of a temperature. In addition, for the sample from the bridge the modulus at the same temperature was slightly higher than the one for the reference sample.

For example at 5°C the value of storage modulus was 8443 MPa for the virgin composite 1 and 9254 MPa (10 % more) for the aging composite 2 and at 25 °C, storage modulus for the first GFRP virgin fragment was 8636 MPa and 8981 MPa (about 4% more) for the second, old one. The level of tensile and flexural strength of aging structure elements was not able to investigate on present stage of research.
