# Research on hydrogen-induced cracking behavior of normalized pipeline steel

**Abstract.** Hydrogen sulfide corrosion test was used to test the hydrogen-induced cracking sensitivity of the normalized BNS pipeline steel. The microstructure and morphology of hydrogen induced crack(HIC) of the normalized BNS pipeline steel after hydrogen sulfide corrosion test were observed with optical microscopy(OM), scanning electron microscopy(SEM). Combined with electron probe microanalyzer(EPMA) and hardness test, the hydrogen-induced cracking behavior of BNS pipeline steel was studied from the aspects of microstructure, crack morphology, center segregation and harness. The results showed that the pearlite band with high hardness caused by center segregation of C and Mn was the main crack initiation and propagation path for the long-size and linear shape hydrogen induced crack at the center of plate thickness, and the type of crack propagation was transgranular. Some tiny hydrogen induced crack nucleated from the small calcium-aluminate inclusion and the tiny hydrogen induced crack would not propagate to form long-size cracks with no suitable propagation path existing around the inclusion.

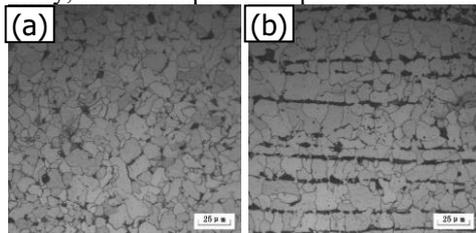
**Figure 1.** Microstructure of the sample(a)quarter thickness (b)center

The microstructure of the quarter thickness and center of the sample was shown in Figure 1. Figure 1 shows that the microstructure of the sample is a mixture of ferrite and pearlite and there are long strips of pearlite band structure in the center of sample but with no pearlite band structure in the quarter thickness of sample. The morphology of the hydrogen induced cracks generated on the sample was shown in Figure 2. Figure 2 shows the cracks produced are clear and long-size, and their shape is approximately linear. The cracks mainly distribute near the pearlite band generated at the center of the sample, and the crack propagation path almost coincides with the pearlite band, as is shown by the arrow in Figure 2(b). The crack at the box in Figure 2(a) was observed at a higher multiple under SEM and the result was shown in Figure 2(c). The Figure 2(c) shows that the long-size and linear shape crack propagates transgranularly.

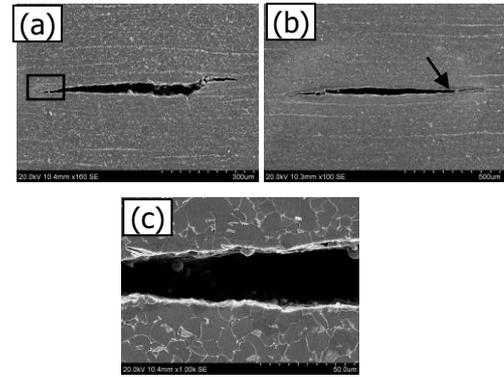
**Figure 2.** Morphology of the hydrogen induced cracks generated on samples

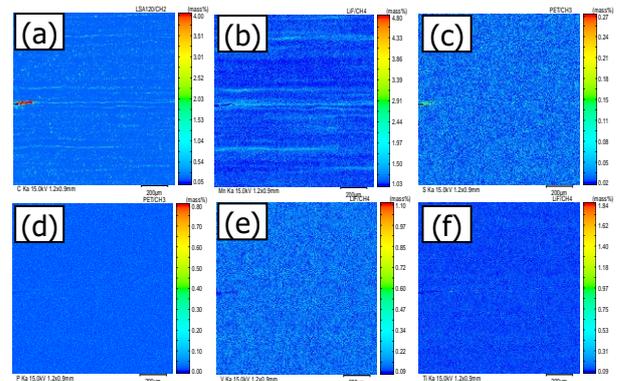
It is well-accepted that the hydrogen induced crack in pipeline steel is easy to initiate at the central segregation band and extend along the segregation band<sup>[5-8]</sup>. Therefore, the SHIMADZU EPMA-1720 electron probe microanalyzer was used to analyze the element segregation at the center of the sample and the element segregation near the long-size crack. The electron probe analysis result was shown in Figure 3 and Figure 4. There are obvious positive segregation of C and Mn at the center of the sample, and the C segregation bands and Mn segregation bands are basically coincided with the pearlite bands, as is shown in Figure 3(a) and (b). So the segregation of C and Mn leads to the formation of pearlite band in the center of sample. There is no sulfur segregation and phosphorus segregation at the center of the sample which are easy to segregate, as is shown in Figure 3(c) and (d). It has been reported in some documents<sup>[7,9]</sup> that carbonitride precipitation of niobium, titanium, and vanadium was observed inside the band structure region and these carbonitride precipitation was considered to aggravate the negative effect of the band structure. And the band structure containing carbonitride precipitation was more likely to induce crack. However, in this investigation, there is neither obvious vanadium segregation and titanium segregation at the center of sample nor the aggregation of precipitation of vanadium and titanium in the band structure region, as illustrated by Figure 3(e) and (f).

**Figure 3.** Electron probe analysis result of element segregation in the center of the sample(a) C (b) Mn (c) S (d) P (e) V (f) Ti

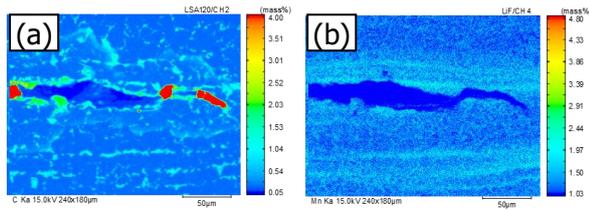
Figure 4 shows the element segregation near the crack. As is shown in the Figure 4, the long-size and linear shape crack generates at the pearlite band structure

where C and Mn segregate. While the crack almost extends along the pearlite band.

**Figure 4.** Electron probe analysis result of element segregation near the crack(a) C (b) Mn

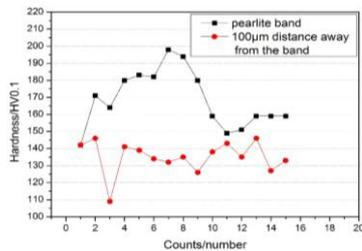
It was pointed out that the origin of the hydrogen induced crack is related to the hard phase in the microstructure<sup>[7,10-12]</sup>. Therefore, the microhardness(HV0.1) test was performed on the pearlite band near the crack and the region 100µm distance away from the pearlite band. And 15 points were tested for both regions, and the test result was shown in Figure 5. The maximum value of microhardness of the pearlite band is 198HV0.1 and the mean value is 169 HV0.1. Meanwhile the maximum value of microhardness of the region 100µm distance away from the pearlite band is 146 HV0.1 and the mean value is 135 HV0.1, as is shown in Figure 5. So the microhardness of the pearlite band was obviously higher than this of the region 100µm away from the pearlite band.

**Figure 5.** Microhardness test result

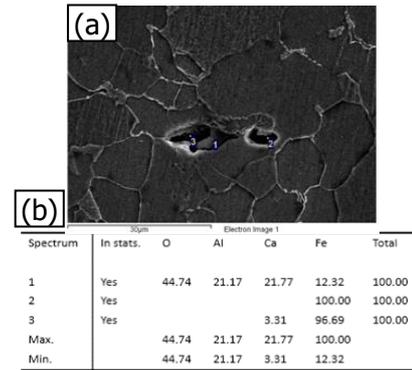
Aside the long-size and linear shape crack at the center of the sample thickness, there were some tiny cracks generated on the sample, as is shown in Figure 6(a). Figure 6(b) shows the energy spectral analysis result of the tiny crack zone, and small size granular calcium-aluminate inclusion was discovered inside the crack. It is well accepted that as a major hydrogen trap, inclusions can cause hydrogen induced crack<sup>[13-16]</sup>. So the tiny crack here should be hydrogen induced crack that nucleated from small calcium-aluminate inclusion, but it doesn't extend further. So the hydrogen induced crack originated from the small calcium-aluminate inclusion would not propagate to form long-size crack if there is no suitable crack propagation path for it.

**Figure 6.** (a)SEM photograph of the tiny crack (b) energy spectral analysis of the tiny crack zone
