Evaluation of tramway overhead line system in city of Osijek

Ivo Haladin^{1*}, Stjepan Lakušić¹, and Ivan Duvnjak²

Abstract. Overhead line system is a vital element of any electrified railway infrastructure. Its performance reflects to all vital parameters such as traction, reliability, availability and safety of railway infrastructure. Operator GPP Osijek runs a 27.5 km long tramway network which plays a key role in transit system of the city of Osijek, Croatia. In 2016 GPP Osijek applied to a tender for acquisition of new rolling stock with 85% EU investment. Mayor requirement prior to rolling stock acquisition was to document, analyse and upgrade current infrastructure (including track structure, electric substations and catenary) to an optimal level. Task of measurement and evaluation of tram track structure and catenary has been appointed to University of Zagreb Faculty of Civil Engineering. Overhead line analysis comprised from several measuring procedures, including supporting columns evaluation, catenary stagger, height, shocks and wear. Such extensive analysis included GPS positioning and on-site evaluation of 1214 supporting columns of overhead line, as well as overhead

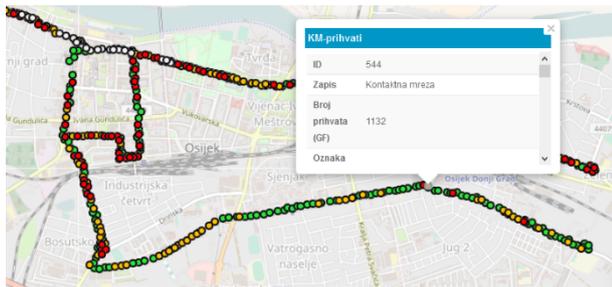
Fig. 1. Acquired GIS dataset of 1214 analysed supports.

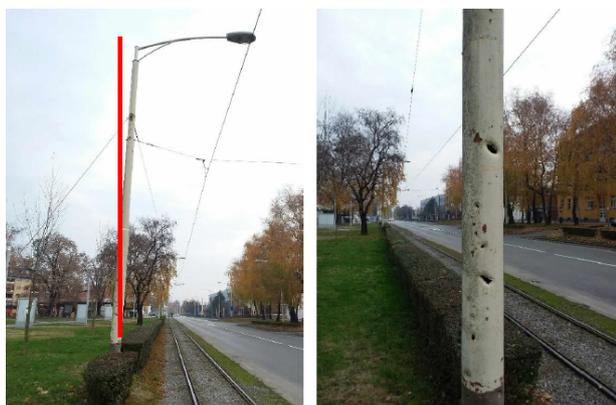
According to analysis, 20 % of columns were characterized as substantially damaged (bent out of vertical axis, corrosion damage, shrapnel damage etc.), as presented in Figure 2; 32 % endangered (minor corrosion or dents); 48 % in good state (not bent, no corrosion or dents).

Fig. 2. Example of substantially damaged columns.

Conducted measurements and further analysis revealed weak spots and sections in overhead line system that are to be replaced or reconstructed due to weakened or damaged support columns (around 20%), worn overhead wire and elevated level of vibrations and shocks on vehicle pantograph. Furthermore recommendations for correction of overhead line alignment in terms of height and stagger have been given for more than 2000 m of track. Priority levels for reconstruction have also been determined.

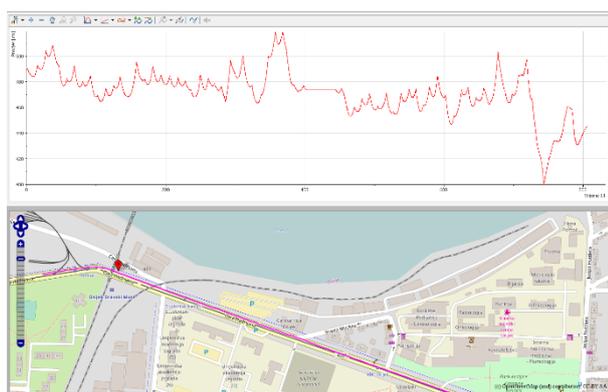
Height difference in respect to travelled distance has also been analysed because it can lead to loss of contact between the pantograph and the wire, Figure 5.

Fig. 5. Substantial height difference of overhead wire (right).

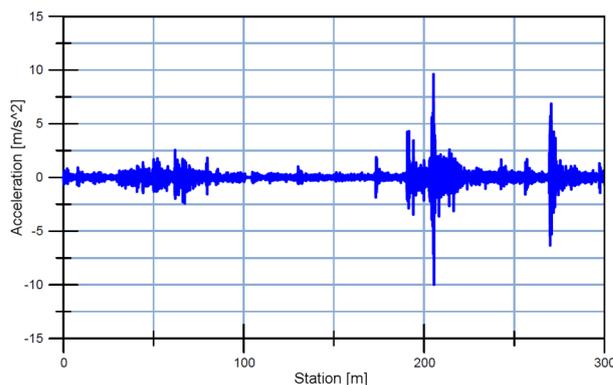
Through vibration analysis different average level of vibrations have been recorded on different track segments as well as individual shock events on the catenary, Figure 6. Such data is important for evaluation of overhead line wear, joints, overlaps and potential weak spots.

Fig. 6. Overhead wire shock time signal sample.

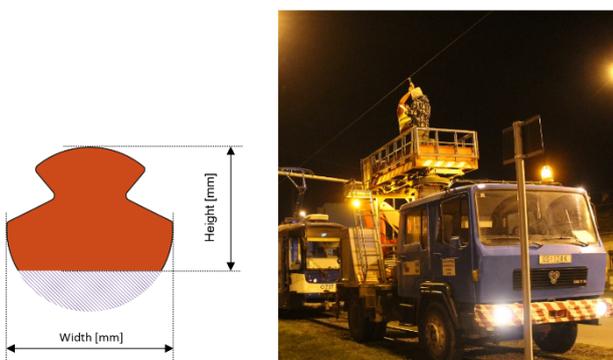
Fig. 9. Measurement of overhead wire wear.

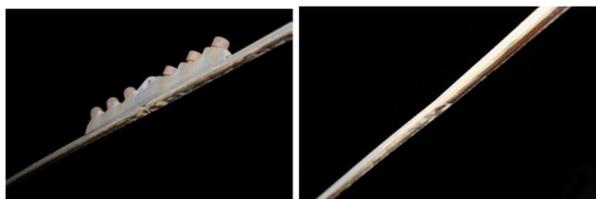
Fig. 10. Inspection of wire joints and potential weak spots.

Such inspection, together with historic data of GPP Osijek maintenance division, revealed 79 joints due to wire breakage, 46 substantially worn spots and other potentially critical points, Figure 10.
