# Safety inspection on level crossing JPL 727 km 537+453 Patak-Pathukan Road, Sleman, Yogyakarta

**Abstract.** Level crossing (LC) safety inspection between a highway and a railroad on Pirak-Pathukan Road, Sleman, Yogyakarta is necessary because this LC is located near various community centers, has high traffic volume, intersects with railway double tracks, and intersecting angle that is not perpendicular. This study aims to evaluate LC technical condition, analyse delay time and vehicles queue length, and evaluate pavement structure condition. The research results indicate: 1) LC technical conditions do not meet the requirements of Regulation of Director General of Land Transport No. 770 Year 2005; 2) The longest duration of LC gate closure occurred on Sunday at 15:05, that is 360 seconds, the highest traffic flow occurred on Monday (from the South side) that is equal to 1443 skr/day, and the longest delay time occurs on Sunday at 15:05, that is 498 seconds; 3) The value of pavement condition index (PCI) is 82% very good.

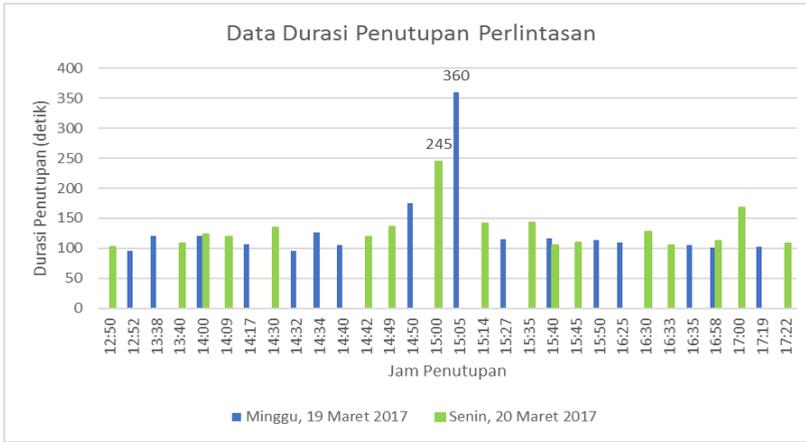
Fig. 2 Level crossing gate closure duration

A survey of level crossing gate closure duration is done to find variations of level crossing gate closure duration caused by the passing train. The data of level crossing gate closure duration for two days of observation are shown in Figure 2 below.

2. Some parameters are analyzed as the impact of level crossing gate closing, including as follows:
  - a. The longest closure duration of level crossing gate occurred on Sunday, March 19, 2017 at 15:05 for 360 seconds, while on Monday, March 20, 2017 occurred at 15:00 for 245 seconds.

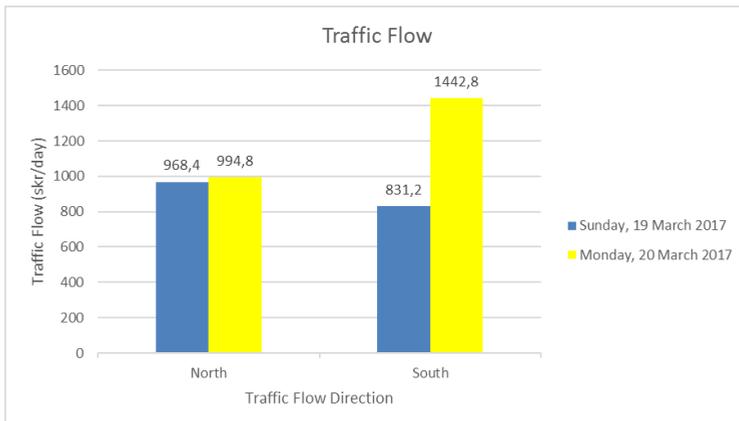
Fig. 3 Traffic flow

The data of traffic flow survey result at level crossing is shown in Figure 3.

- b. The highest traffic flow that occurred on Sunday, March 19, 2017 comes from the North side that is equal to 1932 vehicles/day or equal to 969 skr/day. Furthermore, the highest traffic flow that occurred on Monday, March 20, 2017 comes from the South side that is equal to 2956 vehicles/day or equal to 1443 skr/day.

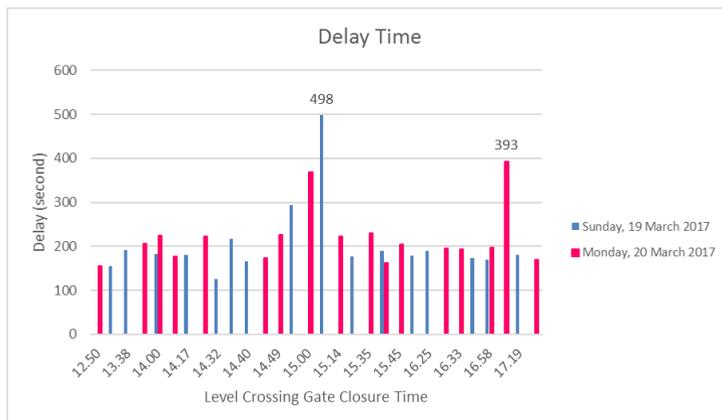
**Fig. 4** Delay time

The queue length varies on each approach lane of level crossing for each level crossing gate closure time. The data of delay time can be seen in Figure 4.

From the survey of delay time and vehicles queue length that conducted for 6 hours from 12:00 to 18:00 on Sunday, 19 March 2017, it can be obtained the result that the longest delay time occurred at 15:05 for 498 seconds. The delay time is influenced by the duration of the level crossing gate closure due to the passage of two trains at almost the same time, causing the vehicle queue length is 65 meters in the North side and 87 meters in the South side of level crossing. Furthermore, from the survey of delay time and vehicles queue length that conducted for 6 hours from 12:00 to 18:00 on Monday, 20 March 2017, it can be obtained the results that the longest delay time occurred at 17:00 for 393 seconds which is causing the vehicle queue length at that hour is 31 meters in the North side and 125 meters in the South side of level crossing.

- c. The longest delay time on Sunday, March 19, 2016 occurred at 15:05 for 498 seconds with a queue length is 65 meters from the North side and 78 meters from the South side. Moreover, the longest delay time on Monday, March 20, 2017 occurred at 17:00 for 393 seconds with a queue length of 31 meters from the North Side and 125 meters from the South Side.

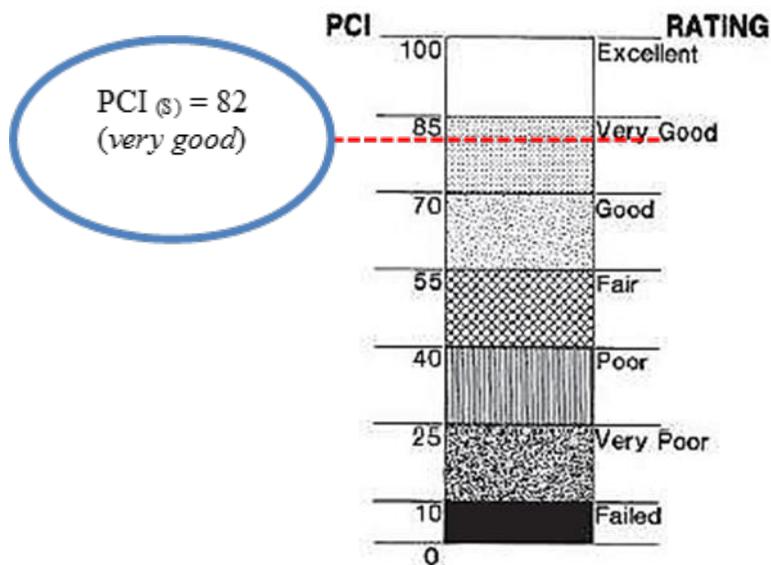
Fig. 5 PCI value chart

Based on calculations, Total Deduct Value (TDV) is 35 with Q value is 3, resulting Corrected Deduct Value (CDV) is 18 from the CDV chart. Furthermore, the pavement condition value is obtained by subtracting 100 (one hundred) with the value of CDV that has been obtained. If the CDV value is known, then the PCI value of each segment unit can be calculated by the formula (5).

From the PCI value of each segment unit, it can be concluded that the amount of PCI value of this road segment as in the following figure.

3. There are 4 types of damage on the road segment JPL 727 KM 537 + 453 along the 200 meters North-South direction, which are : patching (9.33%), bleeding (0.22%), depression (0.8%), and railroad crossing (4.8%). The value of the pavement conditions index (PCI) is 82% therefor it can be concluded that the road pavement is in very good condition.
