The possibility of extending work time of tribocouple welding improved stainless steel with improved carbon steel

Vlatko Marušić¹, Predrag Dašić², Ivan Opačak^{1*}

Abstract. In the conditions of tribo-corrosion wear, extending of life time of parts can be achieved by using stainless steel, which is hardened to sufficiently high hardness. In the tribopair bolt/shell/slice of the bucket elevator transporter conveyor machine, the previously improved martensitic stainless steel for bolts is hardened at ≈ 45 HRC and welded with the improved high yield carbon steel for bolts. As the additional material, an electrode based on Cr-Ni-Mo (18/8/6) is used. The structure and hardness of welded samples are tested. On the tensile tester, resistance of the welded joint is tested with a simulated experiment. Dimensional control of wear of elements of tribopair was performed after six months in service. The analysis of test results showed that with regulated additional material and by applying the recommended welding parameters, the properties of the weld, which provide the necessary reliability of the joint in the conditions of tensile load, can be achieved, with a significant increase in the we

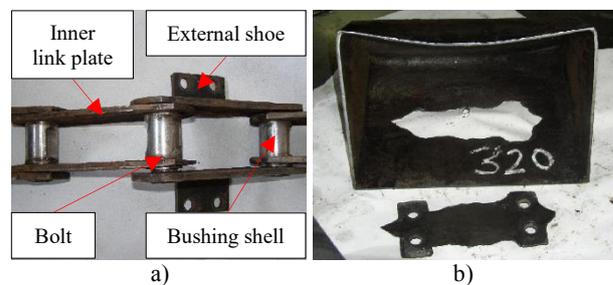
According to the original documentation: breaking force of elevator chain is about 2500 N and declared service life of a chain is two years. Figure 1 shows the parts of the original elevator chain after about six months of work.

Fig. 1. Appearance a damaged chain (a); buckets severed of link shoes (b).

Dimensional control measured: 1. wear of a bolt is ≈ 3 mm, only the surface of bolt in contact with capsule is worn; 2. only the surface of bolt in contact with capsule is worn; 3. wear of a shell on the outside is $\approx 2,2$ mm and on the inside to ≈ 1 mm, with emergence of upsetting compound shell/slice and increasing the gap at about 0,8 mm by an upsetted compound. Chain pitch is 160 mm. Wear of a tribocouple, which causes a change in chain pitch (slice, shell and bolt) is about 8 mm, and there is 6,25 tribocouples on meter of a chain. Conclusion can be that the chain extension, as a result of wear parts, can reach more than 50 mm per meter, resulting in overall chain elongation of 1,600 mm in total length chain of 32 m. Wear so big reflects to chain pitch, and this sometimes results in ripping buckets of link shoes.

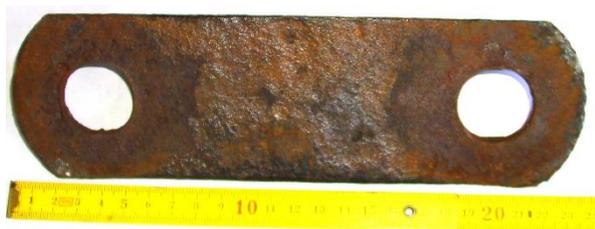
Chemical analysis showed that the slice and link shoes, are made of improved steel, C45E. The measured surface hardness of slices and link shoes, mean is about 210 HB. The thickness of these parts of the chain before the installation was 8 mm. Dimensional control was found that the corrosion caused local reducing of thickness on max. 6,8 mm. Metallographic search were carried out on a sample taken from a damaged external slice, Figure 2. In slice is pressed bolt Ø30 mm which is additionally welded to the outer side on the slice.

Fig. 2. Original damaged slice.

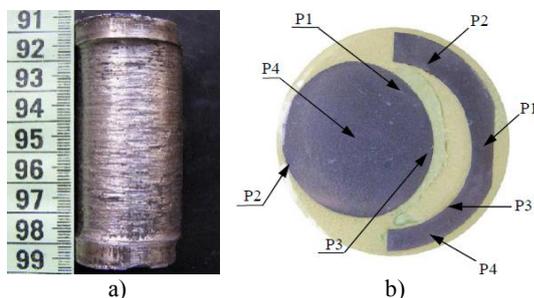
Chemical analysis showed that the bolts (Ø30 x 83 mm) and shells (Ø42/Ø30 x 65 mm) made of austenitic corrosion steel X5CrNiMo17-12-2 [5]. From damaged bolt Ø30 mm, shown in Figure 3.a, sample was cutted and control of hardness is performed. The cross-section of the test sample of damaged bolt is shown on Figure 3.b.

Fig. 3. The appearance of the original bolts in place „worn place“ (a); macro recording cross-sectional sample with marked positions of measuring the hardness of the bolt and the bushing shell (b).

At the macro recording of cross-section of damaged shells, positions of hardness HV1 measuring are marked, Figure 3.b. Hardness values measured HV1 from surface to core of sample taken from damaged bolt and shell are showed in Table 1.

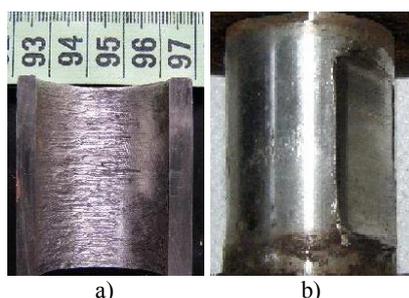
Test of shell is carried out on spot of damaging in towing part with the bolt, Figure 4.a, and in the outer side in contact with the sprocket, Figure 4.b.

Fig. 4. The appearance of the original bolt on spot „worn place“ (a); macro recording of cross-sectional sample with marked positions of measuring the hardness of the bolt and shell (b).

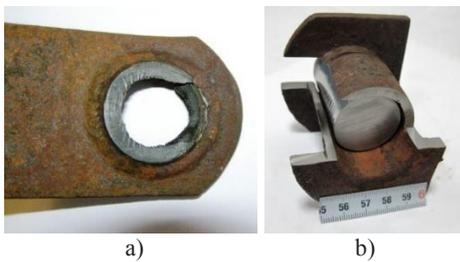
In order to verify welded compound bolt/slice were tested on the testing machine with static tensile tests. The load is added until the termination of welded compound, and broken places served for metallographic examination and hardness control. The appearance of the welded compound slice/bolt after testing is showed on Figure 5.a. The cross-section of tribosystem shell/bolt/slice where will be performed metallographic examination and hardness measurement is shown in Figure 5.b.

Fig. 5. External slice after breaking bolt (a); the cross-section shell/bolt/slice (b).

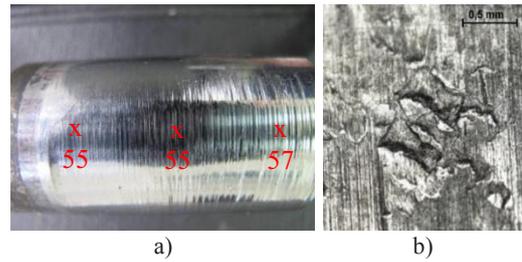
Characteristic traces of bolt wear are shown in Figure 6.a and 6.b.

Fig. 6. Characteristic wear traces of bolts, macro (a); micro (b).

Based on measurements on ten positions, conclusion was that on the most spended part diameter is 29,7mm, which is the higher for $\approx 0,3$ mm compared to the built measure of bolt. Traces of wear in the towing part of the stud characterize radial furrows caused by abrasive action of tiny particles of sunflower shell. These particles, during the work came in contact with bolt/shell, and considering the hardness of micro abrasives ≈ 6 Mohs [7] „furrows“ are interrupted at the point of encountering on harder carbides are logical look of traces of wear. Figure 9 shows the cross-section of the welded joint shell/slice and values of measured hardness HV1.

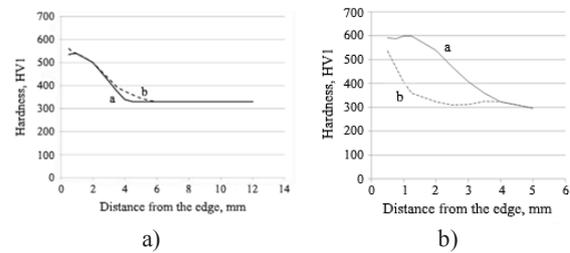
Diagram in Figure 7.a shows the flow of hardness HV1 from the edge to the core of the bolts on the unexhausted part (curve a) and on worn parts (curve b). Diagram in Figure 7.b shows the flow of hardness HV1 from the edge to the core of the shell after use.

Fig. 7. The flow of the hardness HV1 from the edge to the core after use of the bolts (a) and of the shell (b).

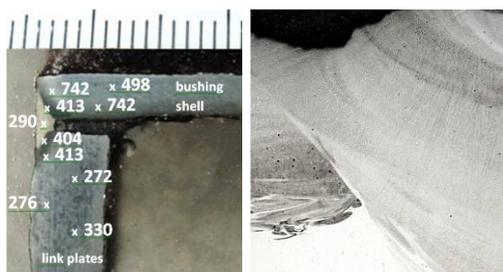
Fig. 9. Cross-section of welded compound link plate/bushing shell and values of measured hardness HV1.

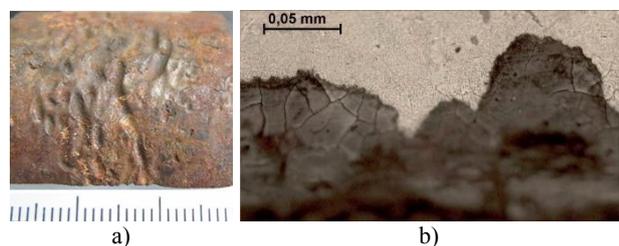
Figure 11.a shows characteristic traces of wear of external surface of shell, Figure 11.b shows traces of shell wear from the inside in contact with bolt.

Fig. 11. The typical wear traces of external carburized surface of bushing shell, the outer surface – macro (a); inner surface (b).

same as carburized shells in contact with bolt; 2. carburized shells are damaged by abrasion and corrosion due action of acid media which has pH value ≈ 5.2 ; 3. wear traces of external shell carburized surface with obvious local damage, suggest that dominant mechanism is abrasion; 4. maximum measured force at break of weld joint bolt/slice is higher than the budgetary breaking force of chain. The analysis results, search of structure and the measured hardness of triboelements show that the application of this approach to solving complex problems of wear elements of straight-chain transporter can achieve significant prolongation of life. Additionally, perhaps the most important, welding shells and bolt to appropriate slice avoid the risk of fracture. this is for all structures including tribosystem most important thing, because intensity of wear based on analyze of structure, hardness, traces of wear and middle media can predict. These results make conditions for possible continuation of research which will, except to increase the wear resistance of triboelements, could go in the direction of more detailed analysis of the impact of additional material for welding shells and bolts with slices so the choice of other parameters for welding process.
