Copper tubing failure due to ant-nest corrosion

Athanasios Vazdirvanidis¹, Sofia Papadopoulou¹, Spyros Papaefthymiou²,
George Pantazopoulos^{1,*} and Dionysios Skarmoutsos³

¹ELKEME-Hellenic Research Centre for Metals S.A., 32011 Oinofyta –Viotia, Greece

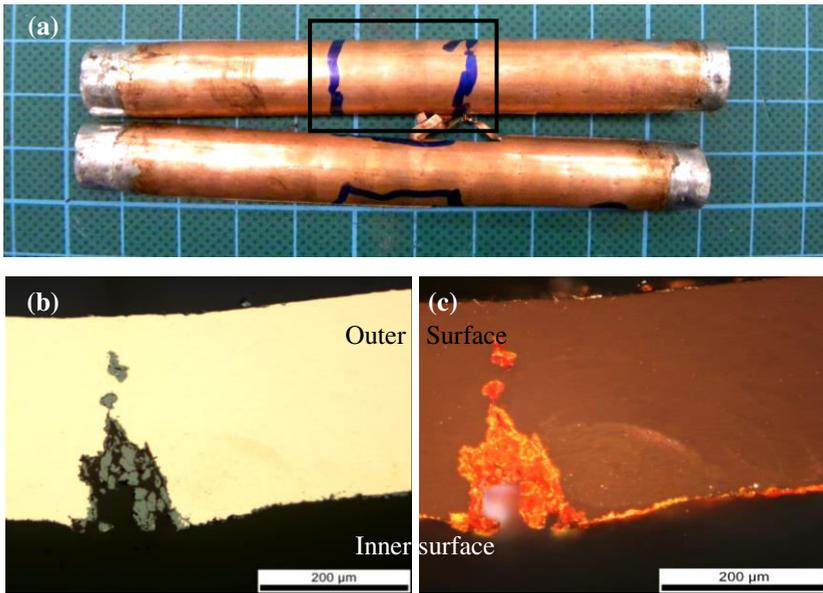
The outer surfaces of these tubes were often without serious indications of corrosion or severe mechanical damage, while the inner surfaces were heavily corroded exhibiting complex and branching channels, covered by corrosion products, while microcracks were found on each one of them. The corroded tubes and relevant features of the corrosion products were presented in Figs. 1-4. In optical micrographs [Fig. 1 (b) and (c)] a branched propagation with oxide deposits inside the caverns was exhibited initiating from tube's inner surface and copper oxides with polarized light. A similar type of corrosion propagation, initiated from the outer surface in this case, is shown in Fig. 2. The morphology of corrosion deposits and pit formation is shown in Fig. 4.

Fig. 1. (a) Macrograph of sample examined ($\text{Ø}12.7 \times 0.35$ for ACR) indicating area of interest, (b) transverse cross-section showing the copper corrosion products (inside-out corrosion) and (c) same area observed under polarized light – copper oxides are reddish.

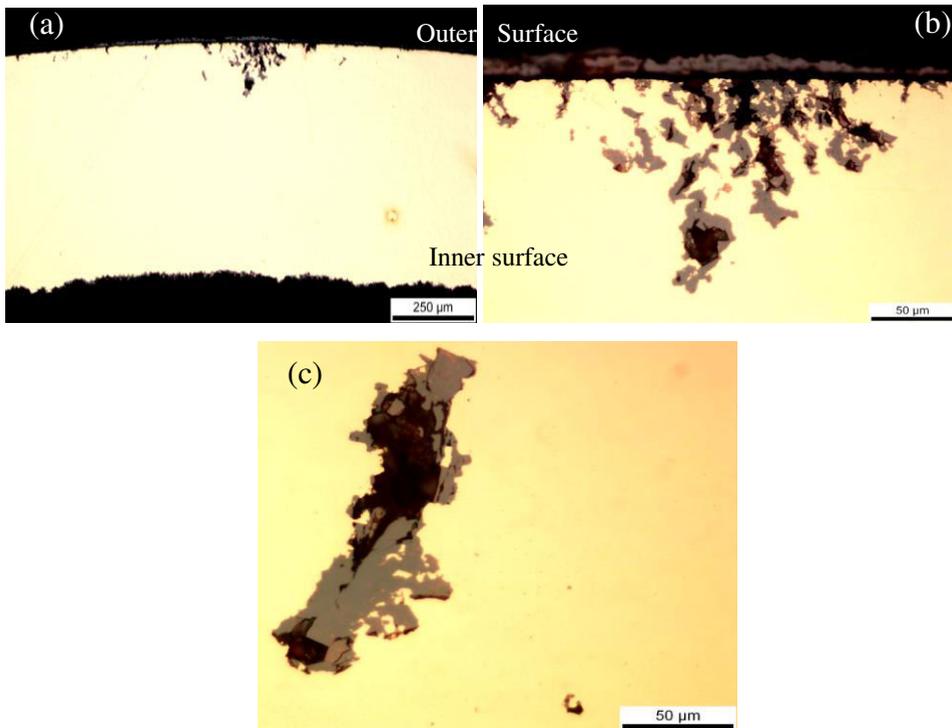
Fig. 2. Optical micrographs, cross-section of another tube showing ant-nest corrosion type failure ($\text{Ø} 15 \times 0.70$ for sanitary use). Note the accumulation of the corrosion products close to the outer surface.

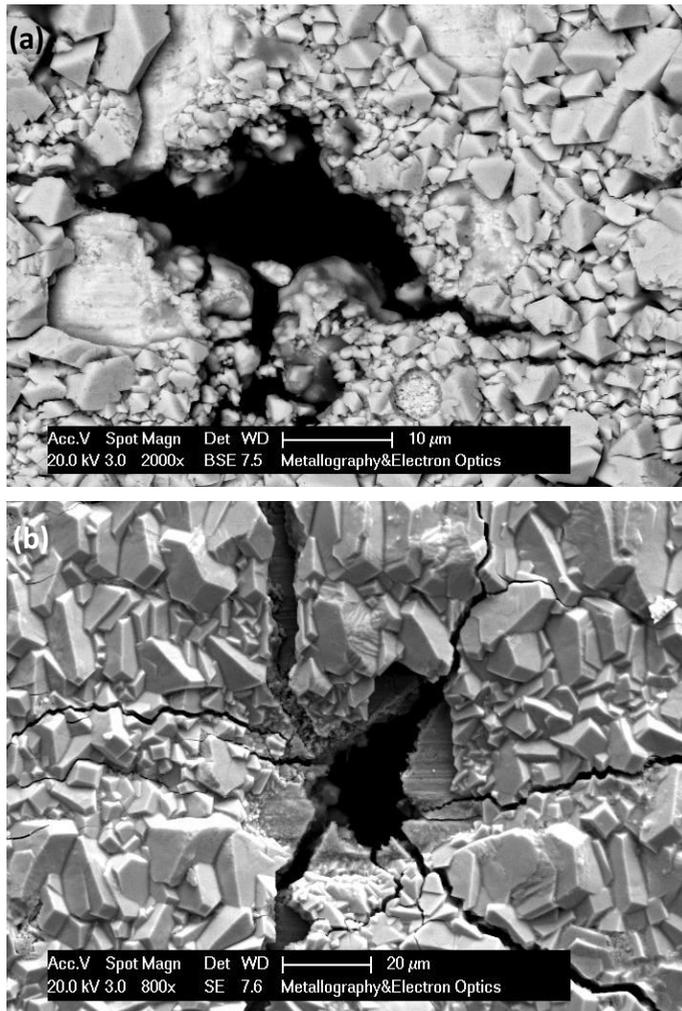
Electron micrographs showing pits' formation and coarse oxides containing also O, S, Al, K and C are illustrated in Fig. 4.

Fig. 3. (a) SEM micrographs of the inner surface showing pits' formation. Note the cubic crystalline oxide products.

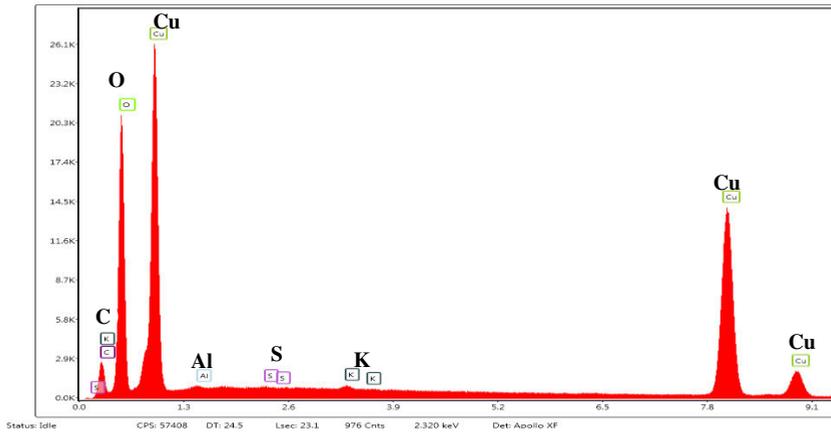
Fig. 4. Typical Energy dispersive X-ray spectrum; full frame analysis of the corrosion products.

Corrosion was propagated through branched and tortuous corrosion channels filled with coarse corrosion products. Chemical analyses exhibited mostly O, S, Al, K but also C which could be attributed to organic matter presence. All the above findings are consistent to the action of ant-nest corrosion mechanism.
