Failure analysis of performance vehicle mechanical gear

Antonios D. Tsolakis, Konstantinos I. Giannakopoulos^{*} and Andreas S. Gkertsos

Department of Mechanical Engineering, Piraeus University of Applied Sciences, Greece

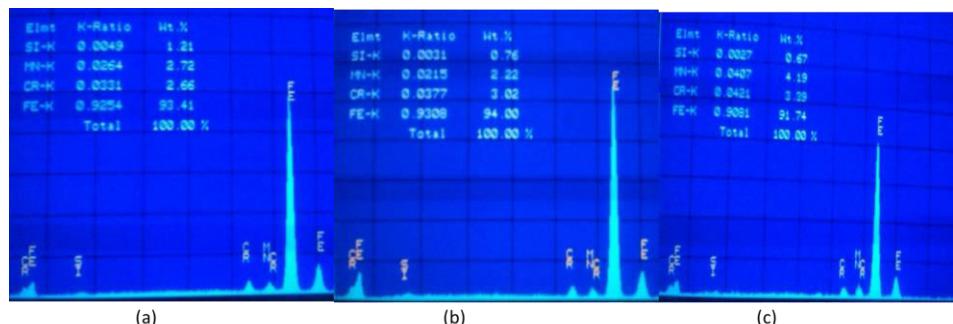
Fig. 4 Different chemical analysis results depicted. 4a on the left edge and 4b on the middle and 4c on the right edge of the gear .

For the determination of the material, chemical analysis was done to the fractured piece of the gear via EDAX chemical analysis. 3 samples were taken in order to validate the results, and below is an average value of each element. Fig.4a, 4b and 4c show each chemical analysis independently.

- 93.05% Fe
- 3.02% Cr
- 3.04% Mn
- 0.88% Si

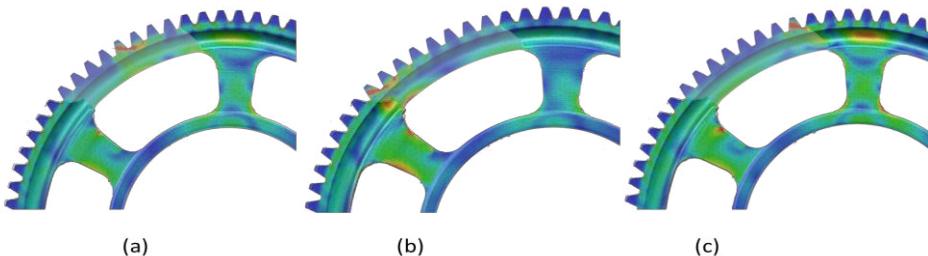
Fig. 7 Multiple Simulation scenarios can be seen. (a) first tooth engagement during fracture, (b) middle tooth engagement, (c) last tooth engagement.

Comparing the results, it is clear that the first case study is valid as the stresses developed in the gear are at the points that the gear suffered fracture. There is a special point in which the simulation presented a concentration of stresses in the inner part of the gear (below the outer surface). That point, is the point where the fractured changed direction and a corner was formed. See Fig.7a

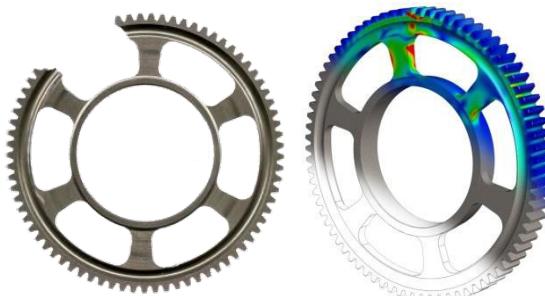
Fig.9 (a) The gear after suffering fracture, (b) the FEA solution superimposed on the gear model

The gearbox was in racing conditions when failure took part. The Go-Kart was speeding in 2nd Gear at wide open throttle when suddenly the driver accidentally downshifted to 1st gear. The result was for the first gear to break a whole piece and eventually the system to go out of operation. In figure 9a,b, the fractured gear and the FEA solution of the fractured gear are shown.

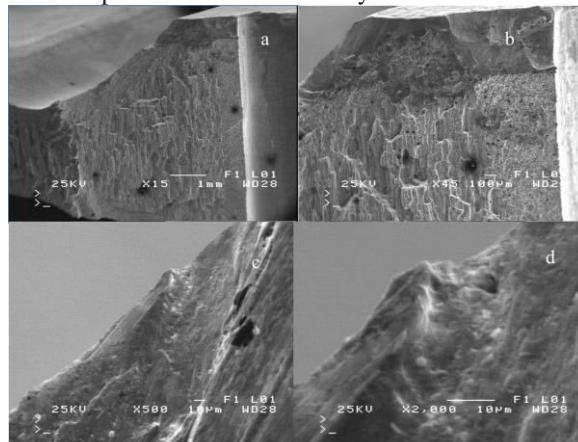
Fig. 9 Fractured surfaces observed by SEM microscope. Different magnifications are presented (a) x15, (b) x45, (c) x500, (d) x2000.

Fig.9a shows the fracture surface of the main part of the gear which exhibit ductile fracture phenomena in the central regions of the surface. In these areas, an intense terrain is present with characteristic crystal detachment areas, whereas in areas near the edge of the gear body mixed fractured phenomena is visible with intense brittle nature (areas of low roughness with evident the slit effect). The existence of such areas on the edge of the main part of the gear may be linked to a surface heat treatment process such as hardening, which explains the presence of different type of fracture in relation to the main body of the gear. Figures 9b and 9c are enlargements of the surface area that was studied in fig.9a. In these figures, it is apparent the phenomenon of successive crushing levels on the edge of the specimen, especially in the mixed fractured area with limited relief. From these two figures, it is possible that the material failure mechanism can be attributed to a fatigue phenomenon of the above layers of the material near the outer surface, to which may be contributed by the hardening heat treatment of the material with a final result, the accumulation of stresses in areas near the edge of the material from which began the phenomenon of fracture. The characteristic "waves" of fatigue are visible with characteristic concentric development, fact that shows that the fracture point of the material may be in the area showed in Fig.9d.

Watching the photos exported from the microscope, there are two distinct areas. The surface area of the main body of the gear which shows traces of ductile fracture, and the area on the surface of the gear which exhibits strong brittle character. This variation is

because the gear was subjected to surface heat treatment and the crystal structure had changed in the outer surface in relation to the main body.

Successive levels of fracture in the main body of the tooth, indicate the failure resulted from fatigue of the surface layers of the gear (which had been heat treated), and then transmitted to the interior, resulting in complete breakage of the portion.
