The role of NDI on the failure analysis of an aircraft propeller hub

Abstract. This paper analyses the causes of an incident in an aircraft propeller hub. The aluminum alloy propeller blade hub was detached from the plane bearing one of its two blades with the other one being jettisoned away. Stereoscopic examination of the fractured hub revealed that it was initially cracked by fatigue, with the crack initiating on the root of the third and fourth spirals and propagating from the inner to the outer. SEM analysis showed that the crack epicentres were created very close or/and on the spiral roots and were attributed to microcracks from corrosion pits and high stress concentration. Non Destructive Inspection was both used on the other side of the hub and the remaining three hubs of the plane and confirmed the presence of cracks similar to those which caused the fatigue failure of the fractured hub but at earliest stage of development.

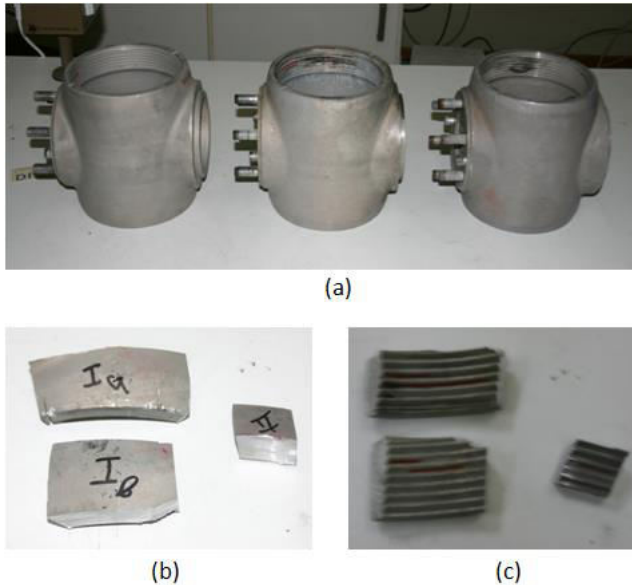
Three hubs, which had undergone Non Destructive Inspection (NDI), were thoroughly examined. In particular, parts of the hubs, in which NDI had detected cracks, were cut off as seen in Fig.1.

Fig. 1. (a) View of the hubs (b) outer side of the hubs cut off parts (c) inner side of the hubs (threads) cut off parts for further examination

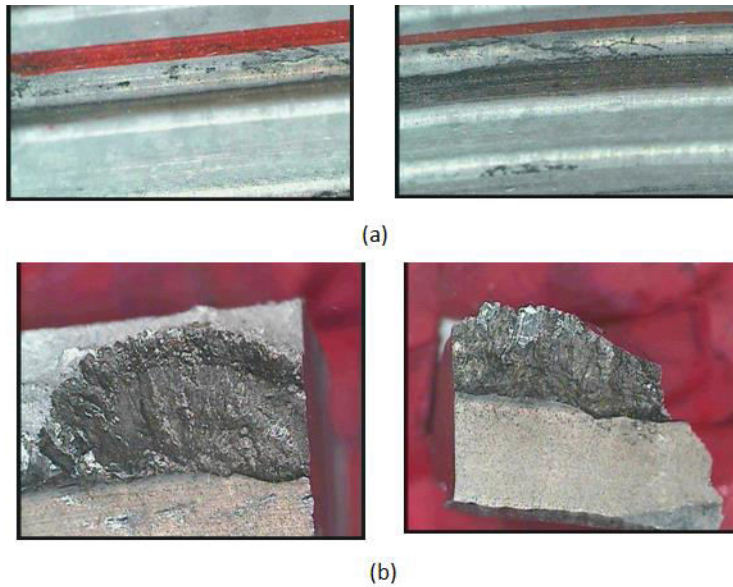
Fig 2 shows parts of the detected cracks. All the cracks were detected between the threads (in between second and fifth). Further on successive incisions were performed in order to open the cracks (Fig. 2b). It is evident that this is a typical case of fatigue fracture from multiple initiation points in stress concentration areas near the thread root. It is similar in nature to the crack from which caused the failure of the incident, but at earliest stage of development, with a depth of about 0.6 cm.

Fig. 2. (a) Cross section of the hub thread with parts of the cracks (b) open crack

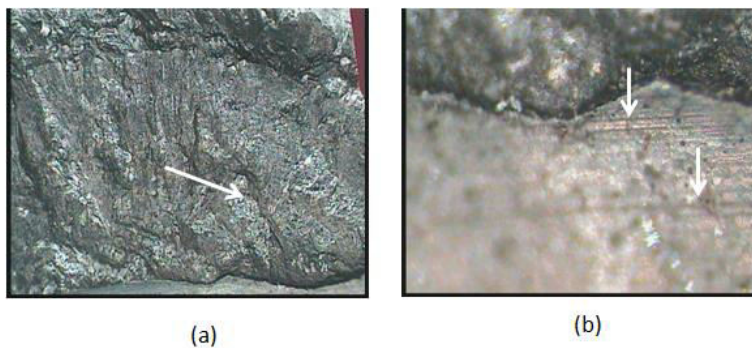
Closer observation of the drilled crack surface (fig. 3) shows typical macro fractural fatigue characteristics, e.g. macro-striations (beach marks indicated by arrows, Fig. 3a), ratchet marks (arrows, Fig.3b) and semi-ellipsoids characteristic morphology (like fingernail).

Fig. 3. Cross section of the drilled crack

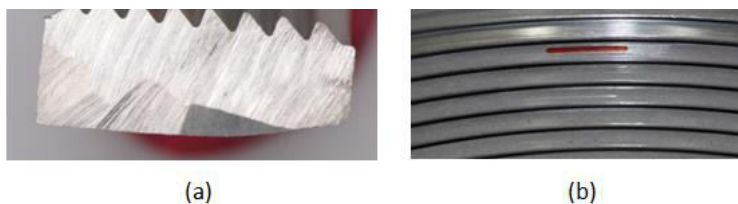
The hubs were made of Al- alloy 2014-T6 (Table 1). The hub threads were saw tooth type with either full or cut off the tops (fig 3a). In areas where cracks were detected as well as in neighbouring areas, different colour shade of the surface was observed which is attributed to the destruction of the anodized surface layer of the threads probably caused by abrasion during assembly - disassembly (Fig. 4b).

Fig. 4. The fractured hub threads

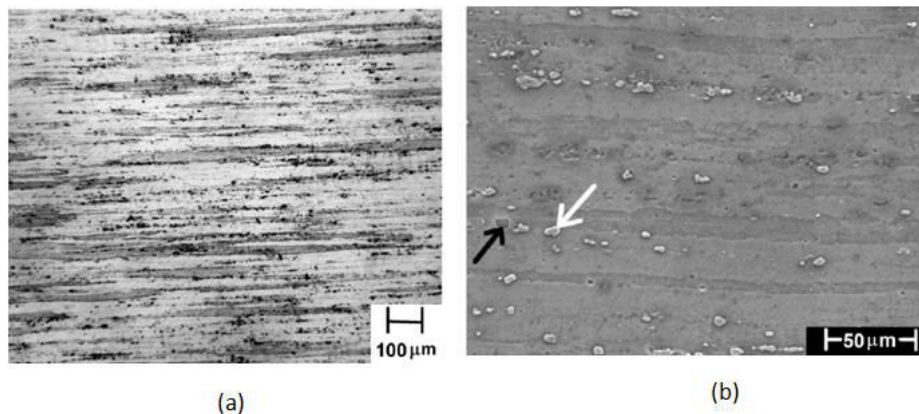
Microstructural study of the hub material is shown in Fig.3 and consists of highly elongated grains with a large number of undissolved second-phase particles (5 to 10µm in size), aligned in the working direction. SEM-EDS revealed that these particles are Al₂Cu (shown by white arrow in Fig. 5b) and Fe–Mn–Al (shown by black arrow in Fig. 5b) intermetallics [2].

Fig. 5. Optical and SEM micrograph of the hub material

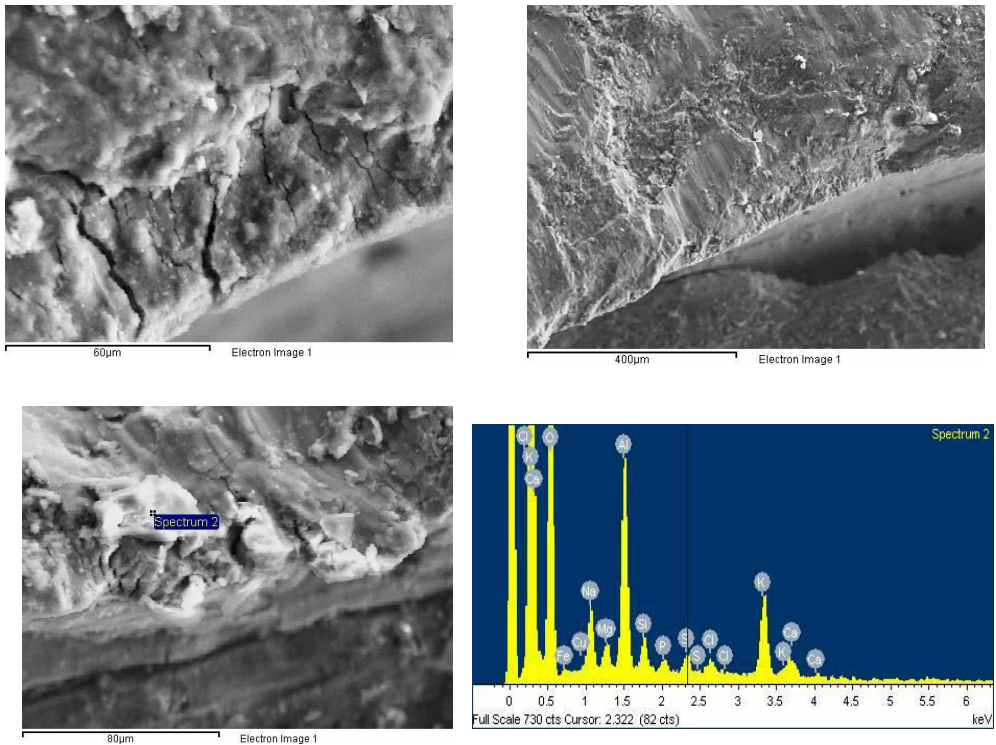
Fig. 6 shows the micro fractural SEM examination of the area with the crack initiation point. A number of microcracks can be observed from pitting and stress corrosion cracking- (SCC) of a similar nature and origin to the microcracks of the failed hub [13].

Fig. 6. Chemical microanalysis of corrosion products in the area of microcracks initiation

Chemical analysis of the corrosion products revealed the presence of O₂, Cl, S, K and Na which proves that the destruction of the anodized surface film enhances pitting and stress corrosion cracking and eventually it is necessary during general inspection to check the overall situation of the protective anodizing film.
