Analysis of the Constructive Features of the Earth Dam

Abstract. The article considers the earth dam of the run-of-river unit – Kuibyshev hydroelectric power station on the Volga river (Russia). The main parameters of the earth dam, peculiarities of its erection and operation are described. The article notes the importance of ensuring a high degree of reliability of water structures constructed near major cities. It is especially important to monitor the condition of retaining structures with long service life. The factors influencing the change of the initial design conditions of operation of the Kuibyshev run-of-river unit dam are discussed. The results of examination of the geometric parameters of the body of the dam, performed at different periods of its maintenance, are analyzed. Examination results revealed significant deviations of the elevation marks of the earth dam surface on the upstream side from the design values. Possible causes of the discrepancy between these parameters and the design solutions are considered. The conclusion is drawn that the most likely reason for these features of the dam design lies in the initial incompleteness of construction. The measures for

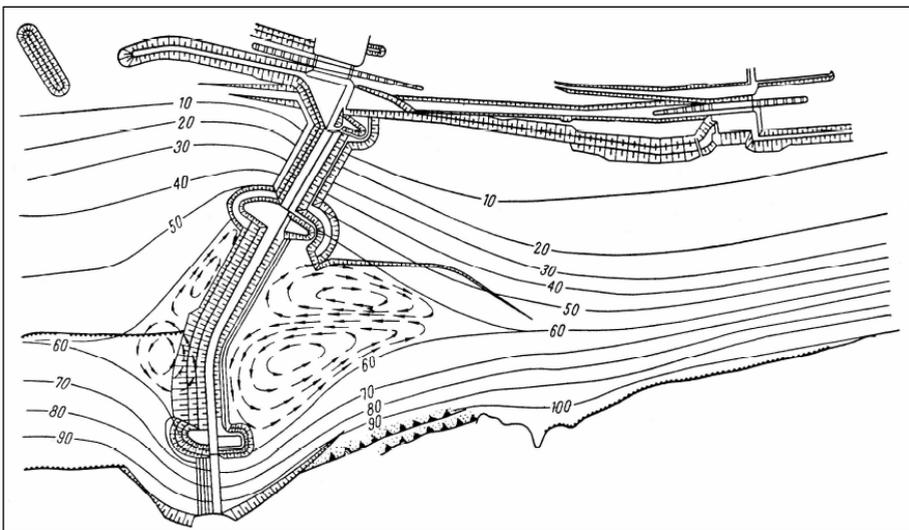
Fig. 3. Flow plan [3].

As a possible reason for the noted discrepancies in the dam profile, the following is stated [3]. The longitudinal axis of the earth dam in top view is significantly fractured. This circumstance caused the inclined water supply to the power station units. The angle between the axis of the station supply channel and the axis of the earth dam is about 50° (figure 3). During the initial period of the dam operation, these features led to significant alongshore stream velocities, which could cause erosion of the body of the dam. In addition, authors point to the possible destructive effects of waves, as well as vertical and horizontal whirlpools.

The analysis of the operating conditions of the earth dam in the first years of operation, carried out by the author, showed that the abovementioned factors could not have such a significant destructive effect.

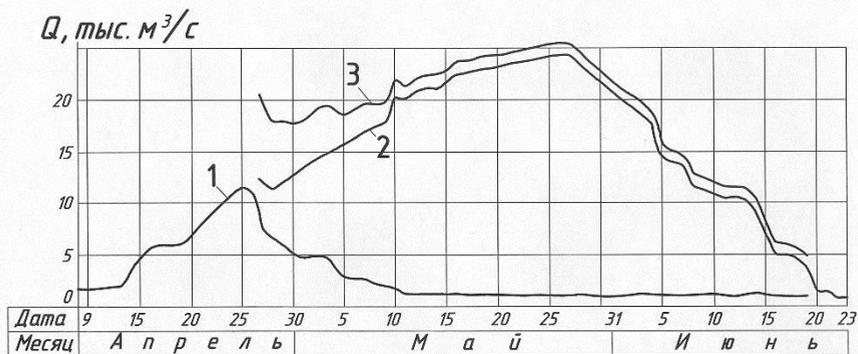
Fig. 4. The schedule of flood discharge through the structures of the Kuibyshev hydroelectric complex in 1956: 1 – water flow through the station building, 2 – through the weir dam; 3 – total discharge.

Indeed, this assumption does not take into account the actual data on the water discharged through the hydropower plant aggregates during the analyzed period. Thus, figure 4 shows the graph of the water flow through the structures of the hydrosystem in the spring-summer period of 1956, according to [3]. The graph proves that the maximum flow of up to 10-13 thousand cubic meters passed through the power station unit only in April 23-26, and after May 11, the discharge did not exceed 1.2 thousand cubic meters. Note that the cross-sectional area in the narrowest part of the power station supply channel, which can be exemplified as the channel cross-section along the ridge of the flooded bridge, was about 7500 m^2 .

Thus, the average flow velocity in the supply channel of the power station was $10,000/7593 = 1.32 \text{ m/s}$ for 4 days. Further, by mid-May of the same year, the average flow velocity decreased quickly to a value of $1200/7593 = 0.16 \text{ m/s}$. It is worth mentioning that the largest velocities are usually observed in the central part of the stream where depths are the greatest. In the coastal zone, the flow is usually slower. The velocities of the water flow along the coastal current near the slope of the dam near profiles No. 5-6, obviously, were even smaller. The abovementioned velocities, most of the time (except for a few days), were below the erosion values, which for fine sands are $0.2\text{-}0.4 \text{ m/s}$.
